Engineering Ethics Case Study: The Taum Sauk Reservoir Failure

"Taum Sauk Upper Dam Breach:

Technical Reasons for the Breach of December 14, 2005"

Taum Sauk Upper Dam Breach FERC No. P-2277

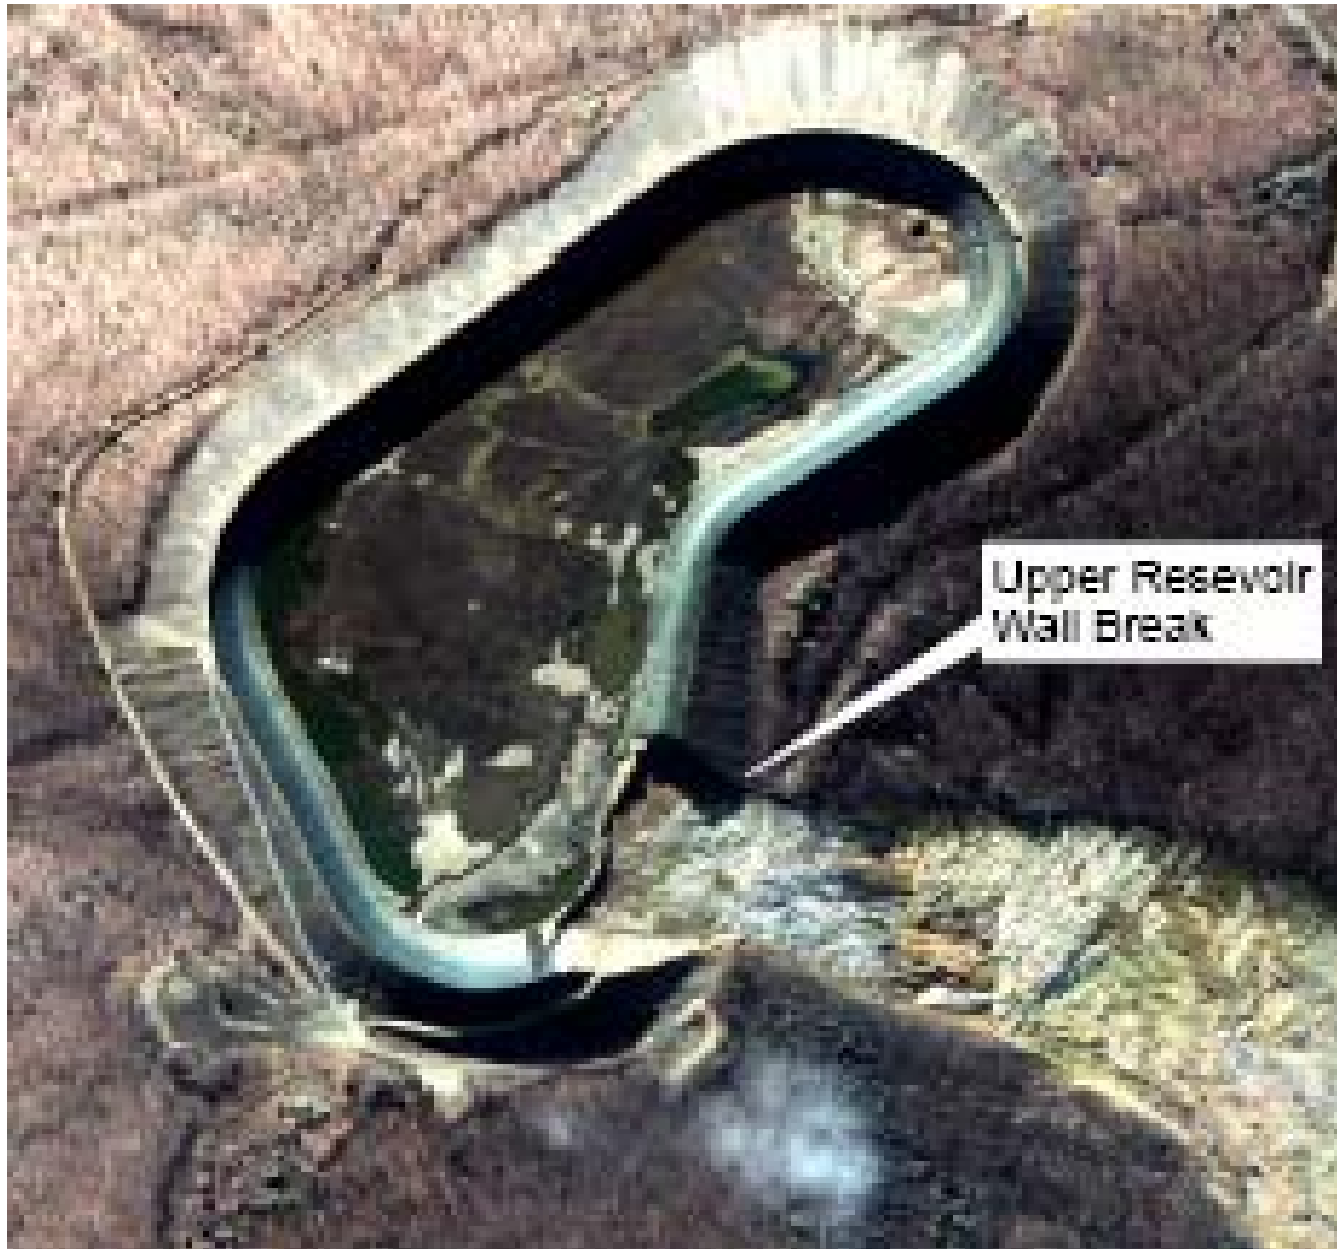
Figure 6-1

On December 14, 2005, an uncontrolled release of water from the upper reservoir occurred at the Taum Sauk Pumped Storage Project resulting in the damage shown in Figures 6-1 and 6-2. The time history of the reservoir transducers and the penstock transducer just before, during, and after the breach is shown in Figure 6-3. It is shown on Figure 6-3 that the full breach developed within about 25 minutes from the initial dropping of the reservoir level.

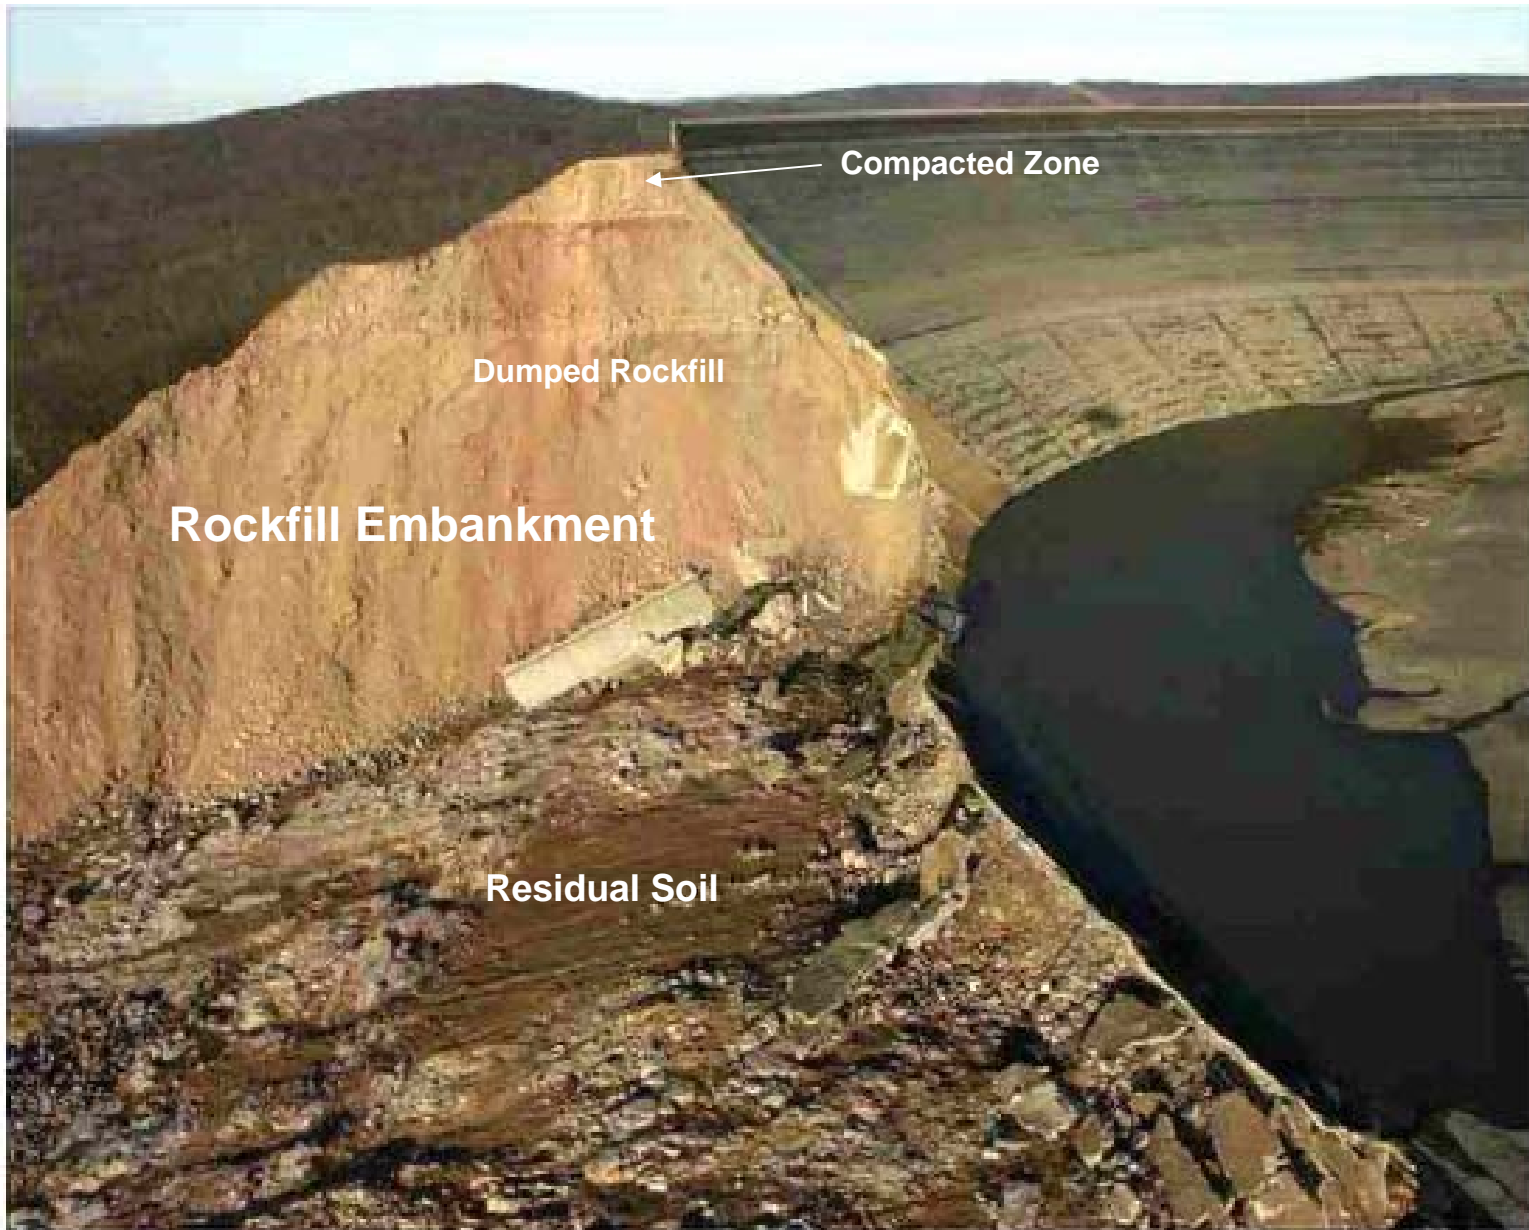
During IPOC inspections at the site, a good cross-section of the embankment could be observed on the north side of the breach as shown in Figure 6-4. In Figure 6-4 the dumped rockfill can be observed below the upper 20 ft of compacted rockfill. The rockfill exposed in this section is dirtier than a normal rockfill and as such would be more erodible and would be less free draining than a normal rockfill. In fact Dr. Frank Nickell (one of the original consultants during design) mentioned in one of his reports that the rockfill with the most fines could be used in the upper 20 ft of compacted rockfill for the roadway on the outside of the parapet wall.

A residual soil zone of weathered rhyolite could also be observed in the breach area; and one location is shown in Figure 6-4. The residual soil was observed to

be clayey and it was judged to have an effective shear strength almost dictated by the clay portion of the soil. Exposed rhyolite bedrock is also observed in Figure 6-4 as well as the remnants of the lower face slab and plinth.

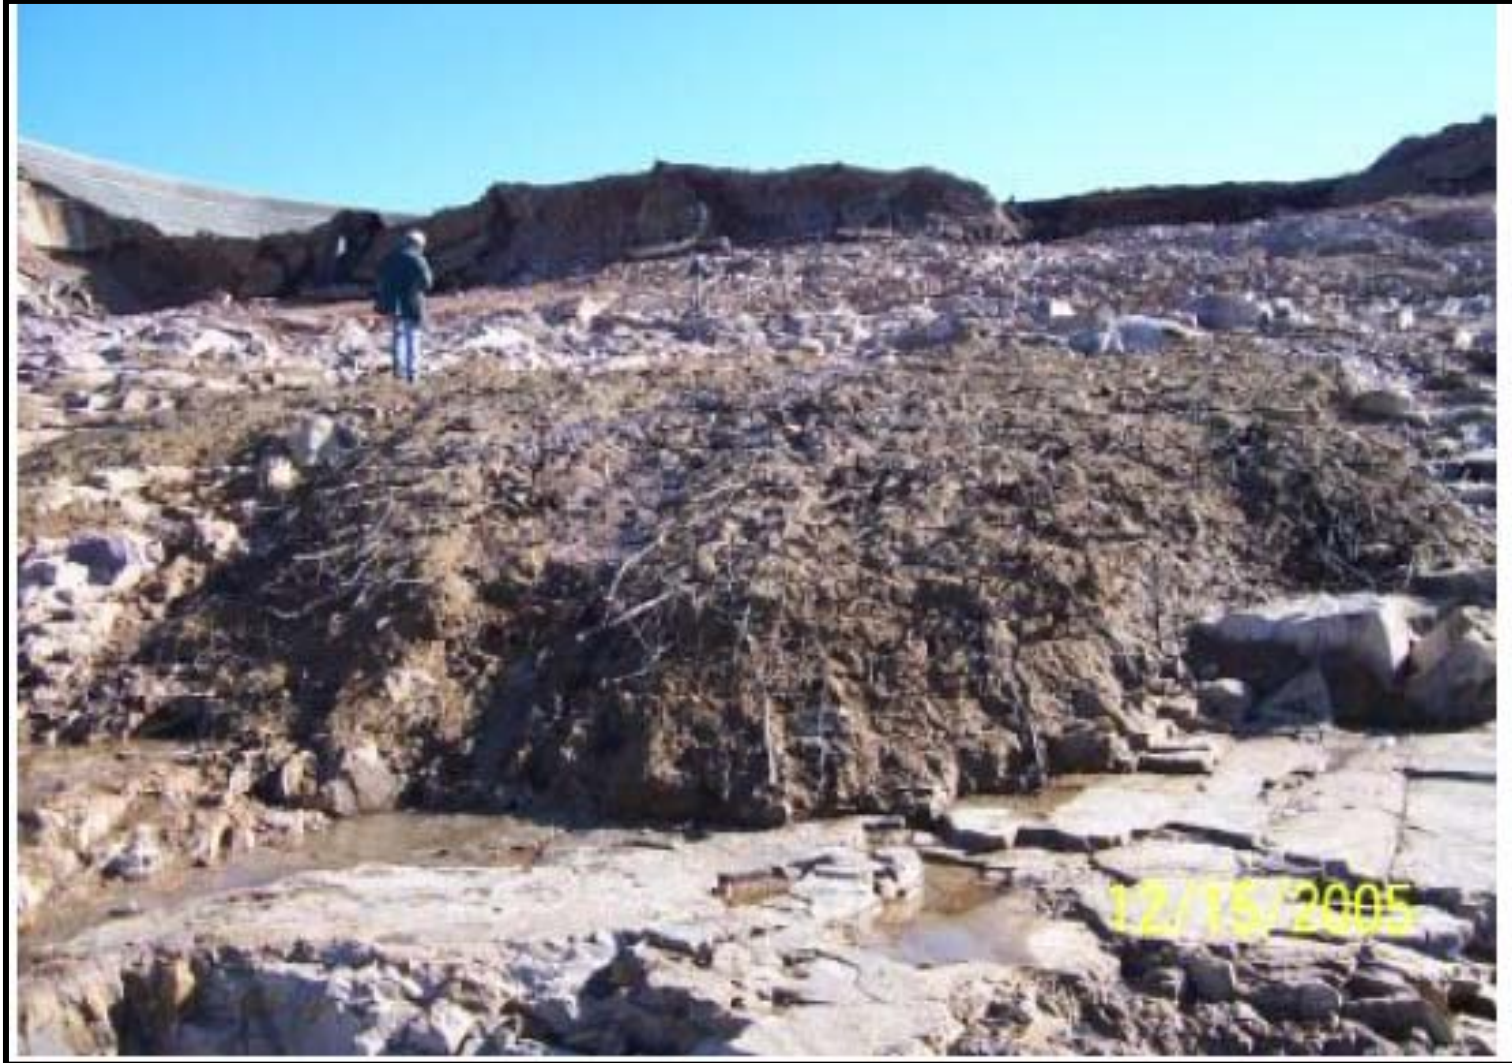
Figure 6-5

A closer view of the exposed rhyolite bedrock and residual soil is shown in Figure 6-5. This photo is taken looking east and the rather flat looking joint surface in the rhyolite dips toward the camera in a westerly direction. This discontinuity was observed in the field to dip nearly west at a dip of about 10° . This discontinuity is described as Fracture Set 8 (FS-8) in the Rizzo Report and is reported to have a dip of 8° and a dip azimuth of 270° . As a result of the observation of the residual soil, the IPOC requested that samples of the residual soil be taken for direct shear testing.

Eroded foundation, note rock jointing and overlying clay materials

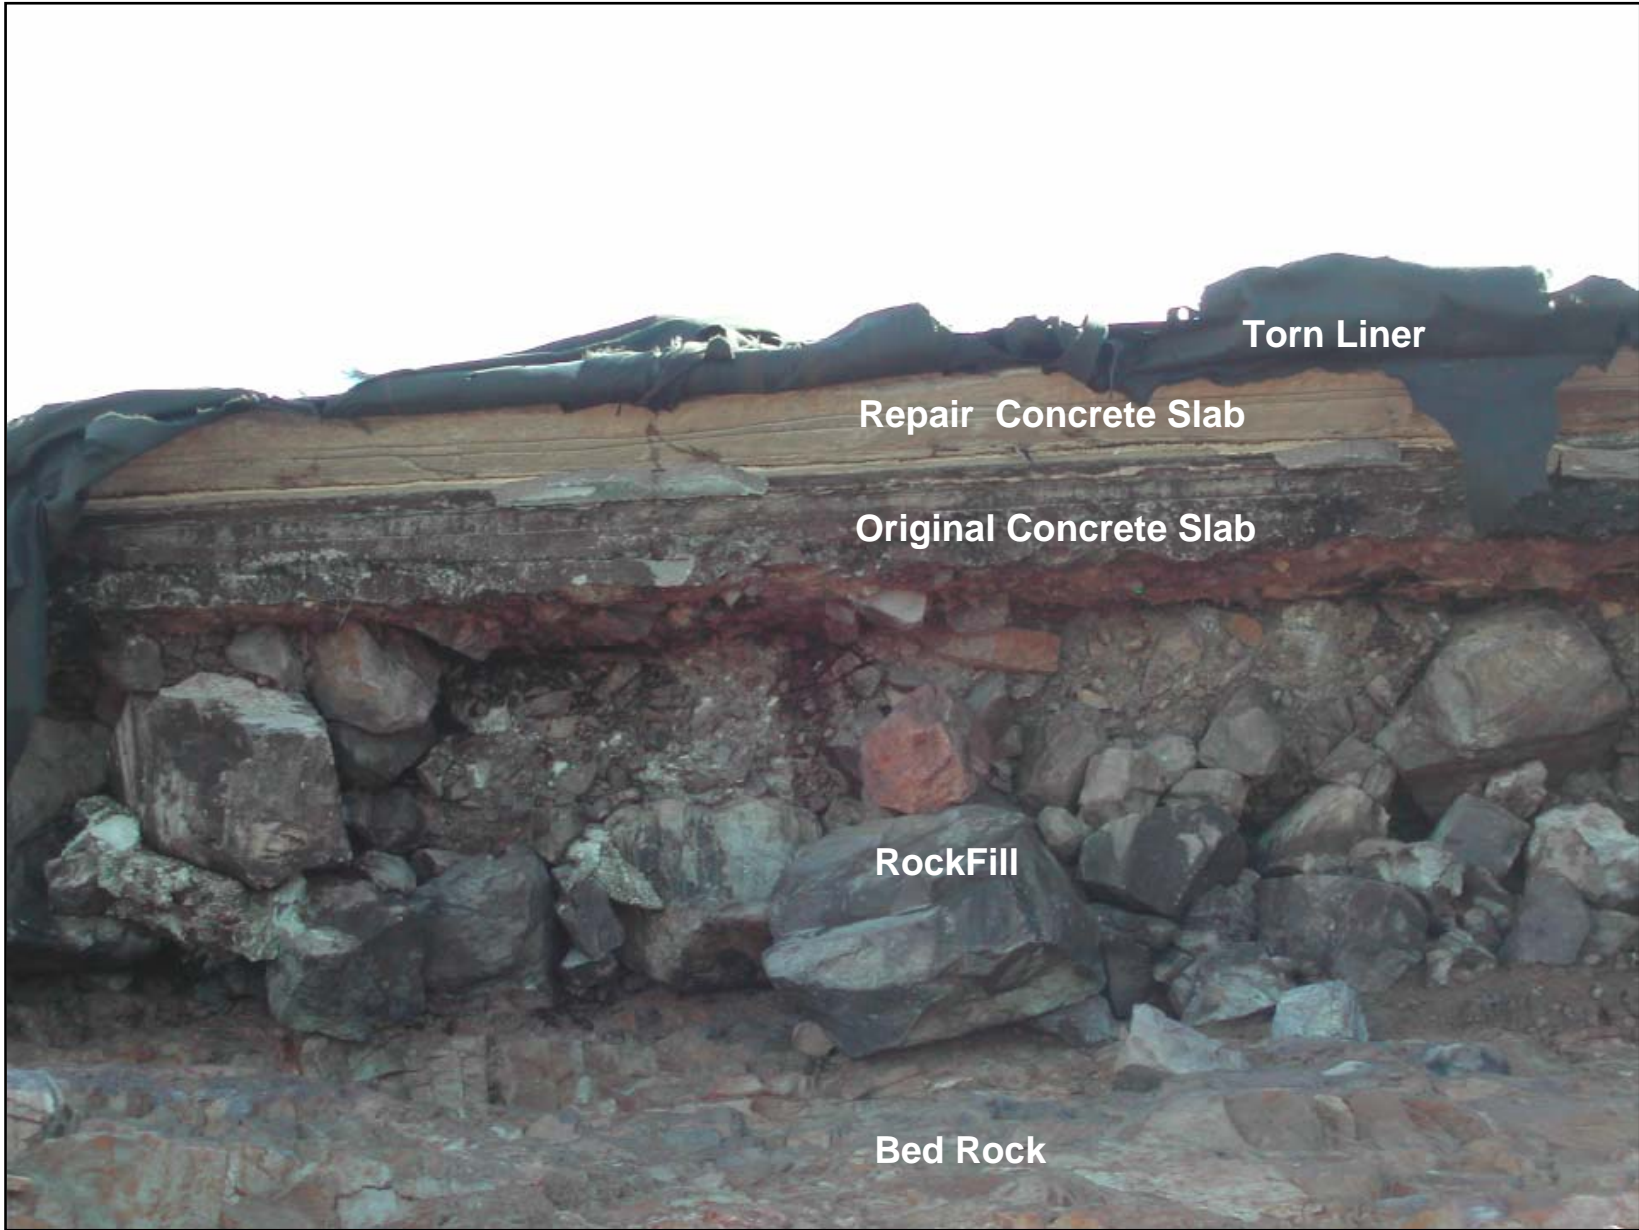
Figures 6-6, 6-7, and 6-8 show three views of the area under the base of the bottom of the face slab and plinth. The most glaring issue revealed by Figure 6-6 for example is that it appears that the plinth was not taken down to the rhyolite bedrock shown at the bottom of the photo. This is not considered good practice today and it was not good practice in 1963. Figures 6-7 and 6-8 show similar construction along the plinth area. This observation makes it consistent to rationalize the blow outs and holes that had to be repaired upstream of Panels 90-95 in 1963 and 1964. It definitely appears from these inspections that the plinth was not extended to bedrock for this dam, at least in the breach area.

Rockfill between top of rock and base of plinth

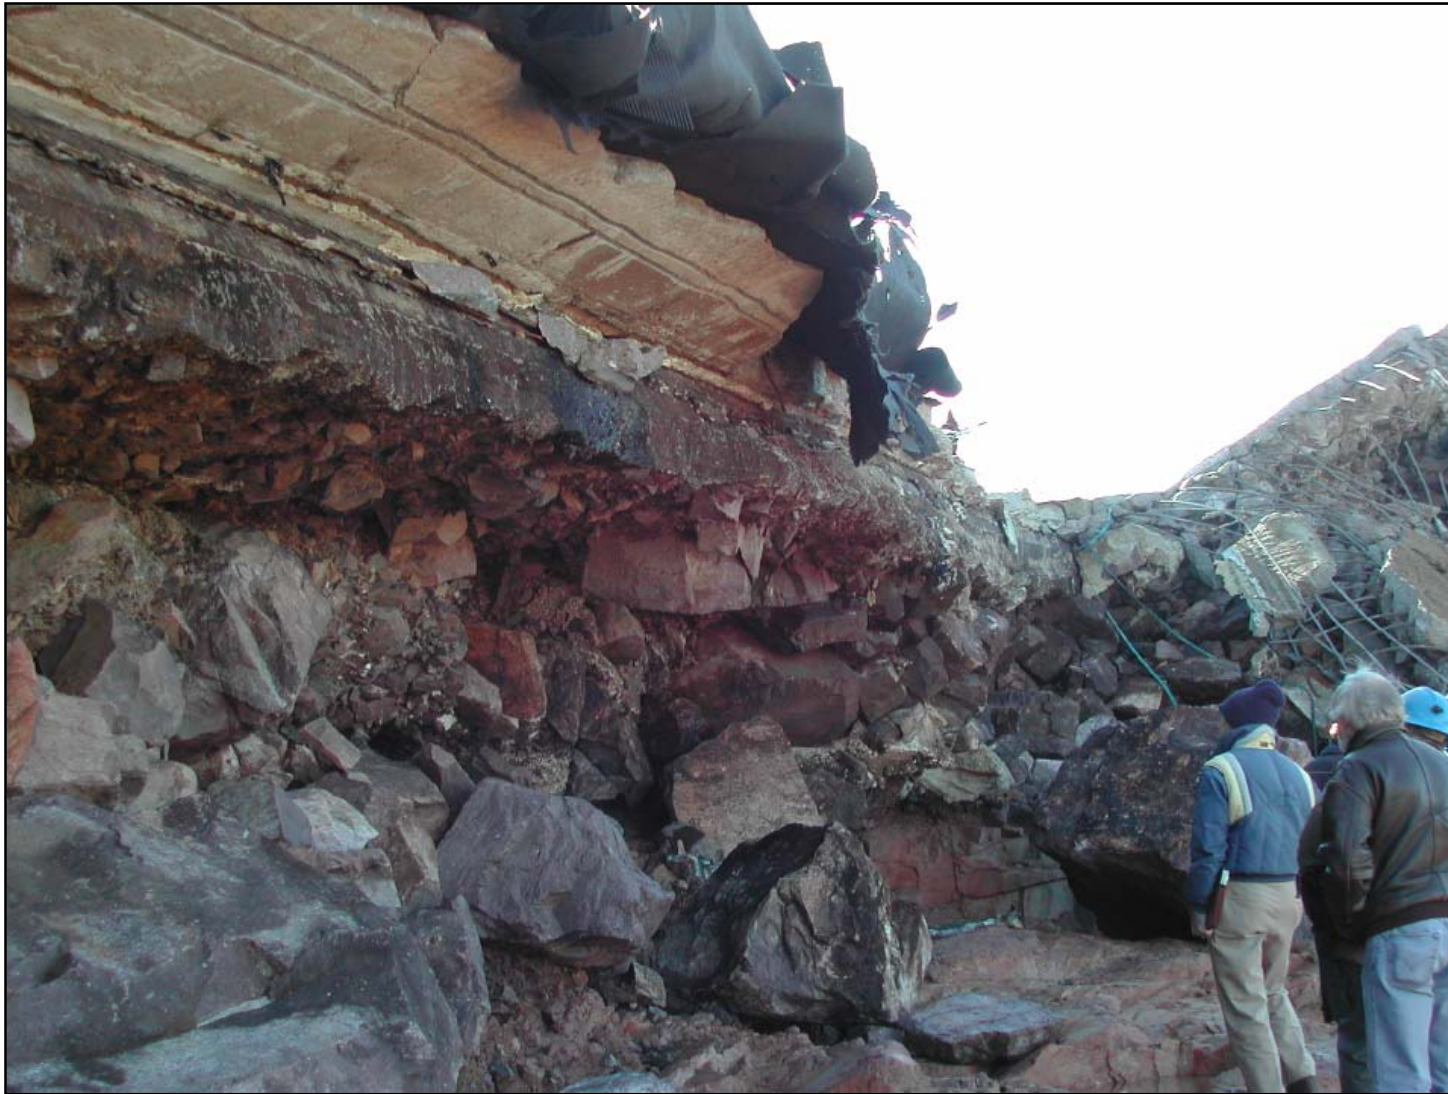
Figure 6-7

Rockfill between top of rock and base of plinth,
note reddish grout in rockfill beneath the plinth

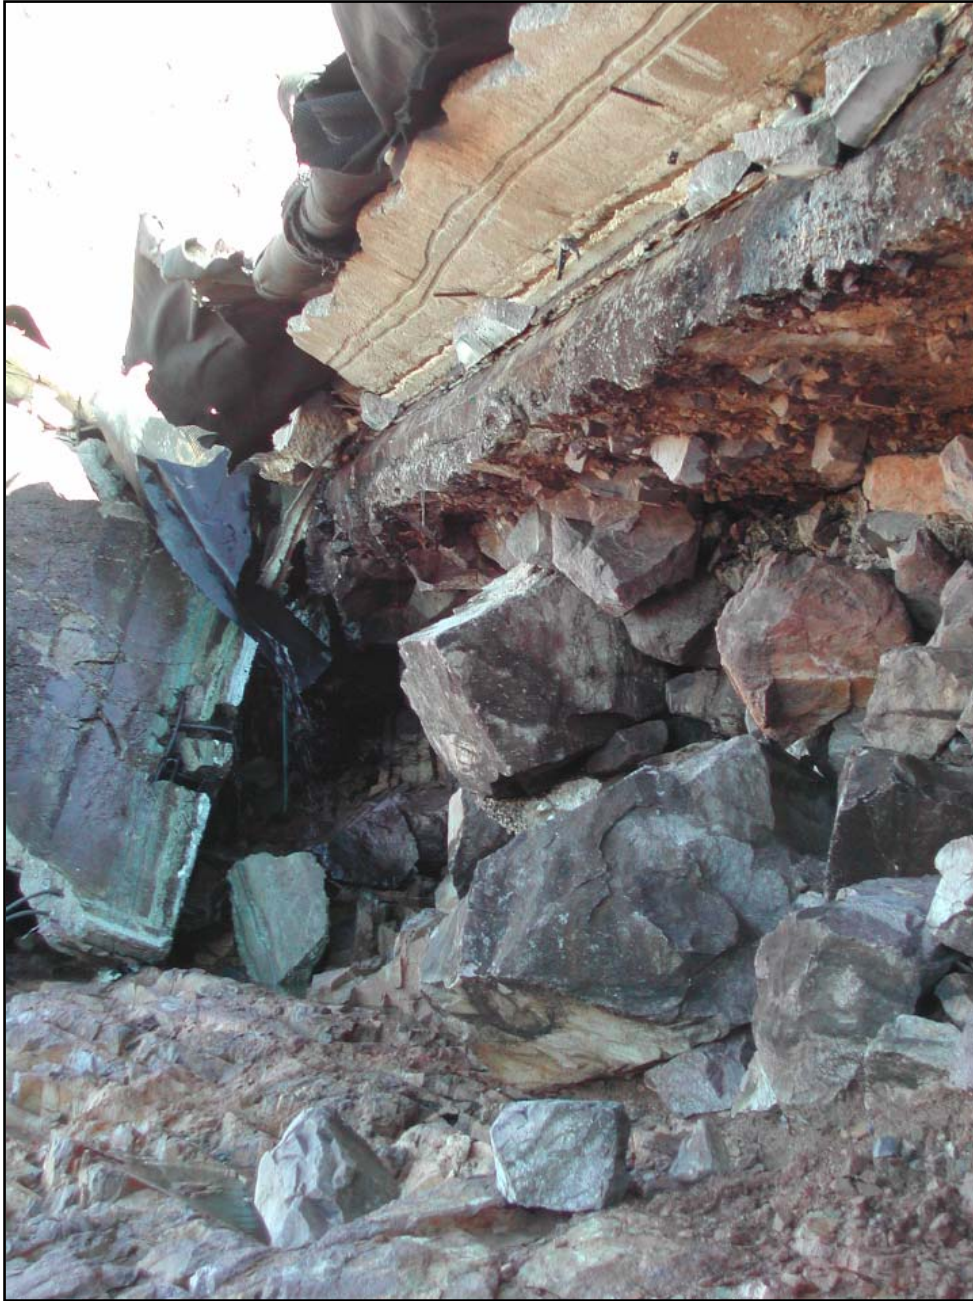
Figure 6-8

Rockfill between top
of rock and base of plinth

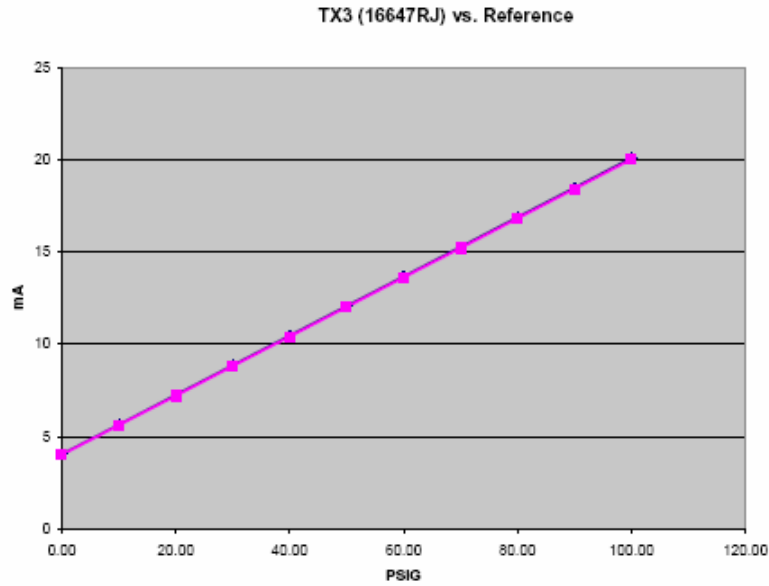
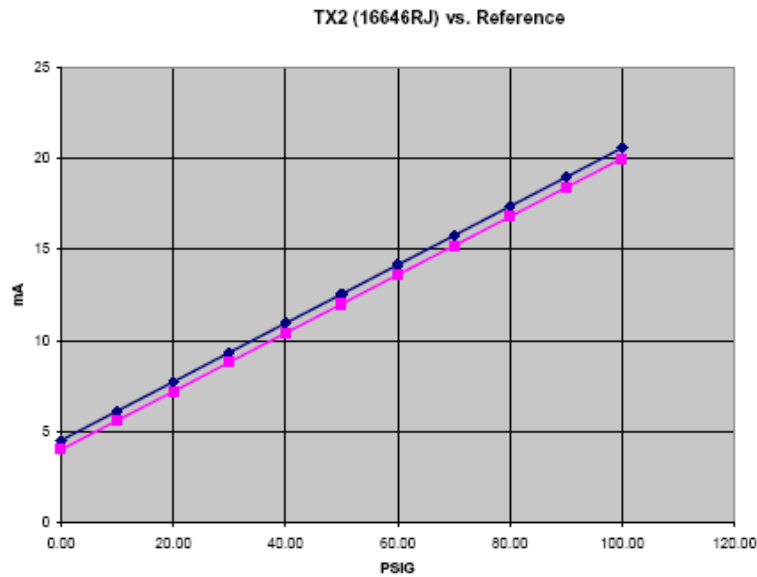
Figure 7-1 shows plots of ma output versus PSIG for TX2 and TX3 compared to a reference (ideal) transducer. Both TX2 and TX3 have linear response to pressure but TX2's ma output represents about a 7.86 feet higher indication than the reference curve while TX3's ma output represents about 0.85 feet higher indication than the reference curve. Figure 6 on page 20 of 76 in Appendix A of the Rizzo report shows that the as found PLC logic includes a subtraction of 9.38 feet from the TX2 pressure indication and a subtraction of 2.4 feet from the TX3 pressure indication. The basis for these adjustment values is not stated in Appendix A of the Rizzo report.

Pressure Transducers TX2 and TX3 Compared to Reference Transducer (TX2 reads average of 7.86 feet high and TX3 reads average of 0.85 feet high)

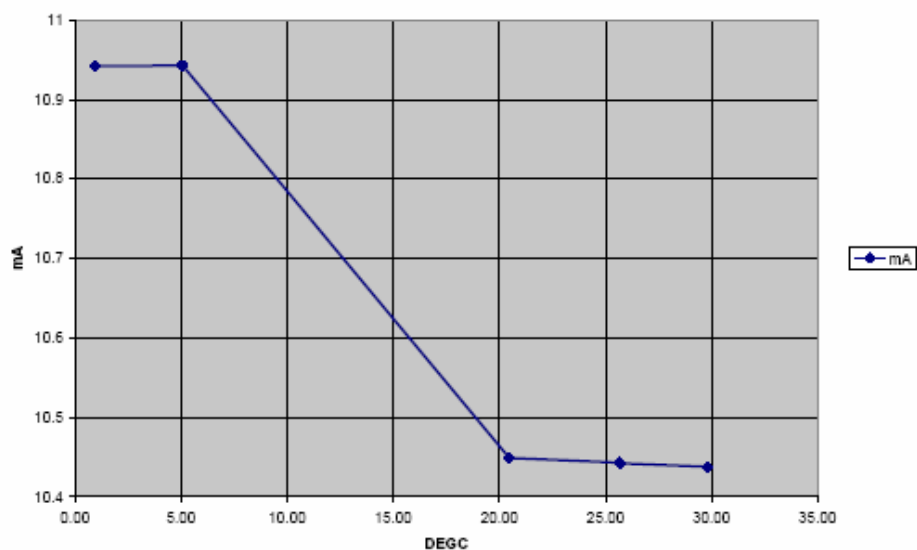
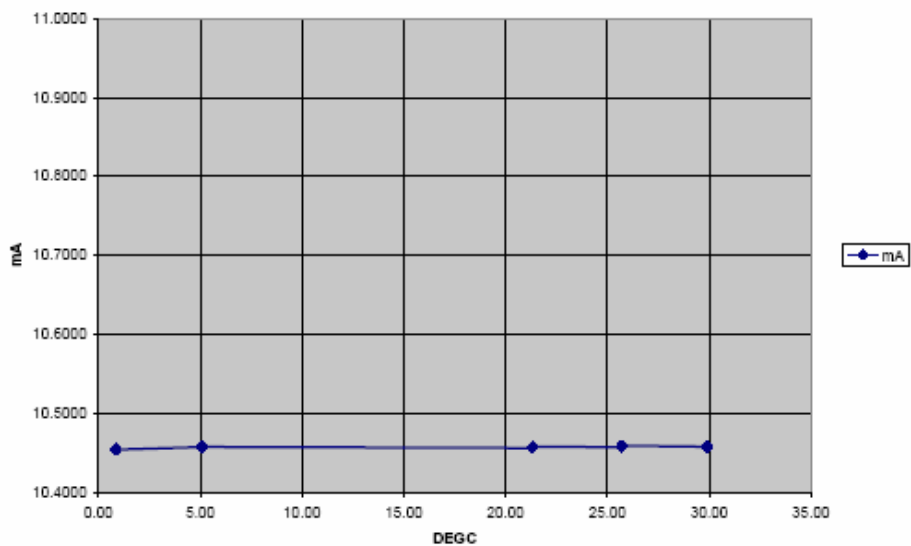
Figure 7-2

**Pressure Transducer Temperature Sensitivity
(TX2 Output Shift Represents +7.11 Ft. of Water Level
at 5 degrees compared to 20 degrees)**

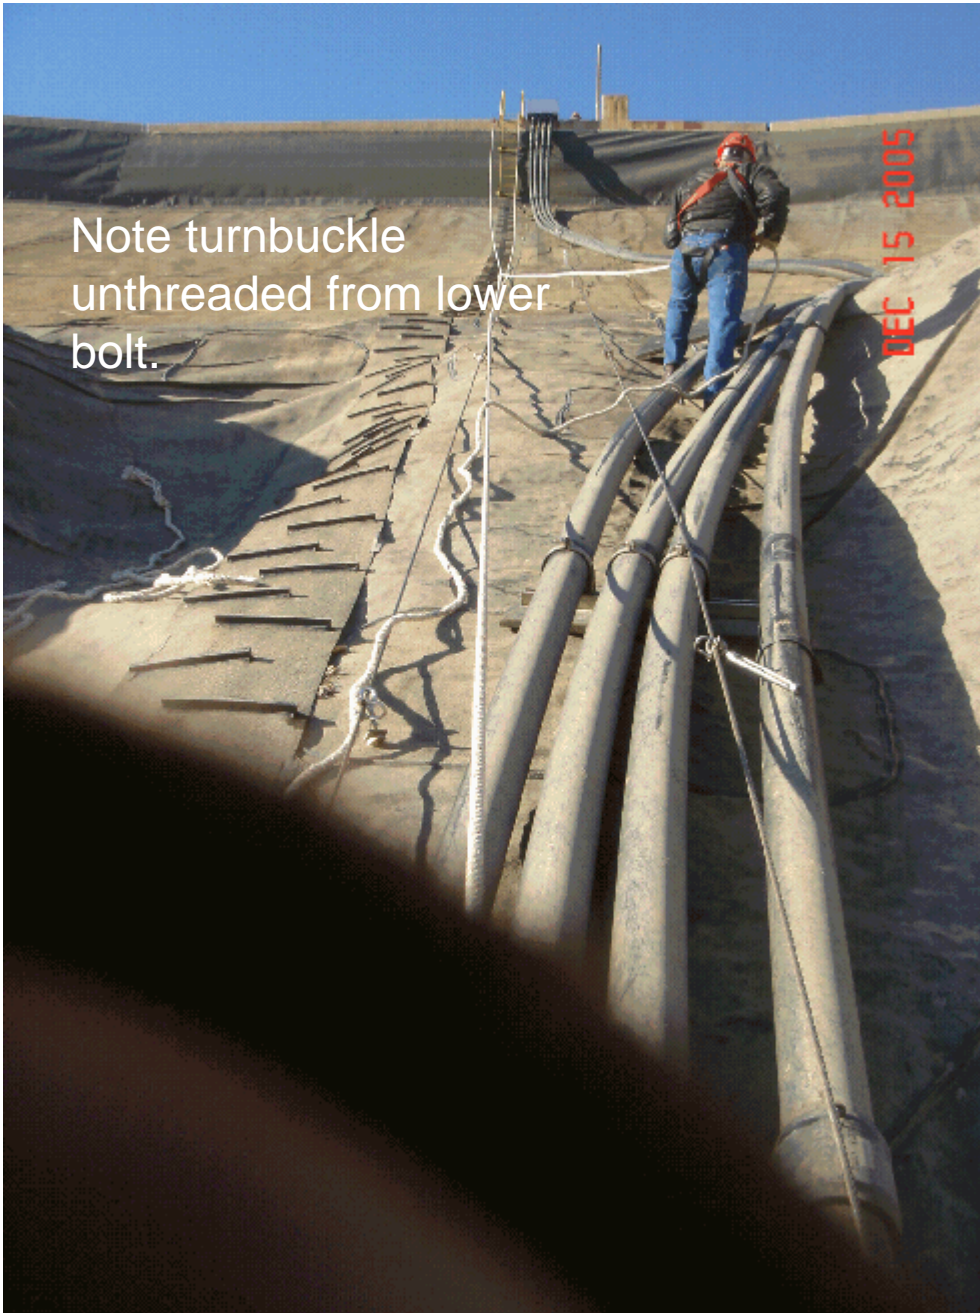
Figure 7-3

Note turnbuckle
unthreaded from lower
bolt.

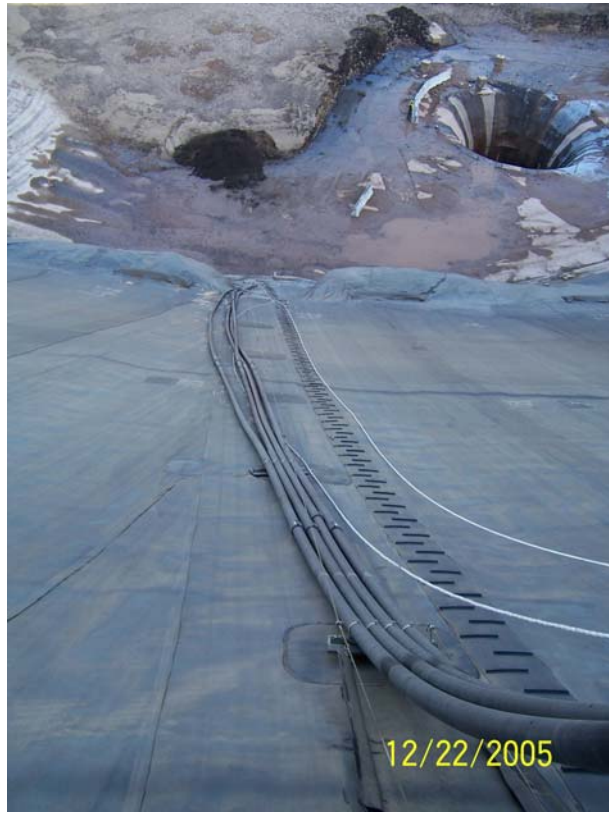
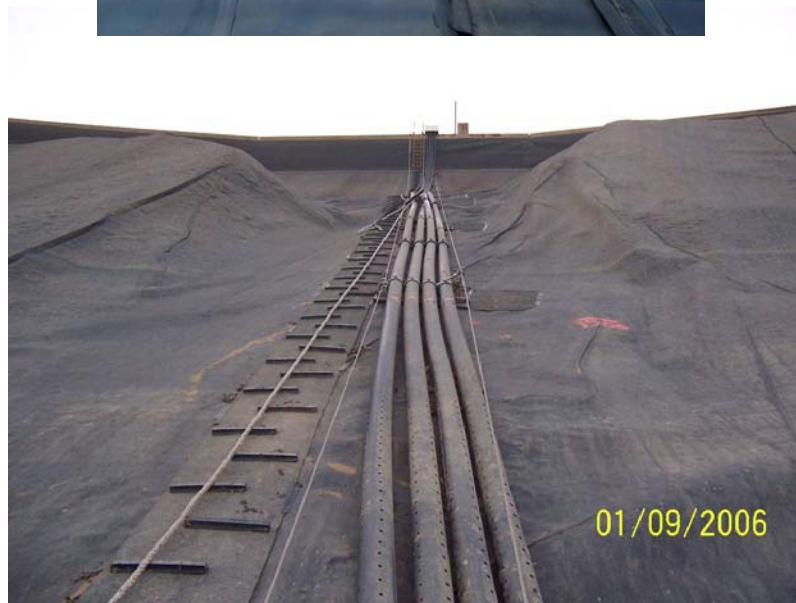
Figure 7-5

Note, straightening of protective pipes between dates of above photos.

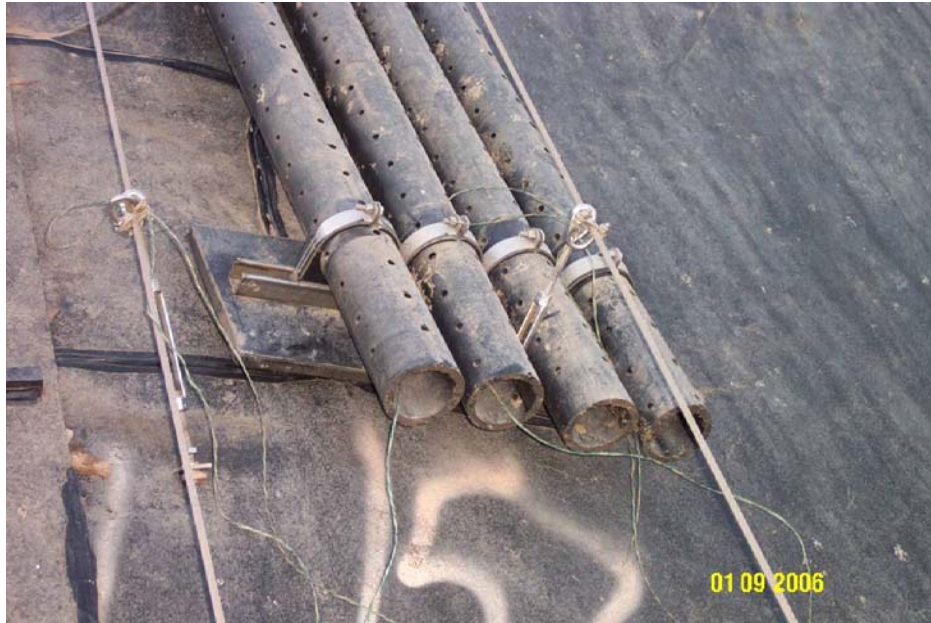
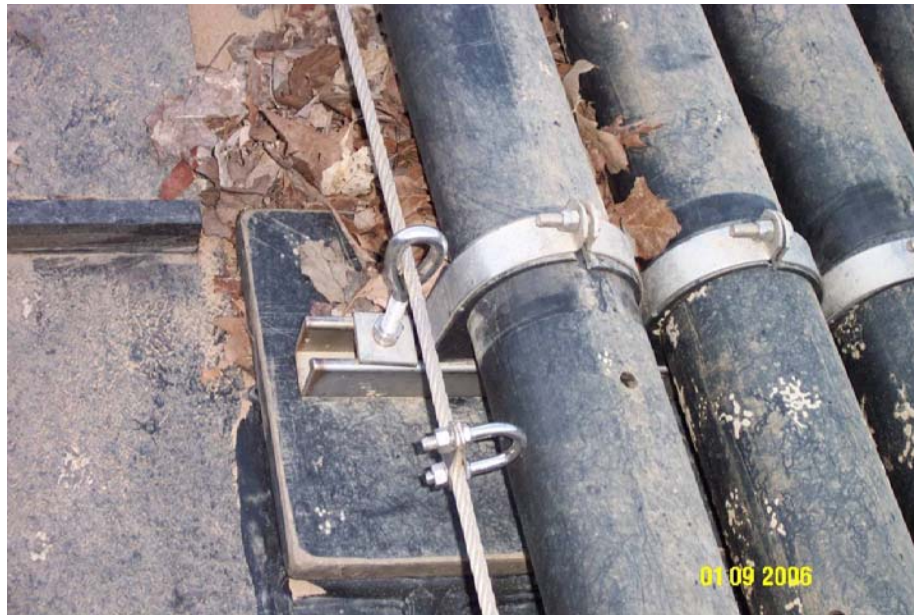
Figure 7-7

To avoid penetrations of the liner material and the creation of possible leakage paths, the protective pipes were supported on plastic plates that were connected by eye bolts to two stainless steel guide cables. The cables were secured only at the bottom and top of the reservoir. Figures 7-7 and 7-8 show these support systems as found after the breach event.

Protective pipe base plates are not anchored to reservoir.
Left guy cable has come loose from base plate in top photo.

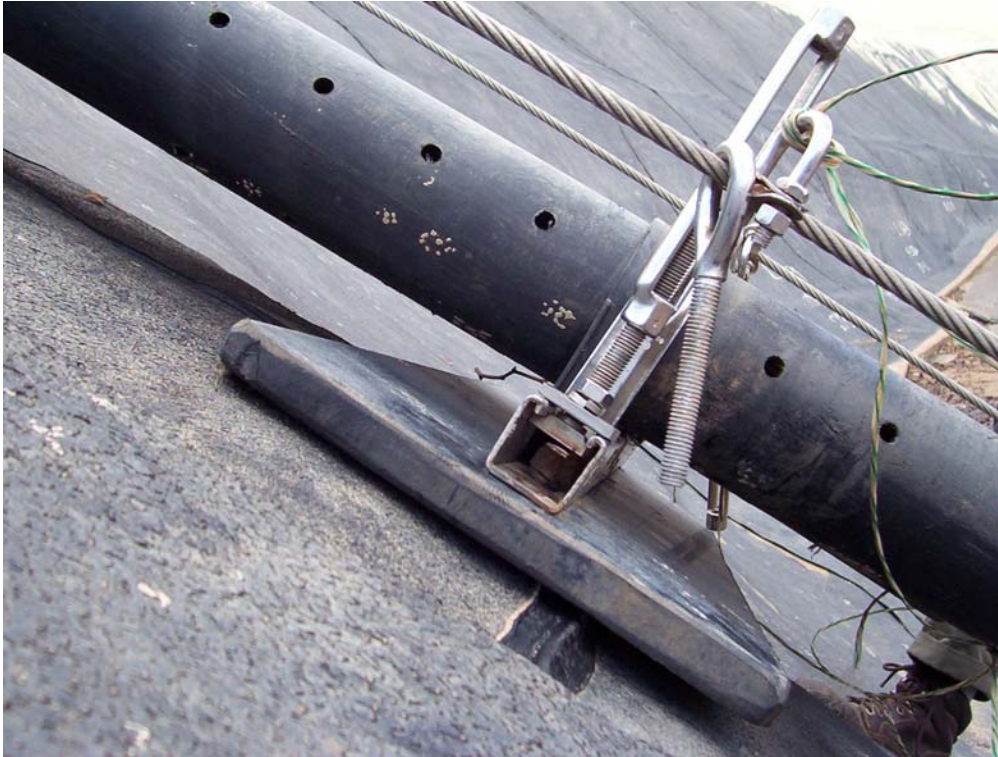
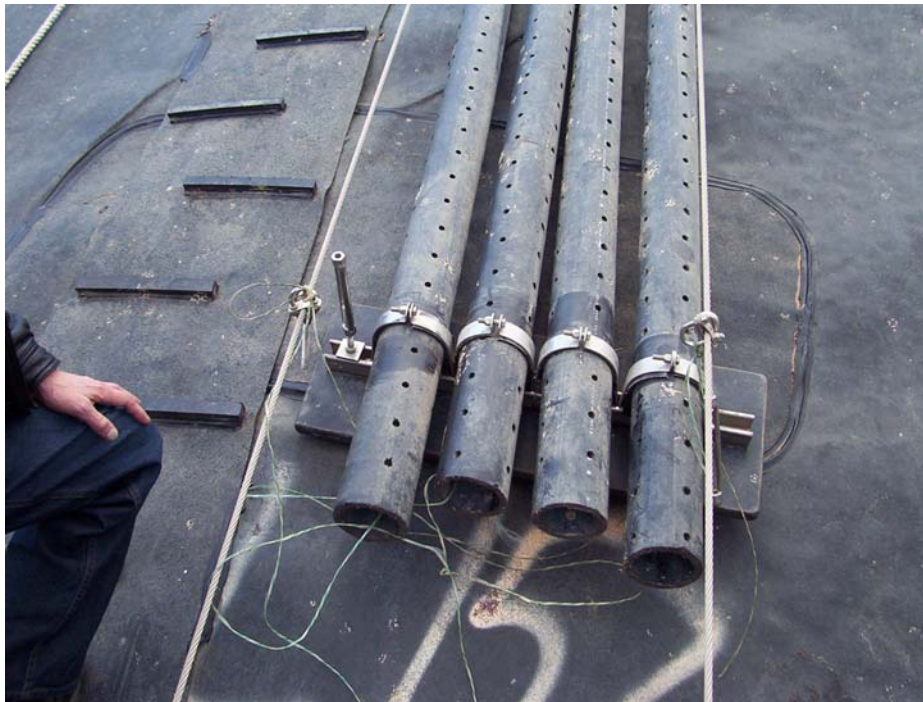
Figure 7-8

Protective pipe support system as found. Note eye bolt unthreaded from turnbuckle. Also note lock washer in place at connection to U channel but lack of lock washer at turnbuckle.

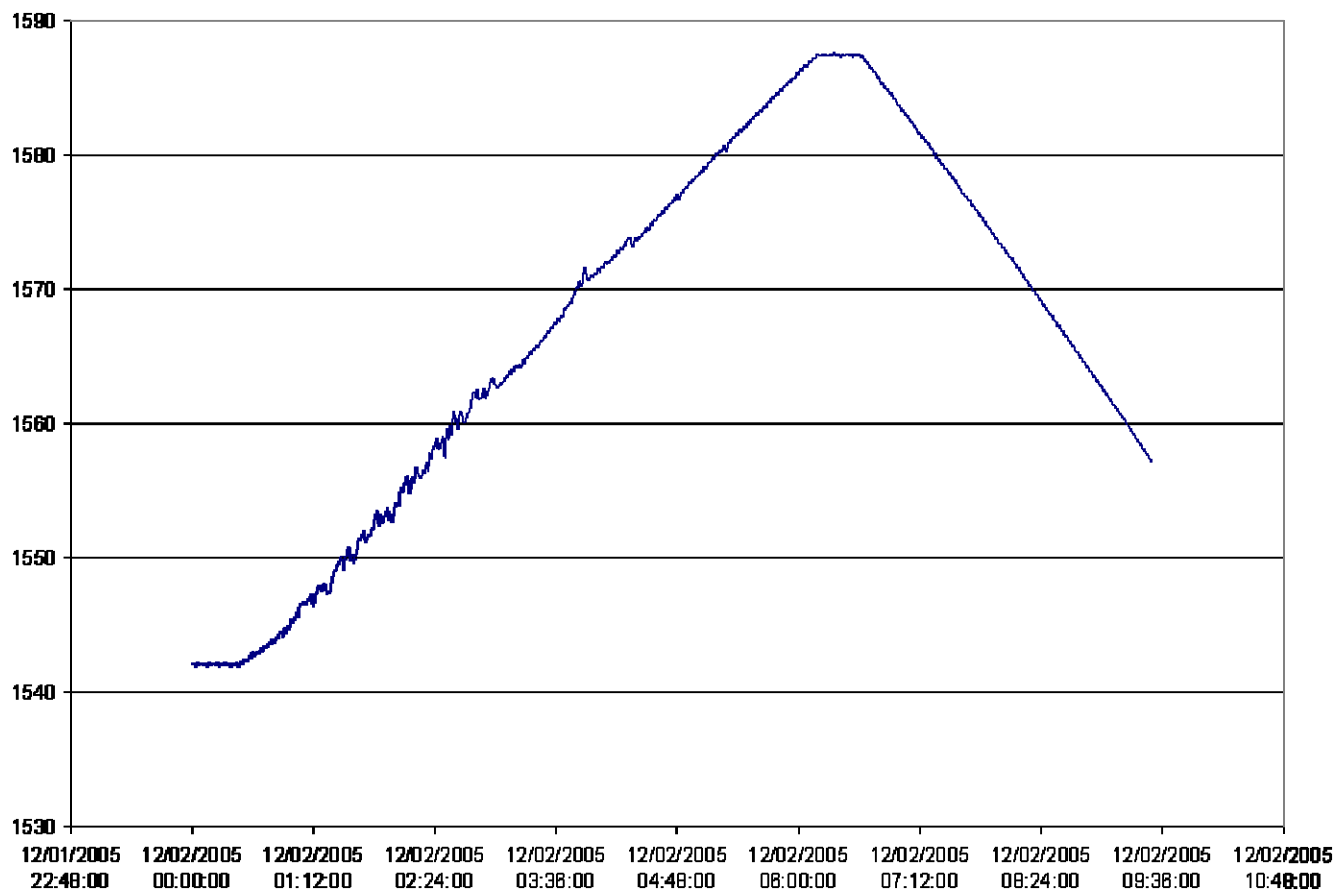
Figure 7-14 shows a continuation of water level readings from December 2, 2005. Once the level rose above about Elev. 1563, the large fluctuations decrease significantly and are very small when the water level was falling during generation later in the day. This pattern of water level fluctuations is found on most days after December 2, 2005. This evidence suggests that the pump discharge pattern created substantial forces acting on the protective pipes and/or the support cables when the water level is lower and that these forces diminish as the flow discharge pattern shifts upward at higher water levels. The evidence also suggests that the generation mode flow pattern into the intake is more stable and produces much less disturbance to the protective pipes. This is consistent with the much higher exit losses associated with discharge into an open reservoir compared to entrance losses for the same geometry.

Dec. 2nd. Note erratic behavior on rising and lower level compared to falling level.

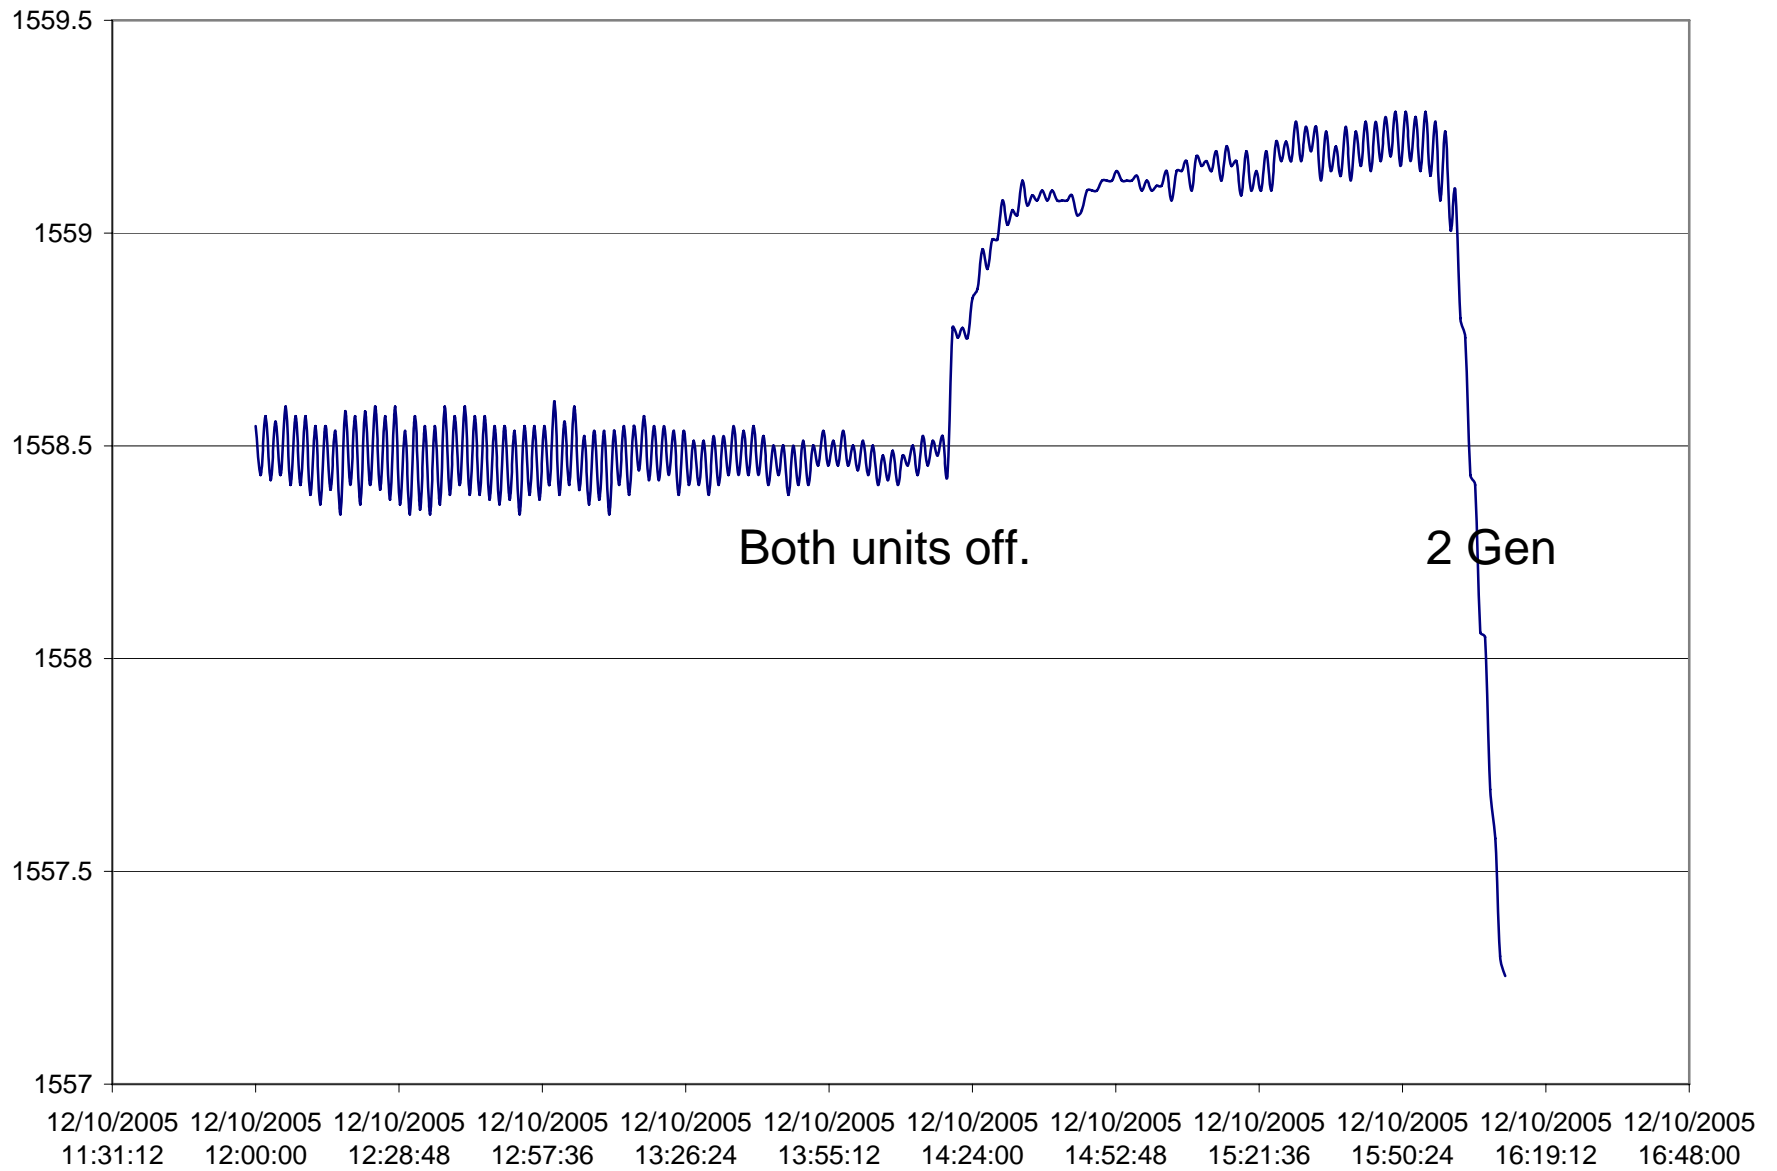
Figure 7-23 shows an interesting pattern of water level readings for December 10, 2005 with both units off followed by both units generating. We don't know if these level fluctuations are due to transducer movement or other causes. The left portion of the plot seems to be damping out until the disturbance around 14:24. The subsequent fluctuations appear to be building in amplitude until the two generators began operation.

Erratic level indications on Dec. 10th.
