Engineering Ethics Case Study: The Taum Sauk Reservoir Failure

"Taum Sauk Upper Dam Breach:

Technical Reasons for the Breach of December 14, 2005"

Taum Sauk Upper Dam Breach FERC No. P-2277

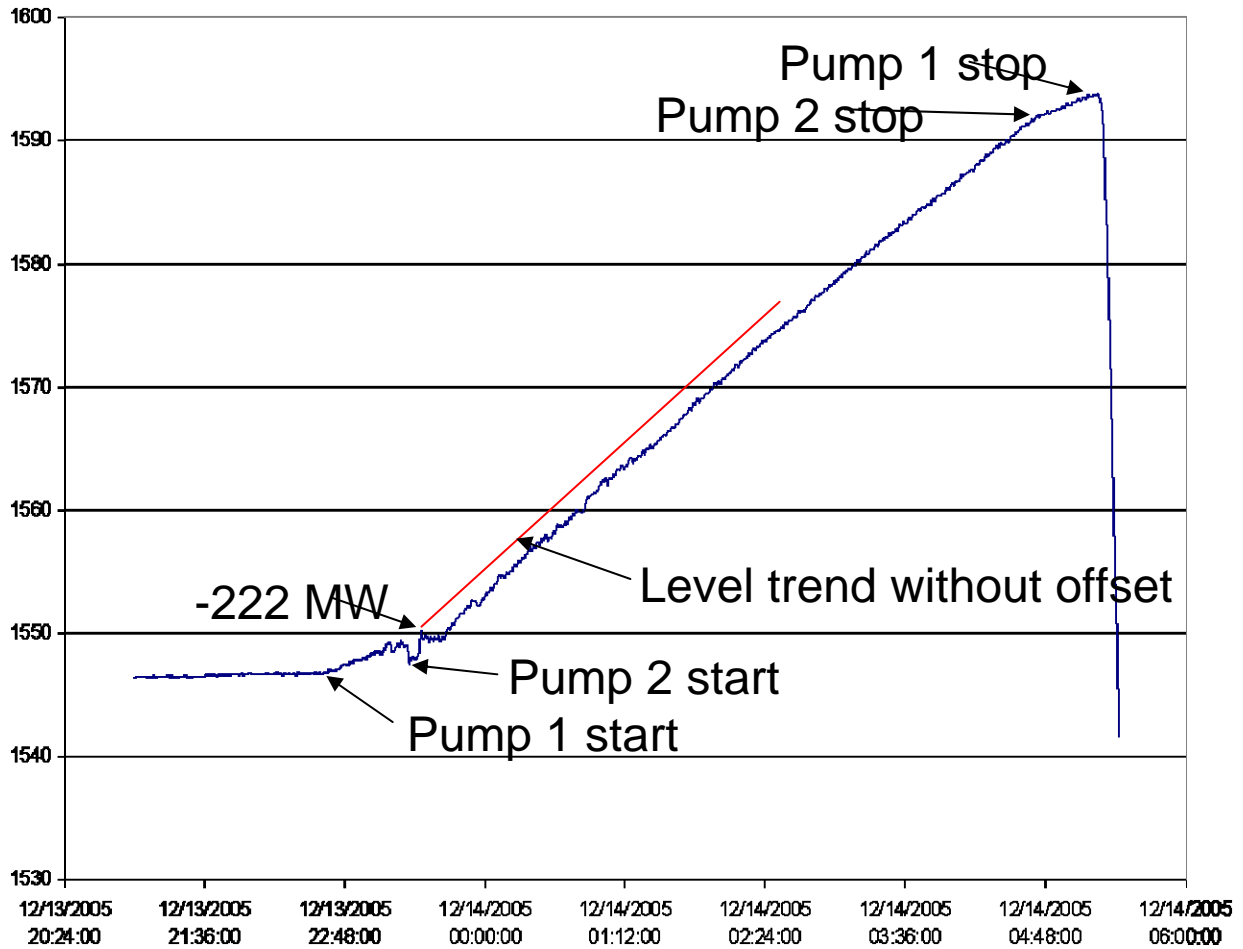
Figure 7-24 shows the water level readings from the start of both pumps on December 13, 2005 through the reservoir failure on December 14, 2005. The – 222 MW arrow shows the indicated water level when pump 2 completed its start sequence. The water level indication remained level for about 12 minutes rather than immediately beginning the more rapid rate of rise that it should have. At that level of Elev. 1550, two pumps were producing a level rise of about 10 feet per hour or about 2 feet in those 12 minutes. While there were smaller subsequent level indication fluctuations, they did not restore the level readings back to the trend line shown.

The most logical explanation is that during those twelve minutes the transducers were moving up at about the same rate as the water level, hence showing no level change during the interval. The line labeled “Level trend without offset” shows where the water level indications should have been without the offset. It should be noted that the level indication at the beginning of the plot is not necessarily accurate given the many indications of prior transducer movement and erratic readings. It is also possible that generating mode flows past the transducers may have tended to bring the protective pipes back to near their original positions resulting in some periodic level error corrections.

**Level indications after pump 2 start shows an offset.
 -222 MW = Completion of pump 2 start sequence.**

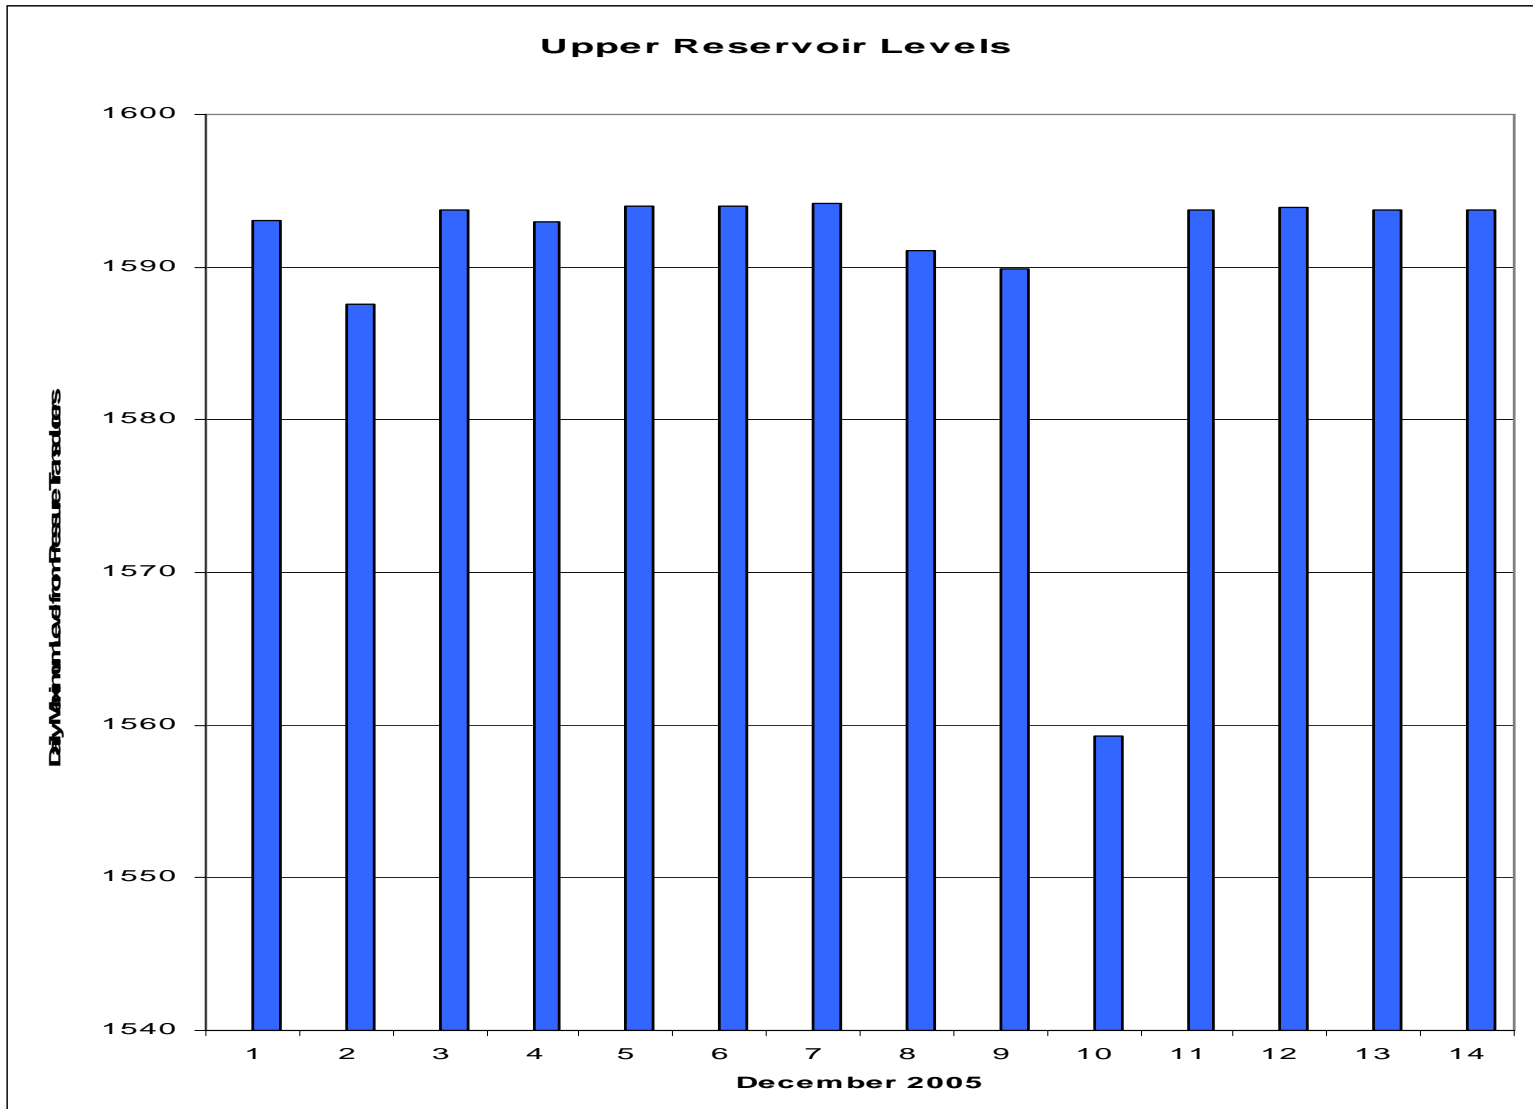
Figure 7-27 is a plot of maximum daily water level indications for December 2005. The plot shows that level indications as high as that shown for December 14, 2005 were achieved on many earlier days. Since reservoir failure did not occur on those dates, it suggests that the level reading offset described above for December 13, 2005 is primarily responsible for the failure to shut down the last pump. As noted above, that offset resulted in the actual water level being at least two feet higher than the pressure transducers indicated.

Daily maximum indicated levels.

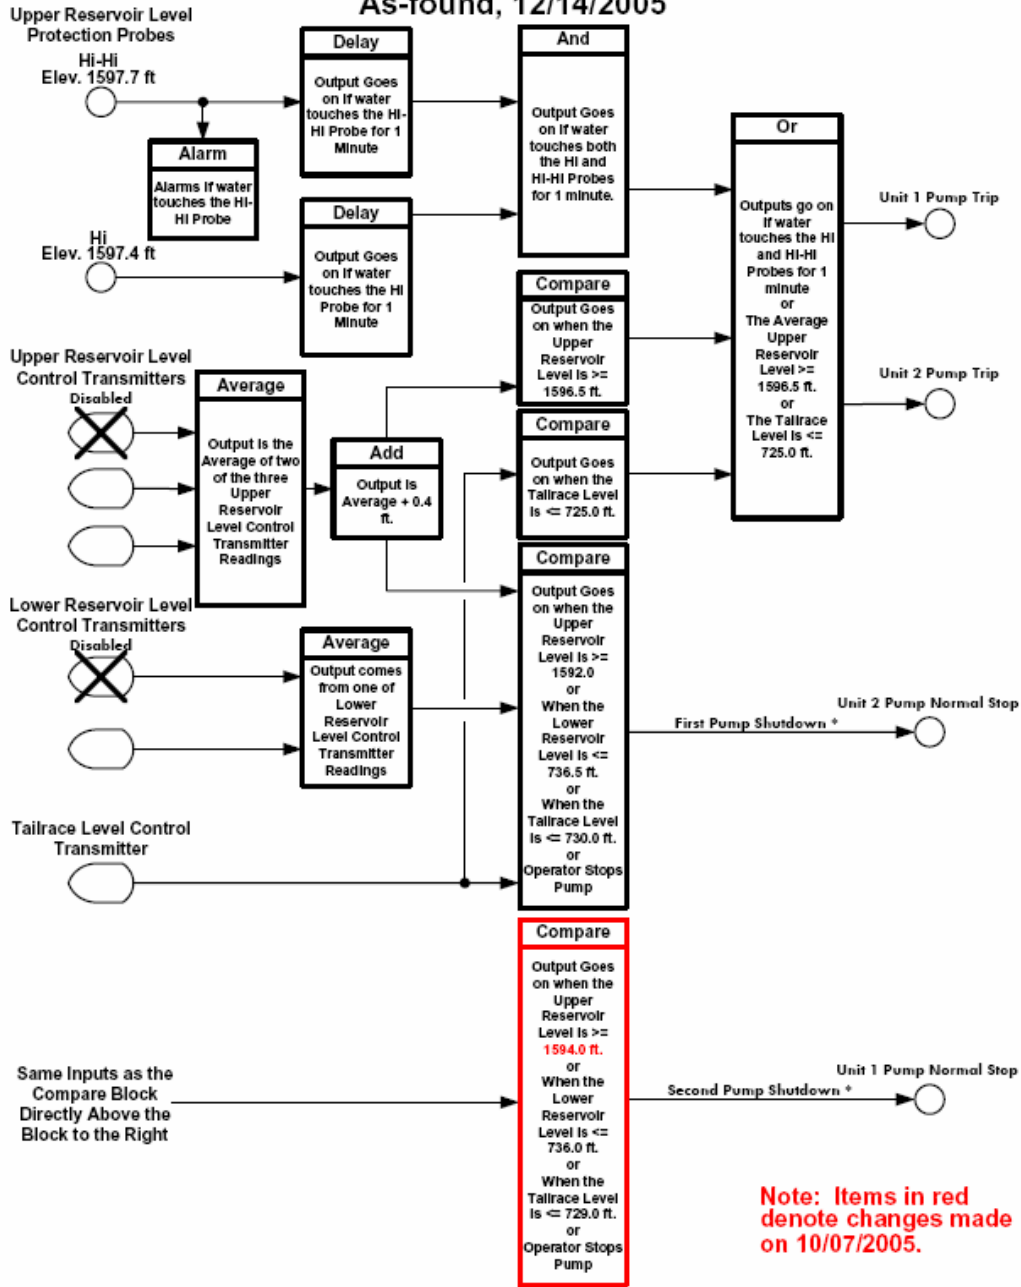
Figure 7-31

Note: Due to programming error made on Sept. 16, 2005, Unit 2 pump shutdown due to level protection probe response was disabled.
