# ENGINEERING FAILURE CASE STUDY: THE SURFSIDE CONDOMINIUM COLLAPSE

Engineering CE Courseware

This course examines the engineering failures that contributed to the catastrophic collapse of the Champlain Towers South condominium in Surfside, Florida, in June 2021. Through an analysis of the event, the course explores structural deficiencies, maintenance lapses, and engineering design flaws that led to the disaster. By evaluating the technical findings and key contributing factors, participants will gain insights into how similar failures can be identified and prevented in future engineering projects. This course is applicable across disciplines involved in structural engineering, forensic analysis, and safety compliance.

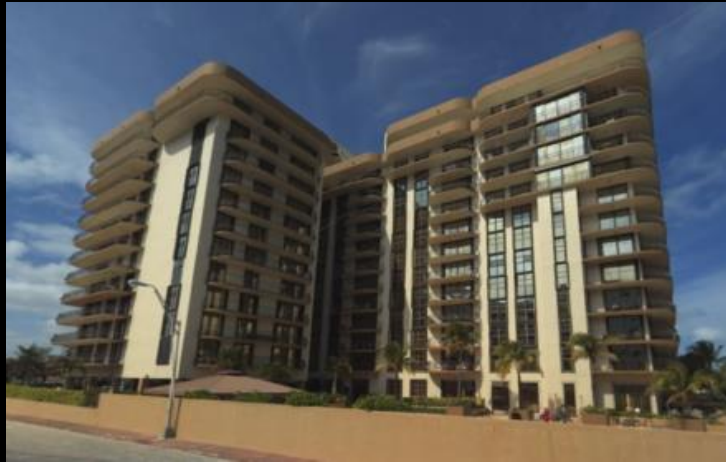
The collapse of the Champlain Towers South condominium is one of the most catastrophic structural failures in modern U.S. history.
