Strengthening School Buildings – Against Earthquake Damage

Design Guide

for Improving School Safety
in Earthquakes, Floods, and High Winds

4 Making Schools Safe From Earthquakes

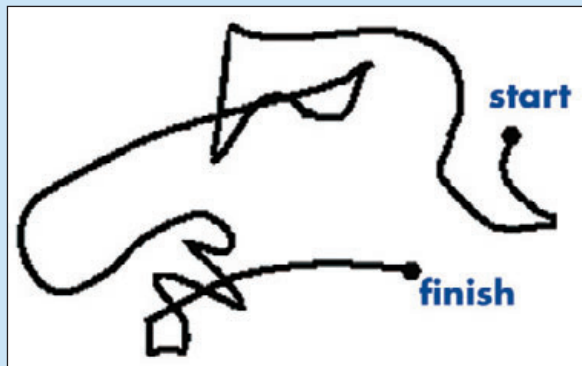
Motion at Site

Scratch left on a floor by a kitchen range in the 1933 Long Beach earthquake that shows the random nature of earthquake motion.

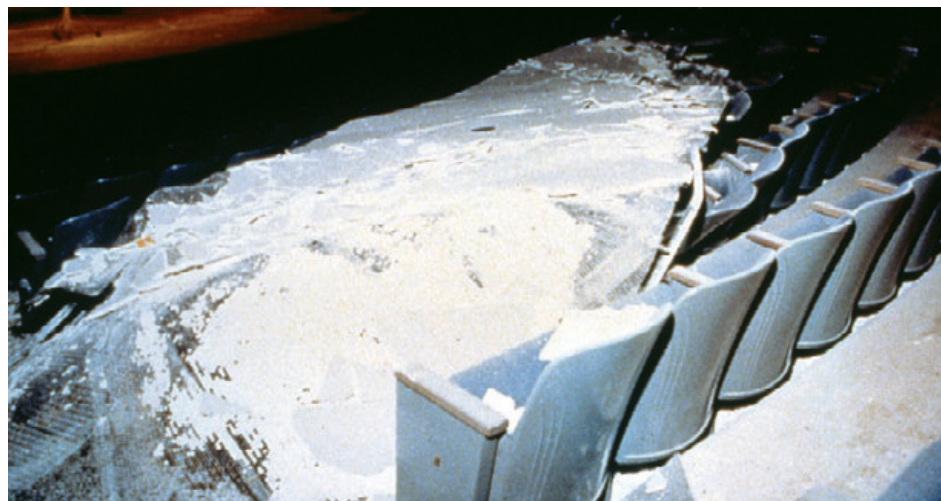
Figure 4-10:
Fallen light fixtures, library, Coalinga, CA, 1983

Pendant light fixtures may fall if they are not securely attached and not designed to swing freely (see Figure 4-10). Large glass walls and windows, not designed to accommodate inter-story drift due to seismic forces, present another hazard for

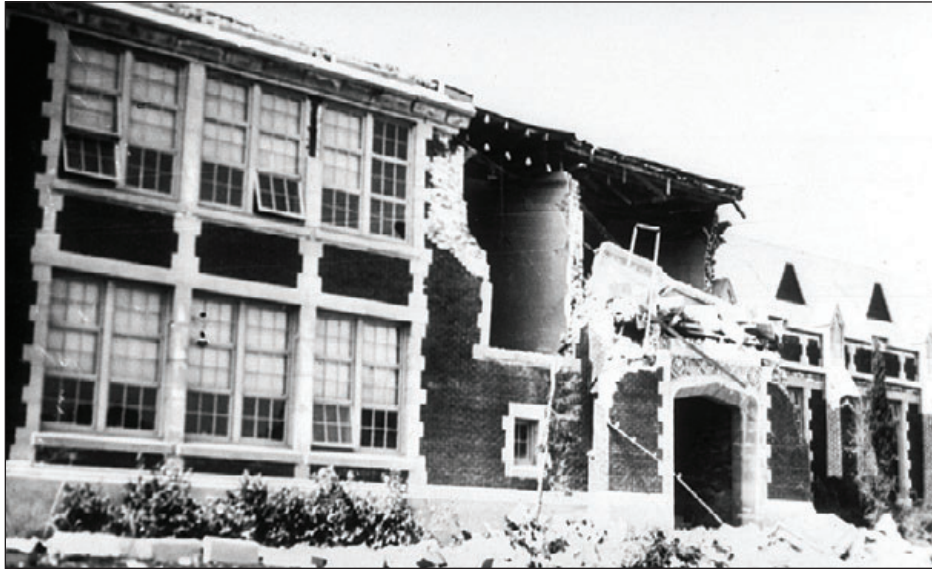
Figure 4-12:
Damage to the John Muir School, Long Beach, CA, 1933

school buildings was so severe that there would have been many casualties had they been occupied (see Figures 4-12, 4-13, and 4-14). As a result, the State passed the Field Act within a month of the earthquake.

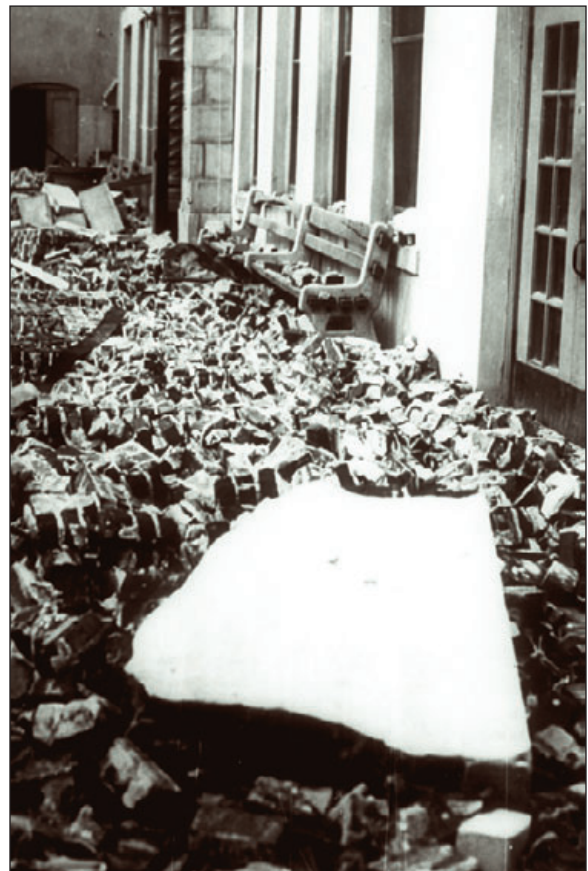
Figure 4-13:
Damage to shop building, Compton Junior High School, Long Beach, CA, 1933

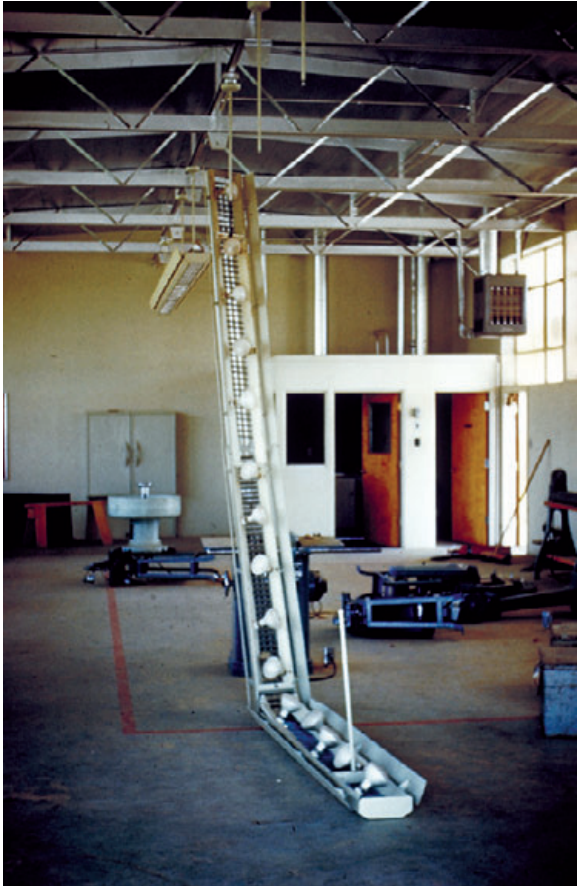
Figure 4-16:
Overturned shop equipment and failed light fixtures, Kern County, CA, 1952

The Bakersfield earthquakes are of particular interest because the incidence of school damage is comparable to that resulting from earthquakes striking today in regions where seismic codes have not been adopted and enforced due to the rarity of seismic events (see Figures 4-15, 4-16, and 4-17).

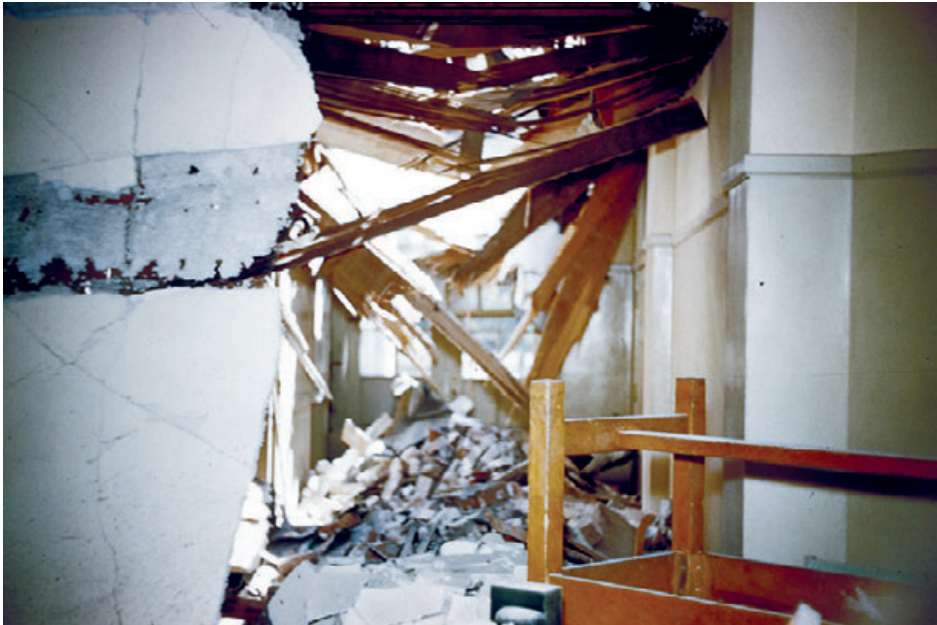
Figure 4-17:
Destroyed exit corridor, Bakersfield, Kern County, CA, 1952

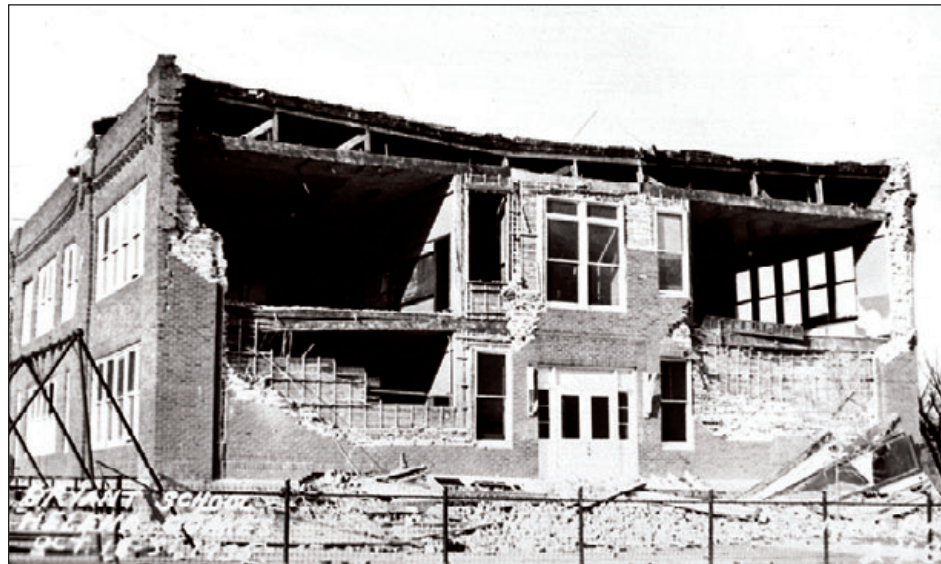
Figure 4-18:
Typical school damage,
Helena, MT, 1935

Other States have experienced similar damage to URM and early reinforced concrete structures. Schools in Helena, MT, suffered considerable damage in 1935 (see Figure 4-18). In 1949, several URM schools in Seattle were severely damaged, resulting in one fatality (see Figures 4-19 and 4-20). At Puyallup High School, three boys on a stage just managed to escape when the roof collapsed (see Figure 4-21). The furniture and contents also sustained widespread damage (see Figure 4-22).

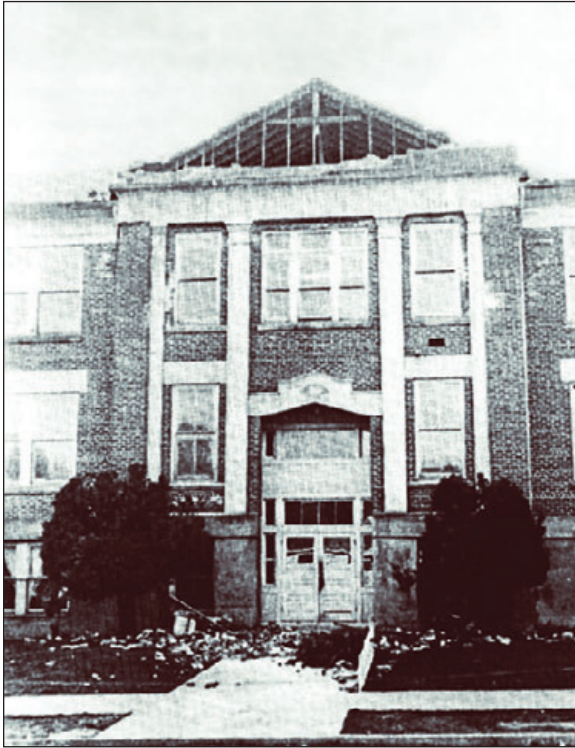
Figure 4-19:
The student body president was killed here by falling brickwork, Seattle, WA, 1949

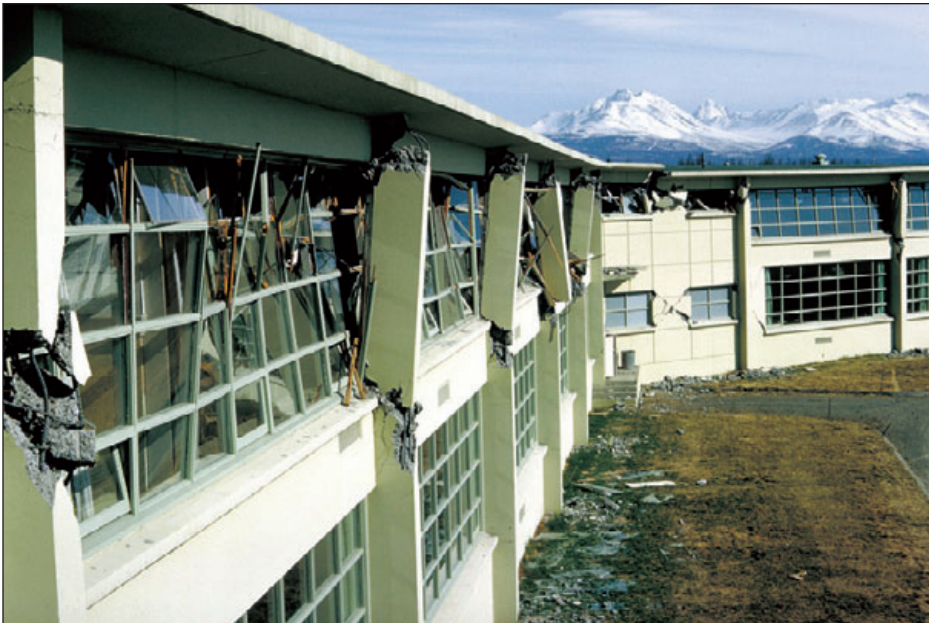
Figure 4-23:
Severe structural damage
to the West Anchorage High
School, Anchorage, AK, 1964

In the Anchorage, AK, earthquake of 1964, which registered 8.4 on the Richter scale, a number of public schools were damaged, but none collapsed. The earthquake occurred on Good Friday at 5:36 p.m. when the schools were unoccupied. The most seriously damaged school (shown in Figure 4-1) was subsequently demolished. At the West Anchorage High School (see Figures 4-23 and 4-24), a two-story nonductile concrete-frame and shear-wall classroom wing suffered severe structural damage and the near total failure of a number of columns. Structural distortion also created a number of severe glass breakages. The second floor was removed during reconstruction and the first floor was repaired and retained. In the San Fernando, CA, earthquake of 1971, there were no injuries and no schools collapsed; however, the earthquake caused \$13.2 million in damages (in 1971 dollars), and 100 pre-Field Act schools were demolished within 1½ years after the earthquake.

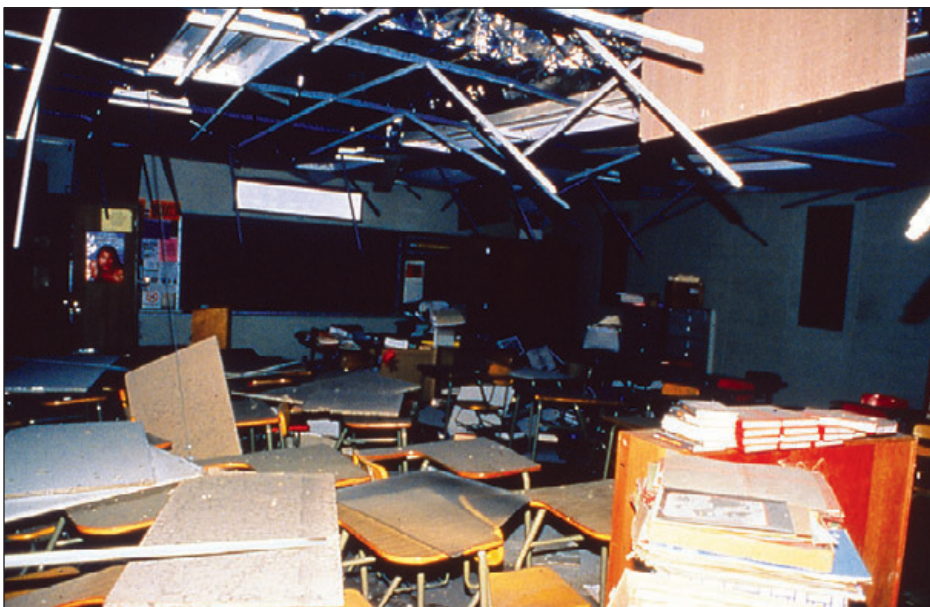
Figure 4-25:
Ceiling damage,
Northridge, CA, 1994
