Section 8	
Inspection and Evaluation of Common Steel Superstructures		
8.4	Pin and Hanger Assemblies	8.4.1
8.4.1	Introduction.....	8.4.1
8.4.2	Design Characteristics.....	8.4.3
	Primary and Secondary Members	8.4.3
	Forces in a Pin – Design vs. Actual.....	8.4.8
	Fracture Critical Pin and Hanger Assemblies.....	8.4.10
8.4.3	Overview of Common Defects	8.4.11
8.4.4	Inspection Procedures and Locations.....	8.4.12
	Procedures	8.4.12
	Visual	8.4.12
	Physical	8.4.12
	Advanced Inspection Techniques	8.4.12
	Locations	8.4.14
	General.....	8.4.14
	Hangers	8.4.16
	Pins.....	8.4.18
	Retrofits	8.4.19
8.4.5	Evaluation	8.4.21
	NBI Rating Guidelines	8.4.21
	Element Level Condition State Assessment.....	8.4.21

Topic 8.4 Pin and Hanger Assemblies

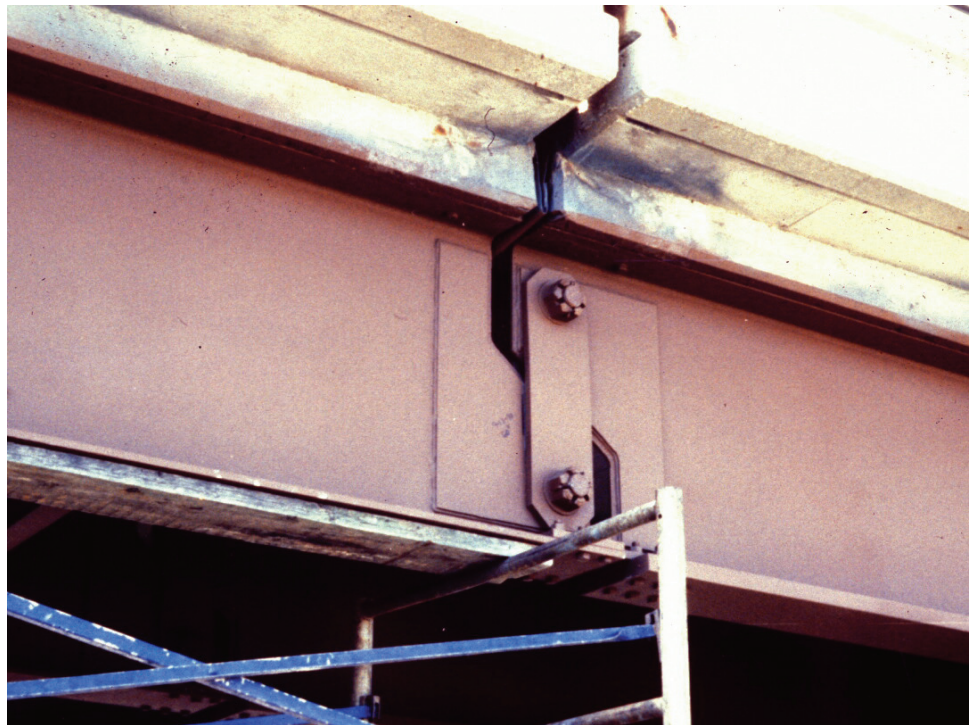
Figure 8.4.1 Typical Pin and Hanger Assembly

Pin and hanger assemblies are devices put in bridges to permit expansion movement and rotation (see Figure 8.4.1). If only rotation of the joint is desired, one pin is used (see Figure 8.4.2). When expansion (longitudinal) movement is also required, a system consisting of two pins with hanger links between them is used.

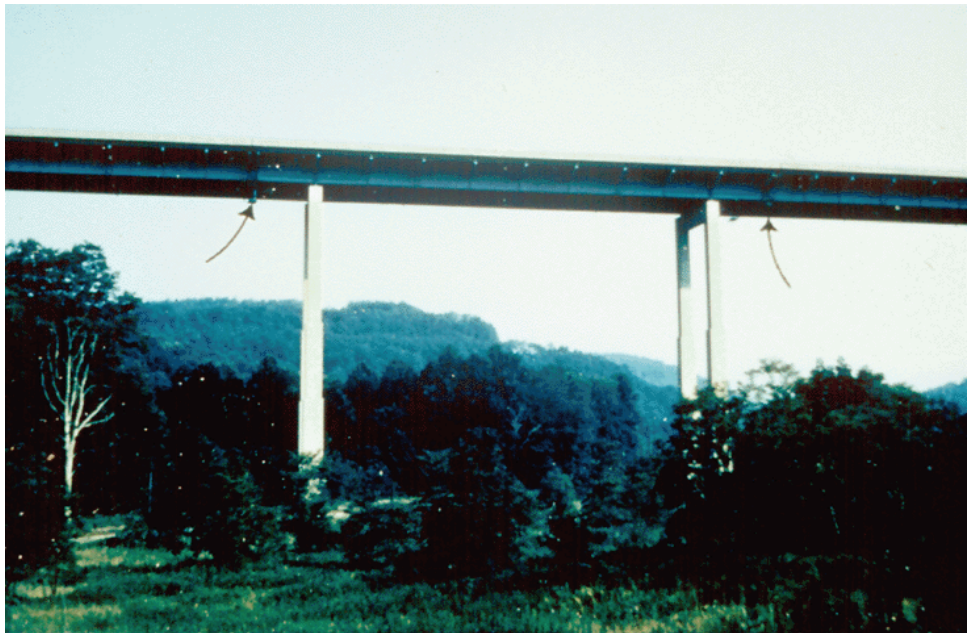
Figure 8.4.3 Pin and Hanger Assembly Locations Relative to Piers

Pin and hanger joints are usually found in multi-span bridges designed prior to 1970. Incorporating a hinge in a structure simplifies analysis. It also moves expansion joints (and drainage related damage) away from the abutments and piers (see Figure 8.4.3).

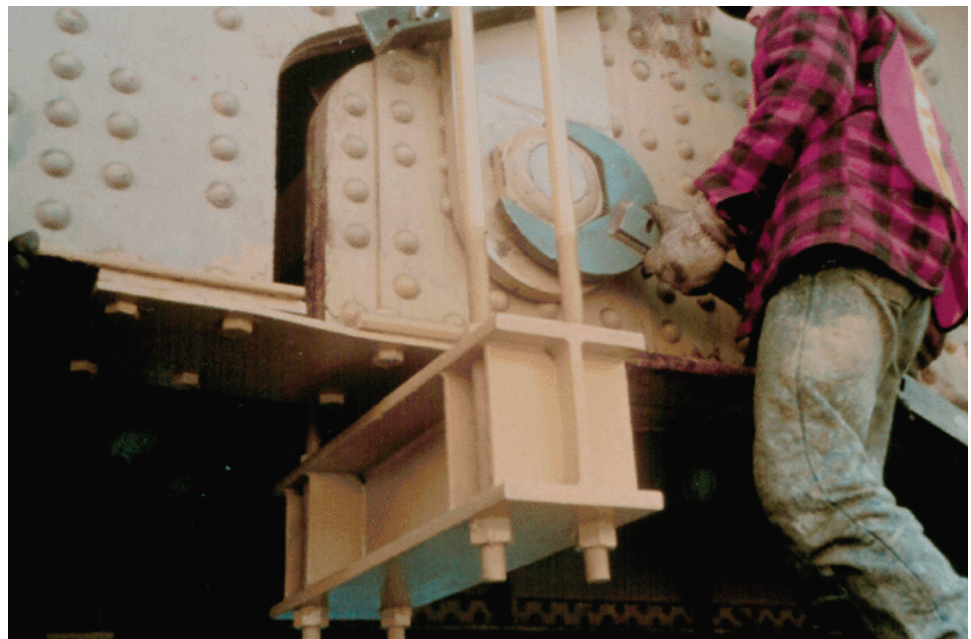
Figure 8.4.9 Retaining Nut

The secondary members of a pin and hanger assembly include through-bolts and the pin cap (see Figure 8.4.8), nuts (see Figure 8.4.9), cotter pins on small assemblies with pins less than 100 mm (4 inches) in diameter, spacer washers and doubler plates which reinforce the beam web around the pin hole (see Figure 8.4.10).

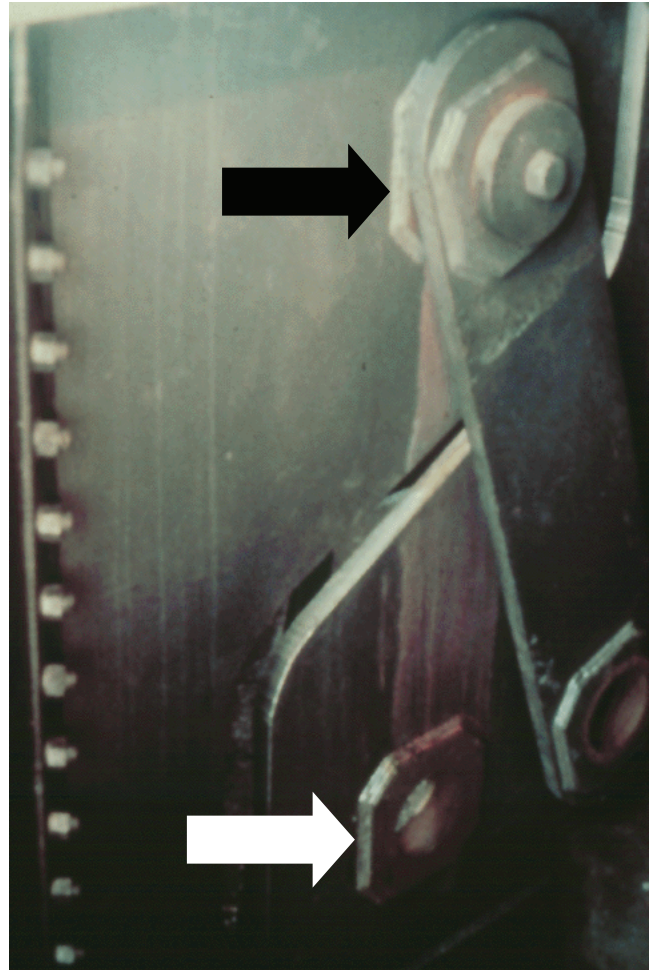
Figure 8.4.10 Web Doubler Plates

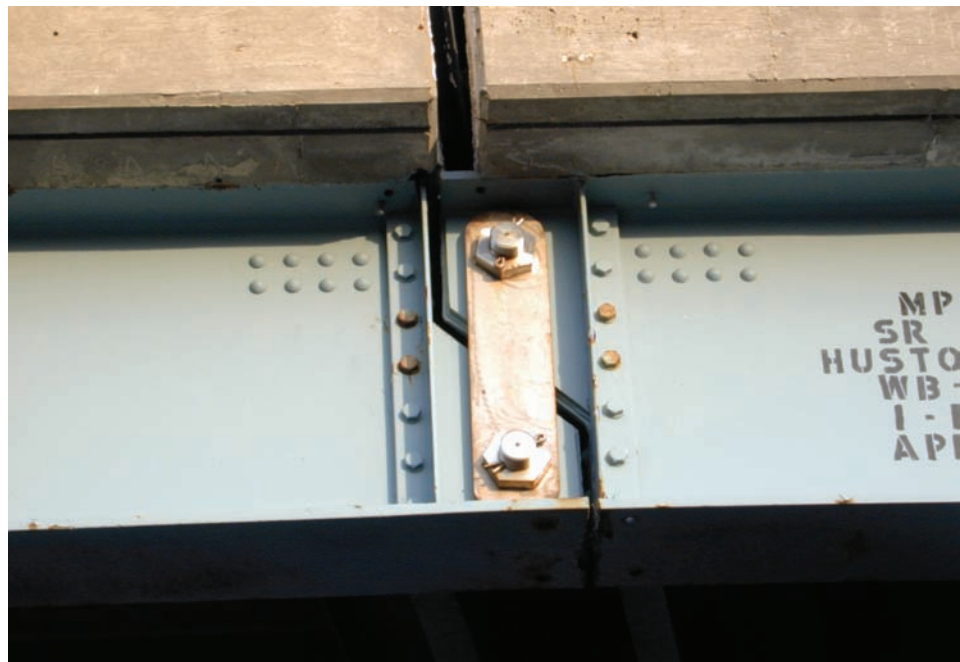
Figure 8.4.25 Stainless Steel Pin and Hanger Assembly

Replacing the pin and hanger assembly in kind with a structural grade of stainless steel eliminates potential failures due to corrosion related problems. Placing a non-metallic insert and washer prevents corrosion between the pin and hanger and allows for normal rotation.
