SECTION 8: Inspection and Evaluation of Common Steel Superstructures  
TOPIC 8.7: Steel Eyebars

# Topic 8.7 Steel Eyebars

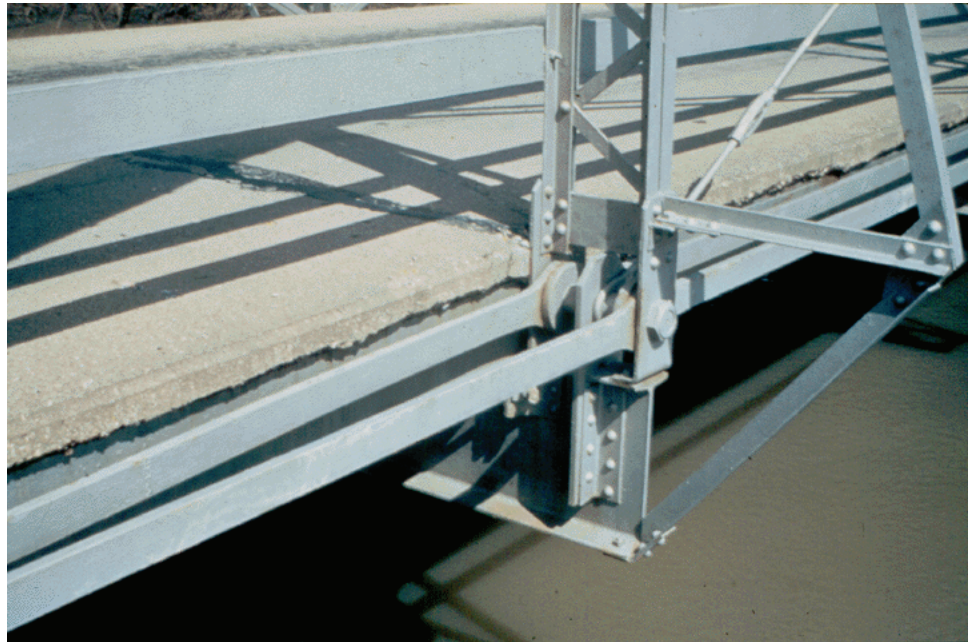
**Figure 8.7.1** Typical Eyebar Tension Member on a Truss

Eyebars are tension only members that require pins to make their end connections. Eyebars are predominantly found on older truss bridges, but can also be found on suspension chain bridges and as anchorage bars embedded within the substructures of long span bridges (see Figures 8.7.1 to 8.7.4).

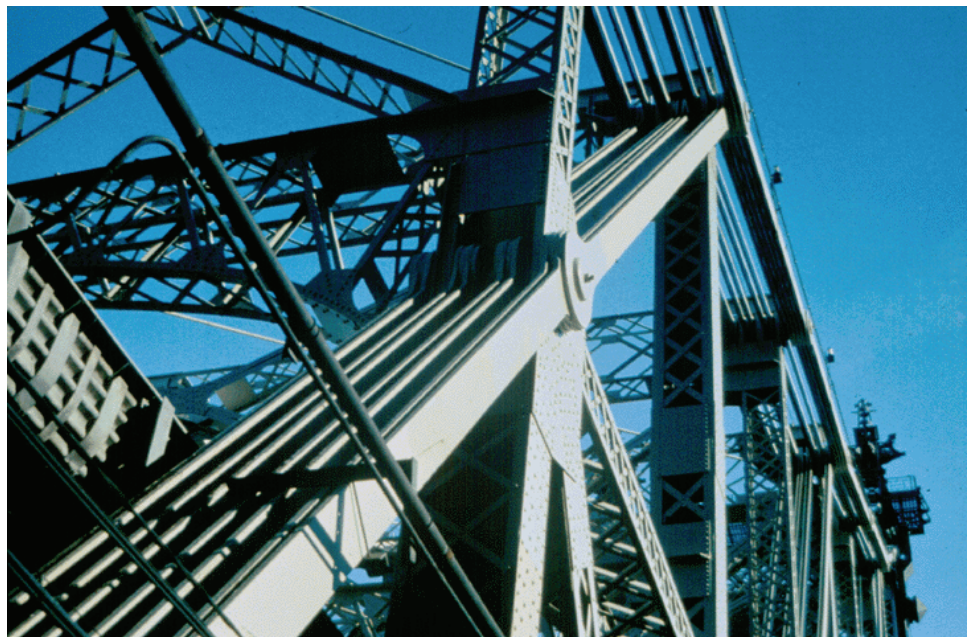
**Figure 8.7.2** Eyebar Cantilevered Truss Bridge (Queensboro Bridge, NYC)

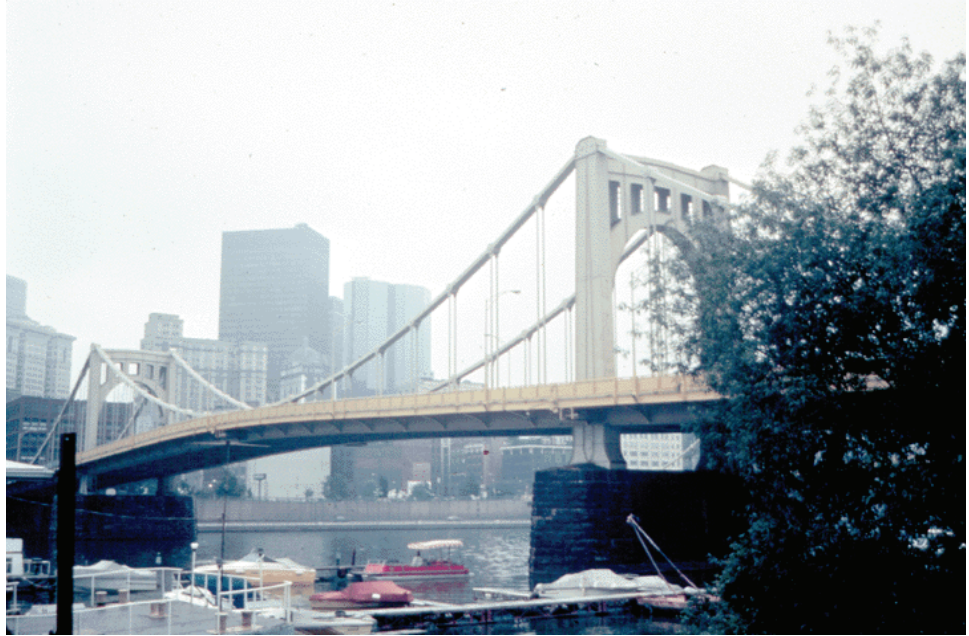
**Figure 8.7.3** Eyebars Chain Suspension Bridge

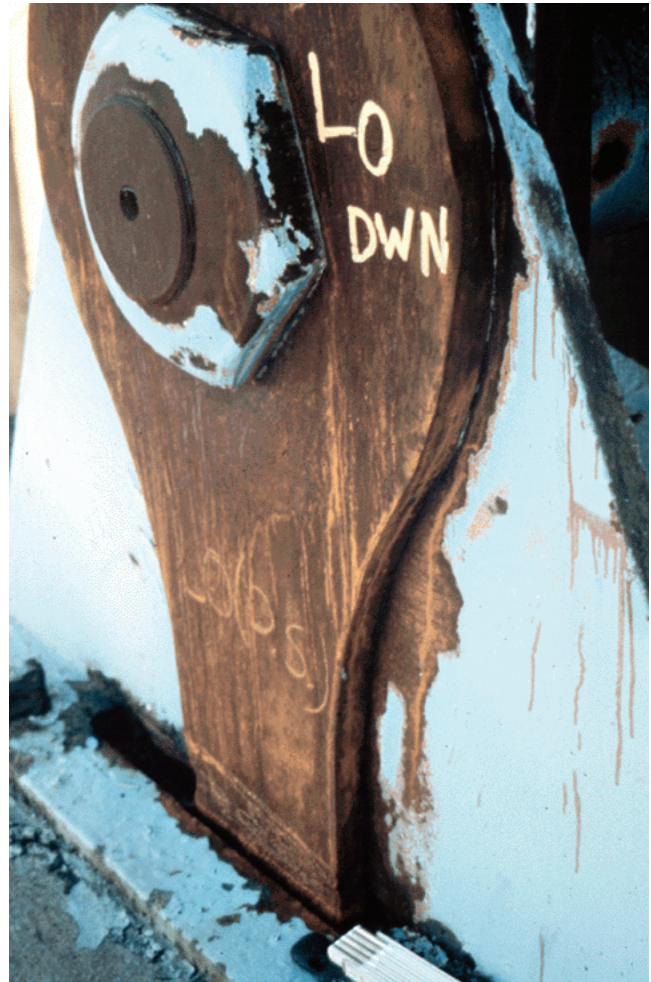
**Figure 8.7.4** Anchorage Eyebars

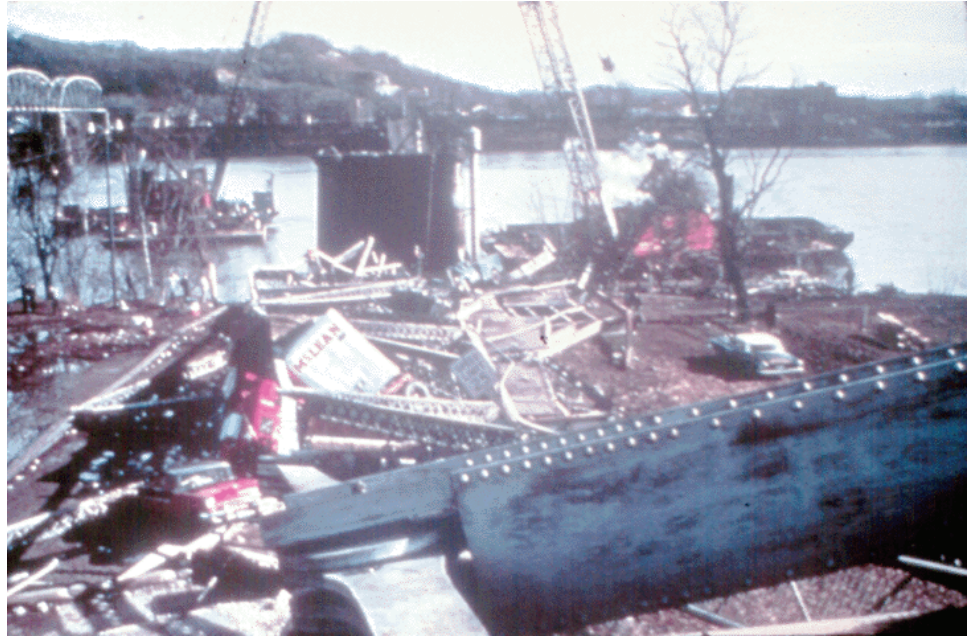
Heat treated steel eyebars have been used in bridges all over the world. One of these eyebars failed on December 15, 1967, sending the Point Pleasant Bridge (Silver Bridge), built in 1928, into the Ohio River between Point Pleasant, West Virginia and Kanauga, Ohio (see Figure 8.7.5). Forty-six people died and nine were injured due to the fracture of an eyebar in the north suspension chain on the Ohio side.

**Figure 8.7.5** Collapsed Silver Bridge

The collapse of the Silver Bridge is attributed to the failure of an eyebar within a nonredundant eyebar member. When the first eyebar failed, the second eyebar was unable to carry the load due to lack of internal redundancy. The Silver Bridge was also not load path redundant which contributed to the complete collapse of the structure. Load path and internal (member) redundancy are discussed in detail in Topics P.2 and 8.1.

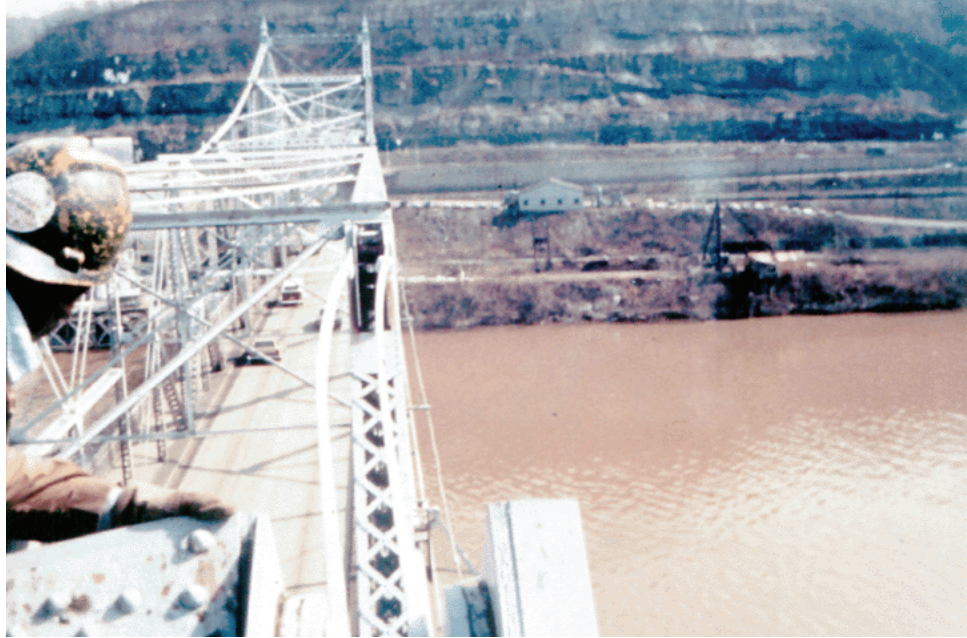
**Figure 8.7.6** Inspection of Eyebars

Since the collapse of the Silver Bridge, there has been considerable public and professional concern over the safety of existing bridges, especially those containing eyebars. Many of these structures have been inspected and analyzed (see Figure 8.7.6). As a result, costly structural modifications and retrofits were made to many of these bridges (see Figure 8.7.7), while some others have been demolished. Eyebars are rarely used in new bridge designs but are present on many existing bridges.

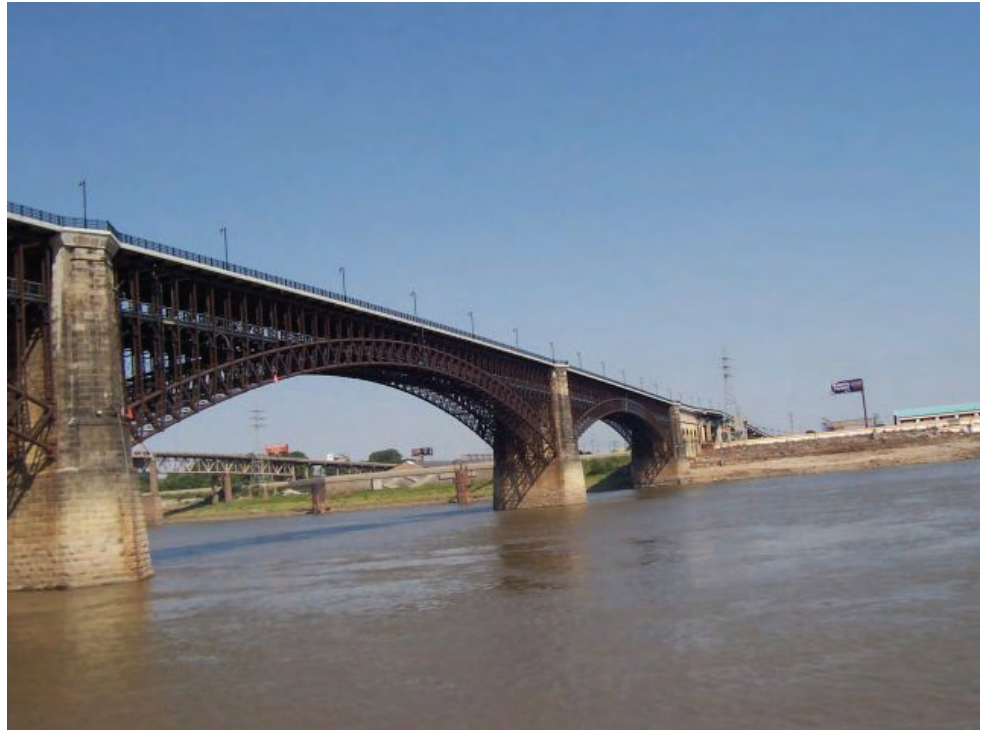
**Figure 8.7.9** Eads Bridge, St. Louis

In the late 1800's and early 1900's bridge spans began to increase in length, providing a need for higher strength steel. Prior to this time eyebars were made of wrought iron. The Eads Bridge in St. Louis, completed in 1874, was the first major steel bridge in America and the first in the world to use alloy steel. (see Figure 8.7.9).

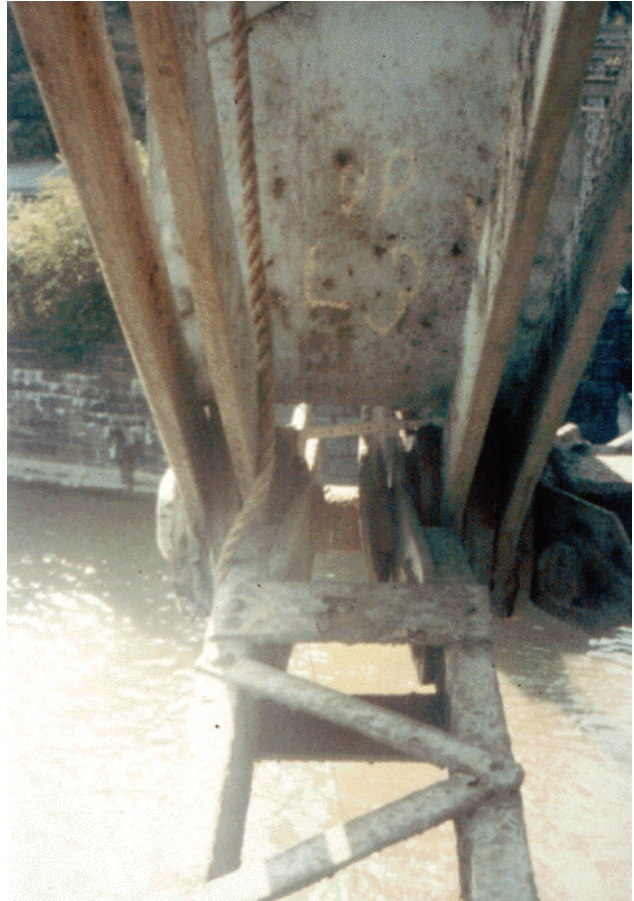
Packing is the term used to describe the arrangement of all the eyebars at a given point. Eyebars may be tightly packed together or spread apart (see Figures 8.7.15 and 8.7.16). The packing should be symmetrical about the center-line of the member.

**Figure 8.7.15** Loosely Packed Eyebar Connection

**Figure 8.7.16** Tightly Packed Eyebar Connection

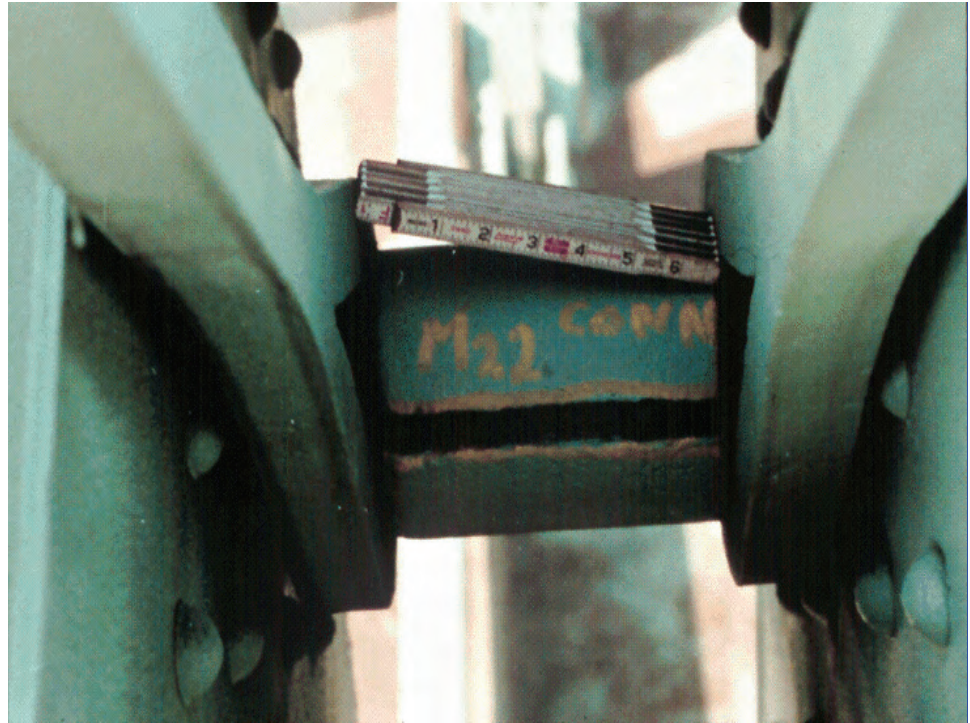
Spacers or steel filling rings are often wrapped around the pin to prevent lateral movement within the eyebar pack (see Figure 8.7.17).

**Figure 8.7.17** Steel Pin Spacer or Filling Ring

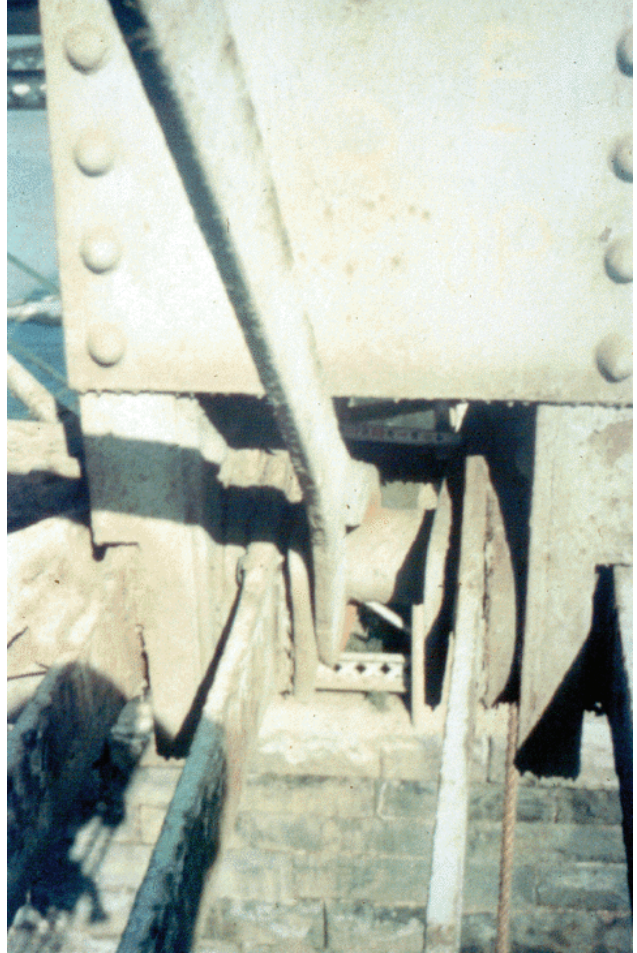
An internally redundant eyebar member will consist of three or more eyebars. Many eyebar members are internally non-redundant, having only one or two eyebars per member (see Figure 8.7.18).

**Figure 8.7.18** Nonredundant Eyebar Member

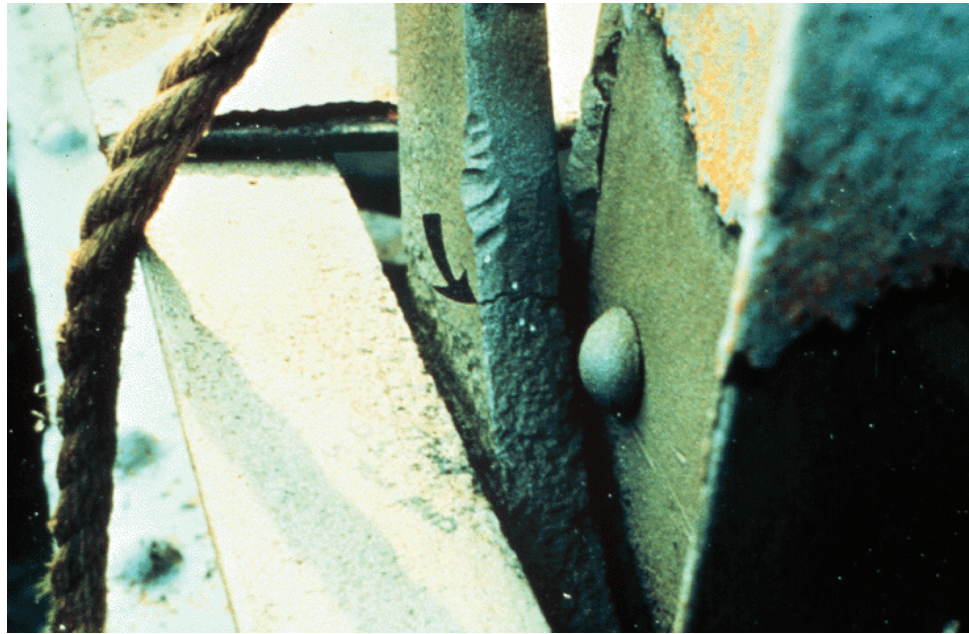
Inspect carefully the forged area around the eyebar head and the shank for cracks. Check the loop rods for cracks where the loop is formed (see Figure 8.7.19). Most eyebar failures are likely to occur in the forge zone.

**Figure 8.7.19** Close-up of the Forge Zone on an Eyebars (Arrow denotes crack)

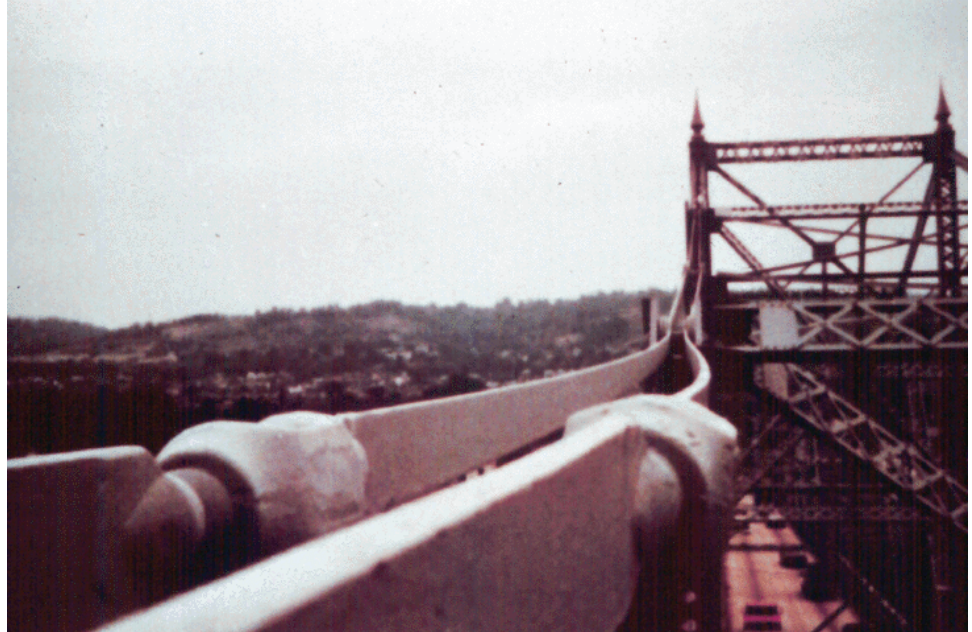
Check the alignment of the shank along the full length of the eyebar. Since the eyebar is a tension member, it should be straight. A bowed eyebar indicates that a compressive force has been introduced (see Figure 8.7.20).

**Figure 8.7.20** Bowed Eyebar Member

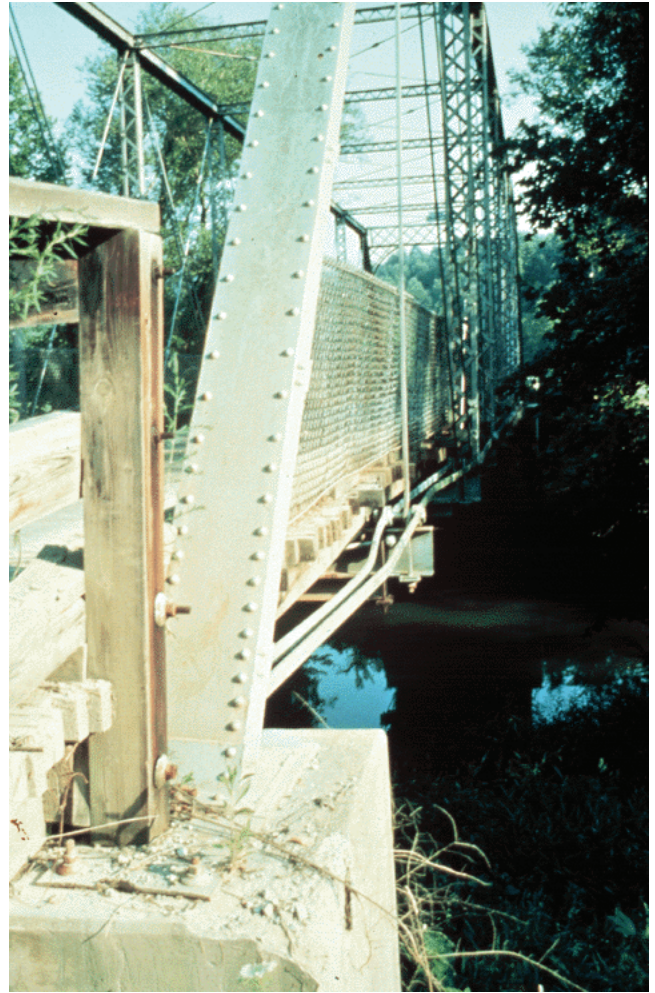
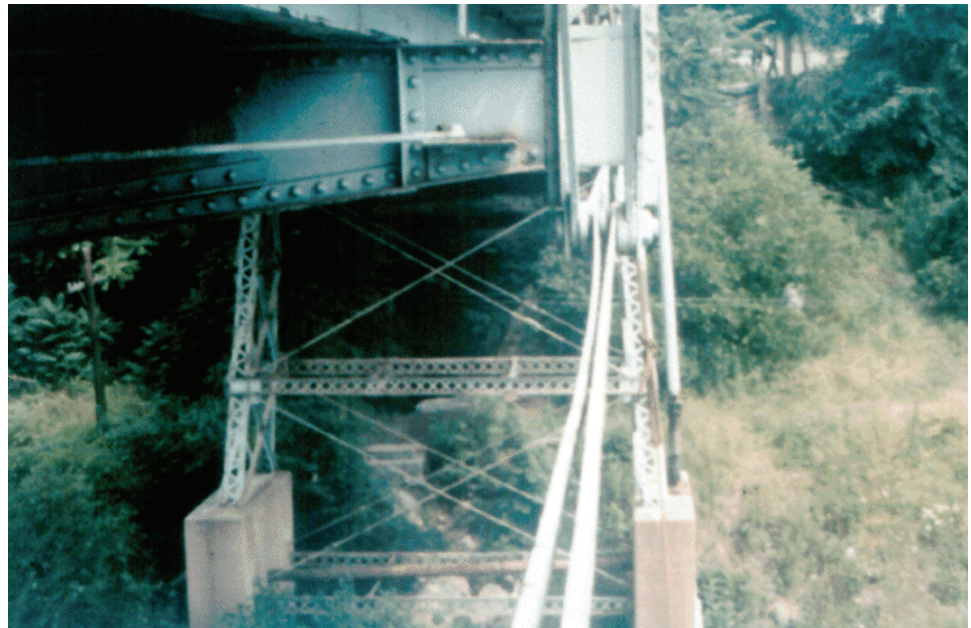
Misalignment due to buckling can also be caused by movement at the substructure or changes in loading during rehabilitation (see Figures 8.7.21 and 8.7.22). The eyebars of the same member should be parallel and evenly loaded.

**Figure 8.7.21** Buckled Eyebar due to Abutment Movement

**Figure 8.7.22** Non-parallel Eyebar Member

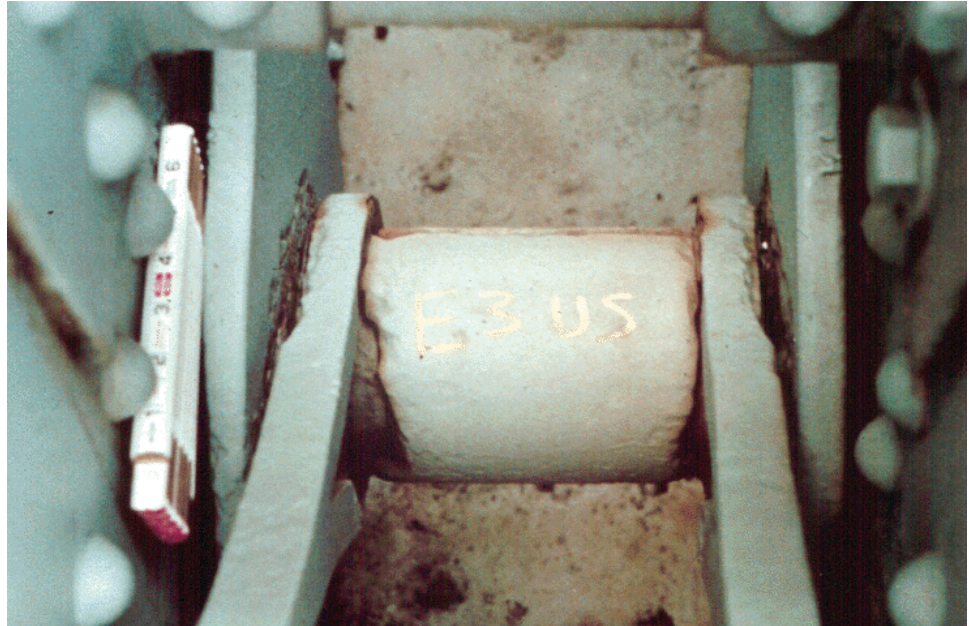
Examine the spacers on the pins to be sure they are holding the eyebars in their proper position (see Figure 8.7.23).

**Figure 8.7.23** Corroded Spacer

Examine closely spaced eyebars at the pin for corrosion build-up (packed rust). These areas do not always receive proper maintenance due to their inaccessibility. Extreme pack rust can deform retainer nuts or cotter pins and push the eyebars off the pins.

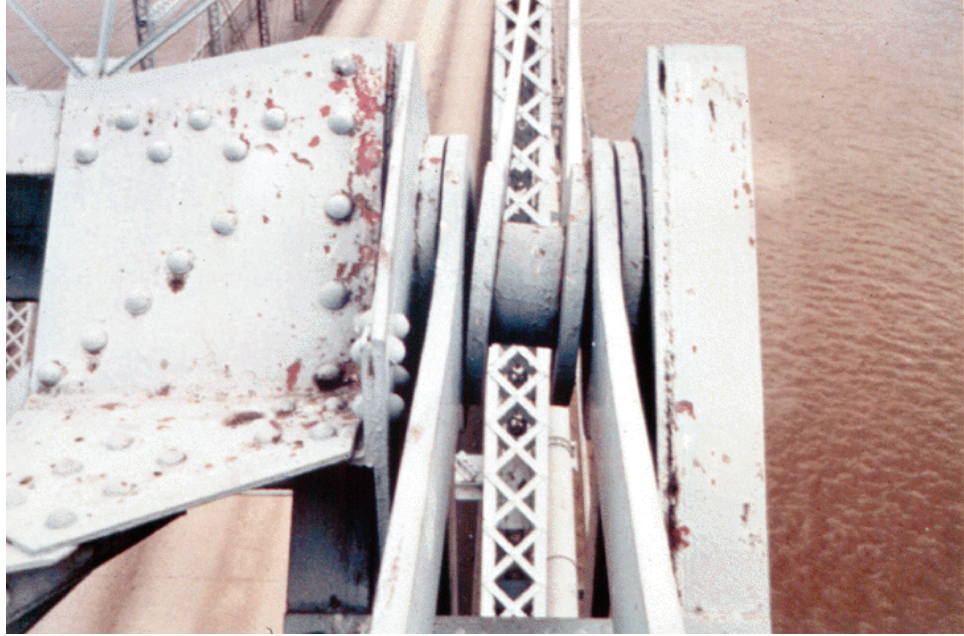
Verify the eyebars are symmetrical about the central plane of the spacer (see Figure 8.7.24).

**Figure 8.7.24** Symmetry at an Eyebars Connection

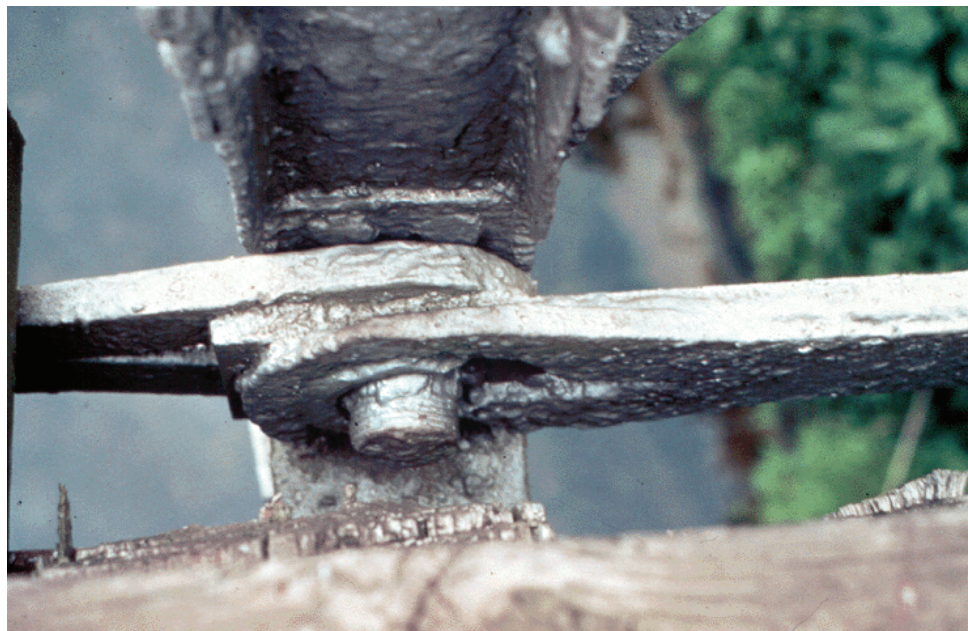
Evaluate the integrity of any welded repairs to the eyebar (see Figure 8.7.26). Check for any unauthorized welds and include their locations in your report so that the engineer can analyze the severity of their effect on the member (see Figure 8.7.27). Most of these bridges are old and constructed of steel which is considered “unweldable” by today’s standards. It is difficult to obtain a high quality “field” weld.

**Figure 8.7.26** Welds on Loop Rods

**Figure 8.7.27** Welded Repair to Loop Rods

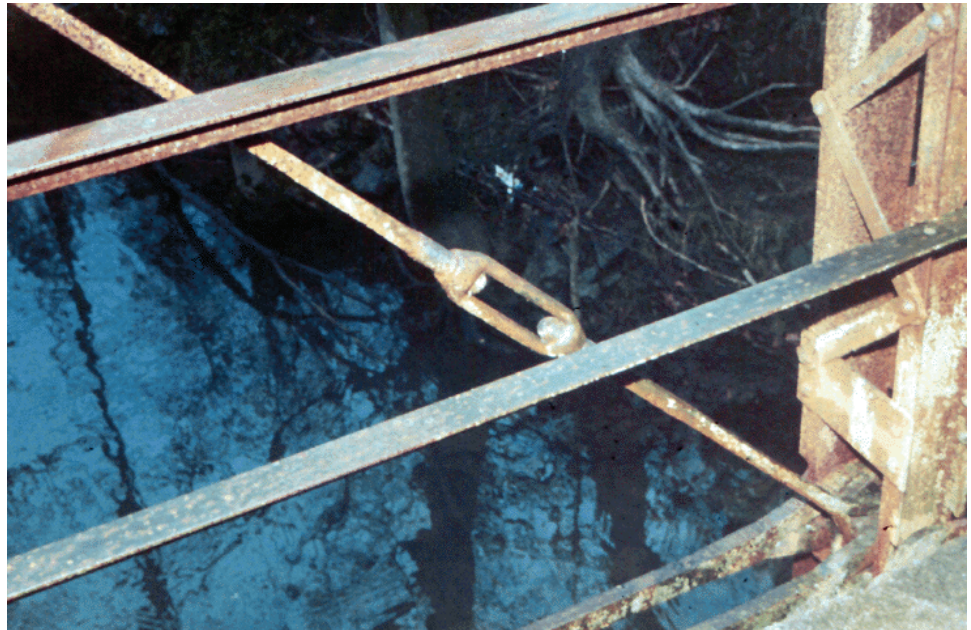
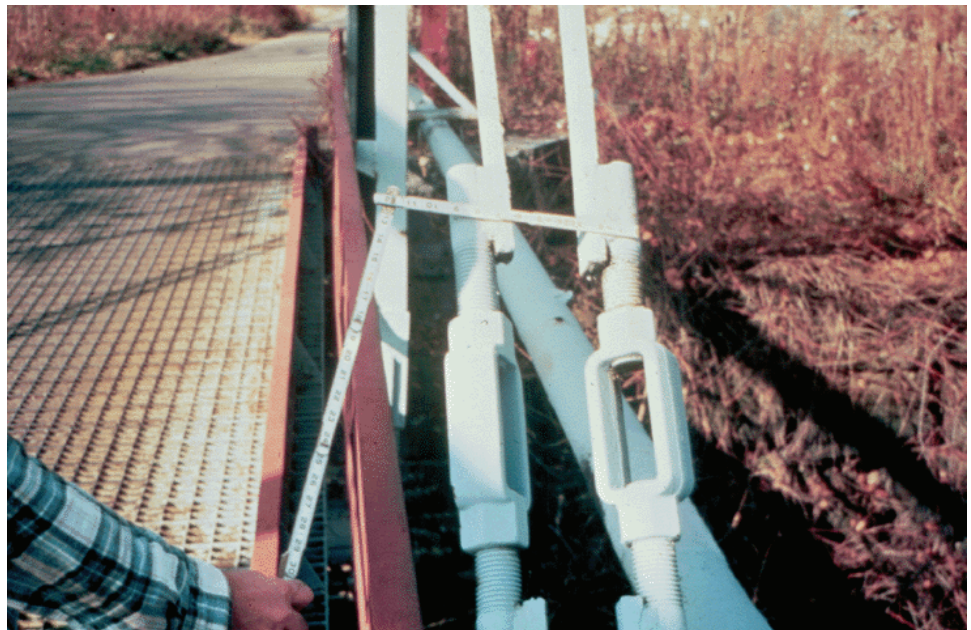
Examine any threaded rods in the area of the turnbuckle for corrosion, wear and repairs. Turnbuckles are often located in counter diagonals (see Figures 8.7.28 and 8.7.29).

**Figure 8.7.28** Turnbuckle on a Truss Diagonal

**Figure 8.7.29** Welded Repair to Turnbuckles

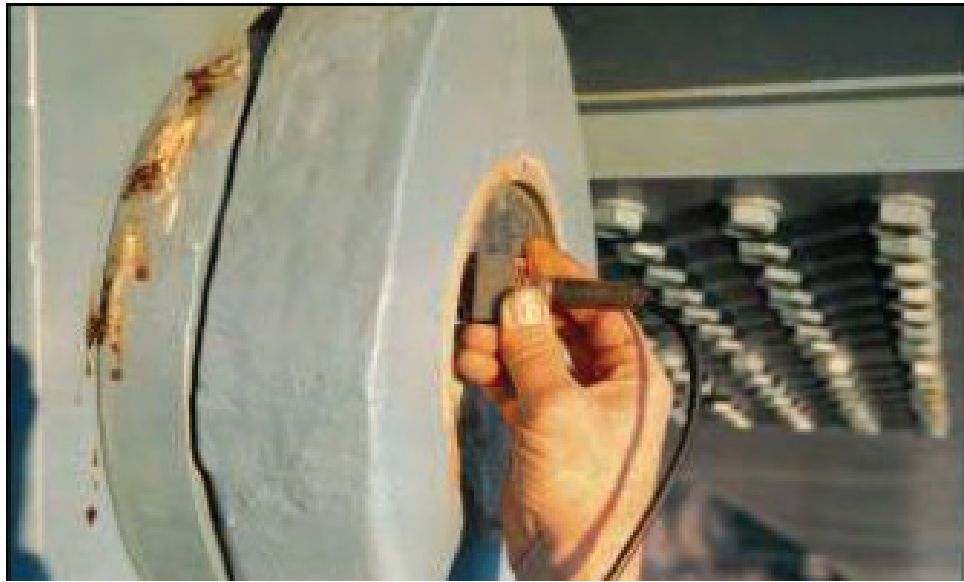
Pins should be inspected for signs of wear and corrosion. Nondestructive methods such as ultrasonic inspection are recommended since visual inspection cannot reveal internal material flaws that may exist (see Figure 8.7.30).

**Figure 8.7.30** Ultrasonic Inspection of Eyebars Pin

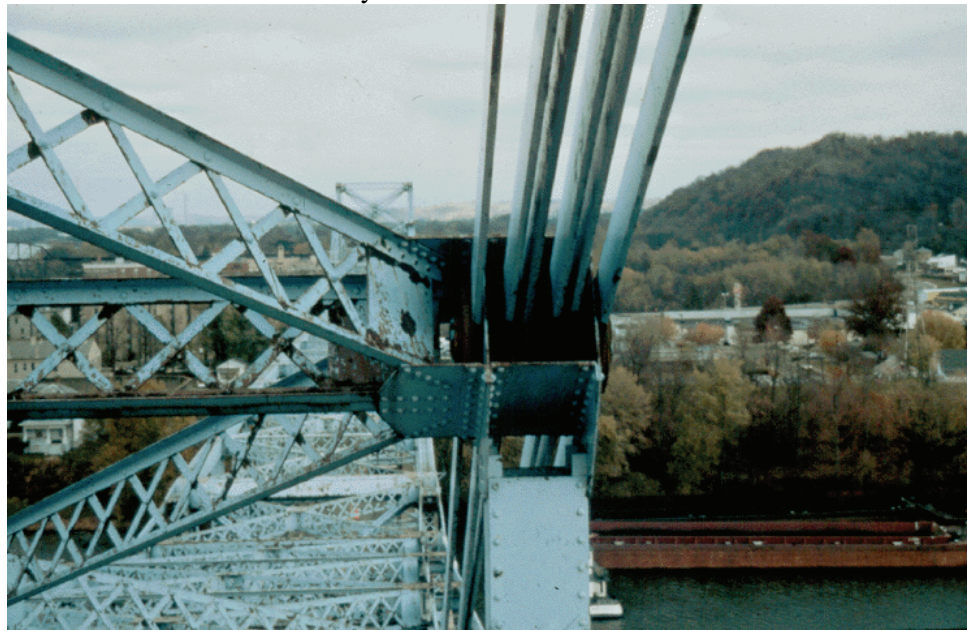
Eyebars are normally used on truss or suspension bridges. Since these bridge types normally only have two load paths between substructure supports, the bridges are considered non-load path redundant. If a steel eyebar member in tension fails causing a total or partial collapse of the bridge, that eyebar is considered a fracture critical member. Truss members that have three or more eyebars between panel points may be considered internally redundant (see Figures 8.7.31 and 8.7.32). See Topic 8.1 for a detailed discussion on fracture critical members and types of redundancy.

**Figure 8.7.31** Fracture Critical Bottom Chord Truss Member: Internally Non-redundant Eyebar

**Figure 8.7.32** Fracture Critical Top Chord Truss Member: Internally Redundant Eyebar
