# Coastal Construction: Maintaining the Building Structure and Envelope

## **Coastal Construction Manual**

**“Principles and Practices of Planning, Siting, Designing,  
Constructing, and Maintaining Residential Buildings in Coastal  
Areas (4th Ed.), Ch. 14, Maintaining the Building”**

# 14 Maintaining the Building

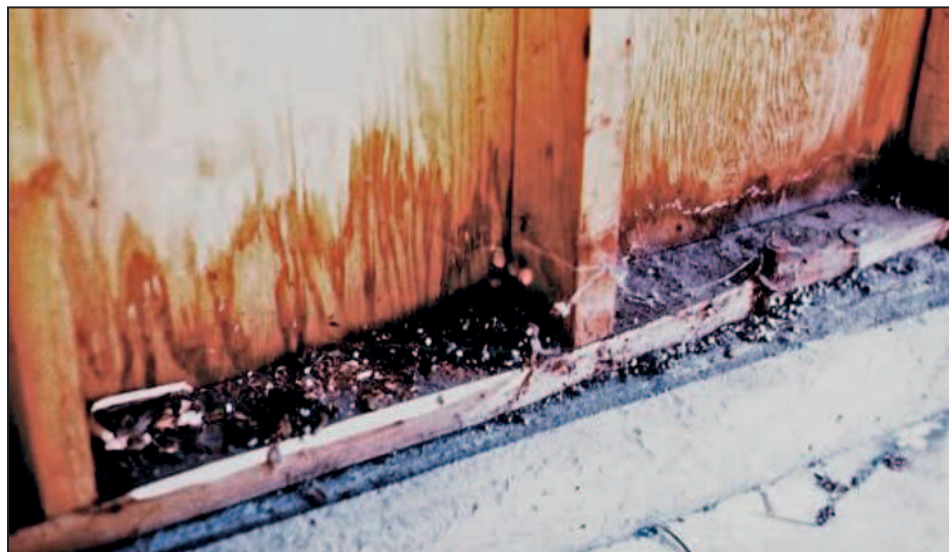
**Figure 14-4.**  
Deteriorated wood sill  
plate

Shearwall sill plates bearing directly on continuous footings or concrete slabs-on-grade, if used in coastal construction, are particularly susceptible to decay in moist conditions. Figure 14-4 shows a deteriorated sill plate. Even if the decay of the preservative-treated sill plate is retarded, the attached untreated plywood can easily decay and the shearwall will lose strength. Conditions that promote sill and plywood decay include an outside soil grade above the sill, stucco without a weep screed at the sill plate, and sources of excessive interior water vapor. Correcting these conditions helps maintain the strength of the shearwalls.
