Alternative Techniques to Riprap Bank Stabilization

**“Alternative Techniques
to Riprap Bank Stabilization”**

Engineering With Nature

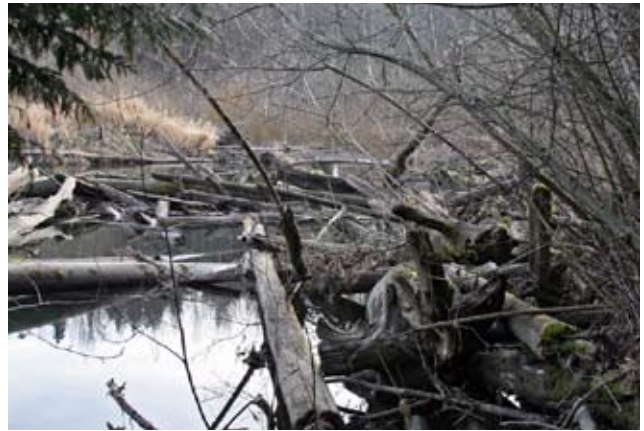
Numerous logs are placed along the toe of the riverbank.

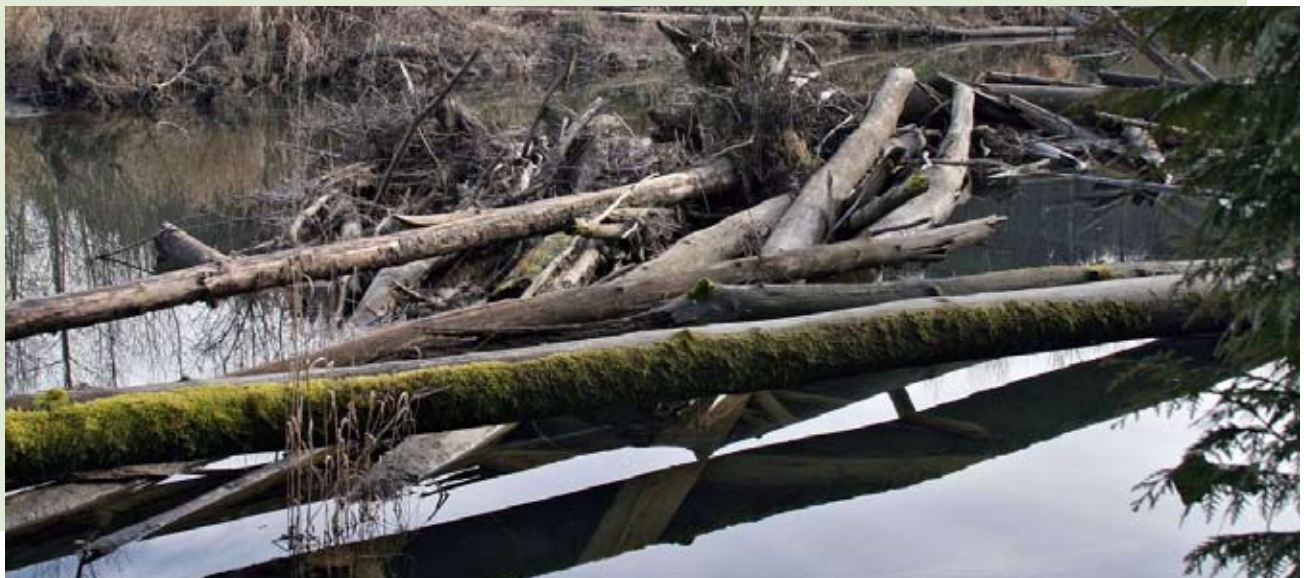
During flooding additional woody debris is recruited by the original logs.

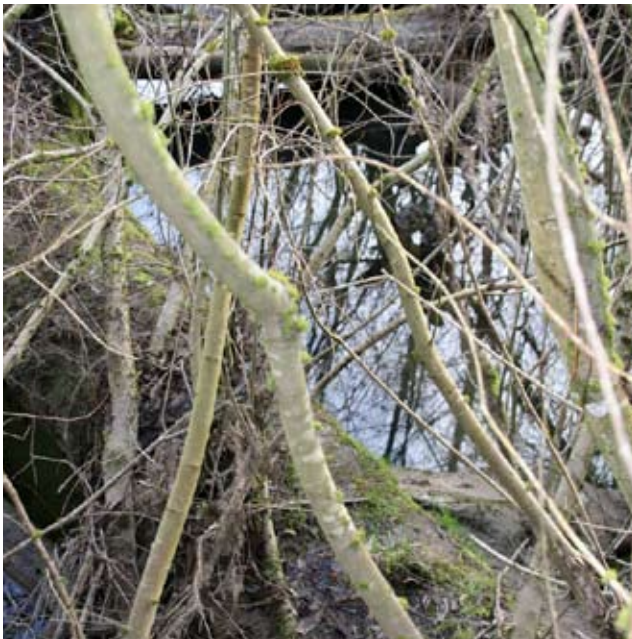
Recruited vegetation lends cohesion to the riverbanks.

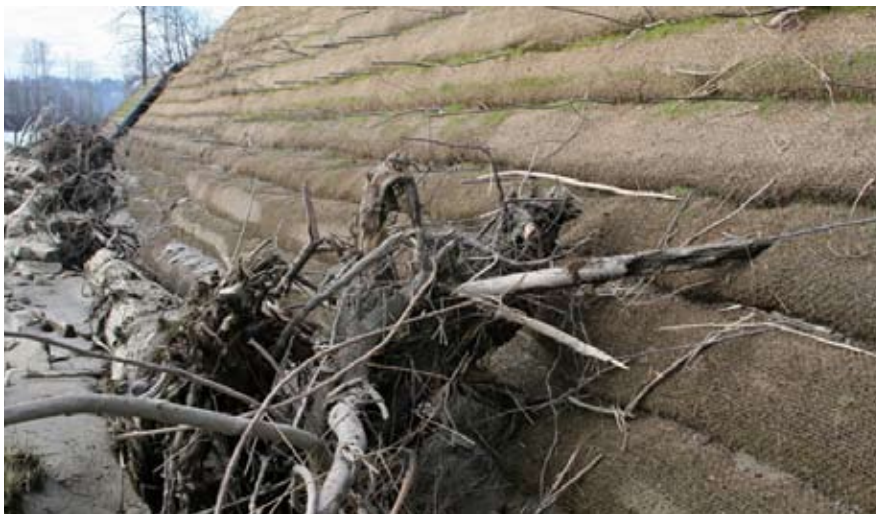
The offsetting of the soil wraps comprising the structural earth wall (SEW) give it its step-like appearance. The logs anchored to the toe of the embankment protect the structure from fast flowing woody debris and provide habitat for migrating fish during high water.

Since the embankment along Riverview Road is so steep, typical stabilization techniques were impractical. Jones and his team of Snohomish County Road Maintenance workers built a structural earth wall (SEW) composed of a number of soil wraps placed in a step-like fashion starting from the waterline and climbing to the top of the embankment. Each step is created by laying down a 13-foot wide roll of polypropylene or polyethylene geo-grid fabric. The grids are

weighted down by layers of compacted gravel-borrow taken from a local quarry. The geo-grid is folded over, and another layer of gravel is used to weigh it down further. As each wrap is completed, the following one is offset by at least one foot, creating the step-like appearance. The outer face of the wall is covered with a layer of heavy coir fabric, and topsoil which is then hydro-seeded. This allows the geo-grid to lock in place and secure the embankment without threat of degradation from exposure to ultraviolet light. Finally, the entire embankment is planted with live willow cuttings which ultimately take root. As the trees grow, their root structures add to the stability of the embankment.

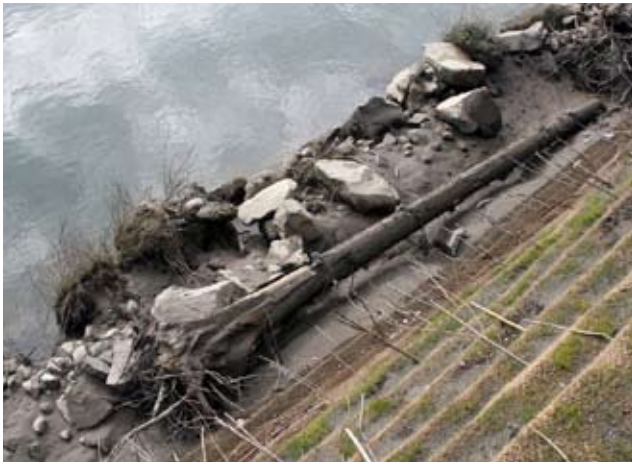
The willow cuttings planted throughout the embankment lend root cohesion and stability to the structural earth wall.

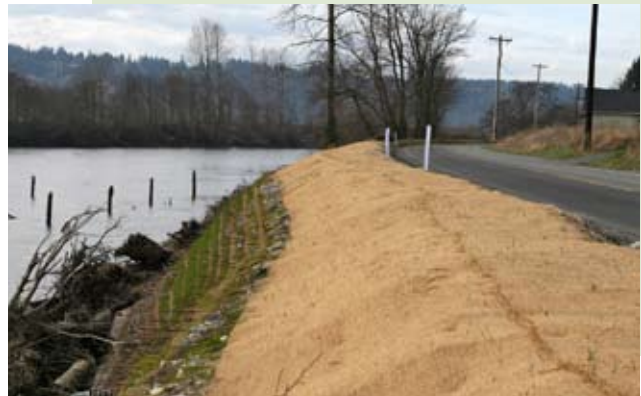
Eventually the coir fabric and the structural earth wall itself will be completely overgrown with hydro-seeded grass and other vegetation.

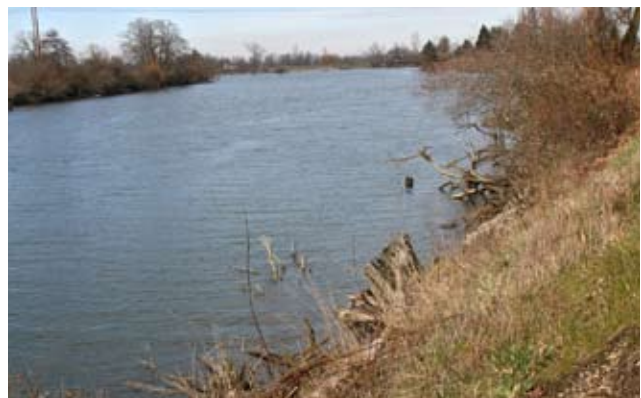
The completed project, a short distance down the road, is now fully vegetated and looks entirely natural.

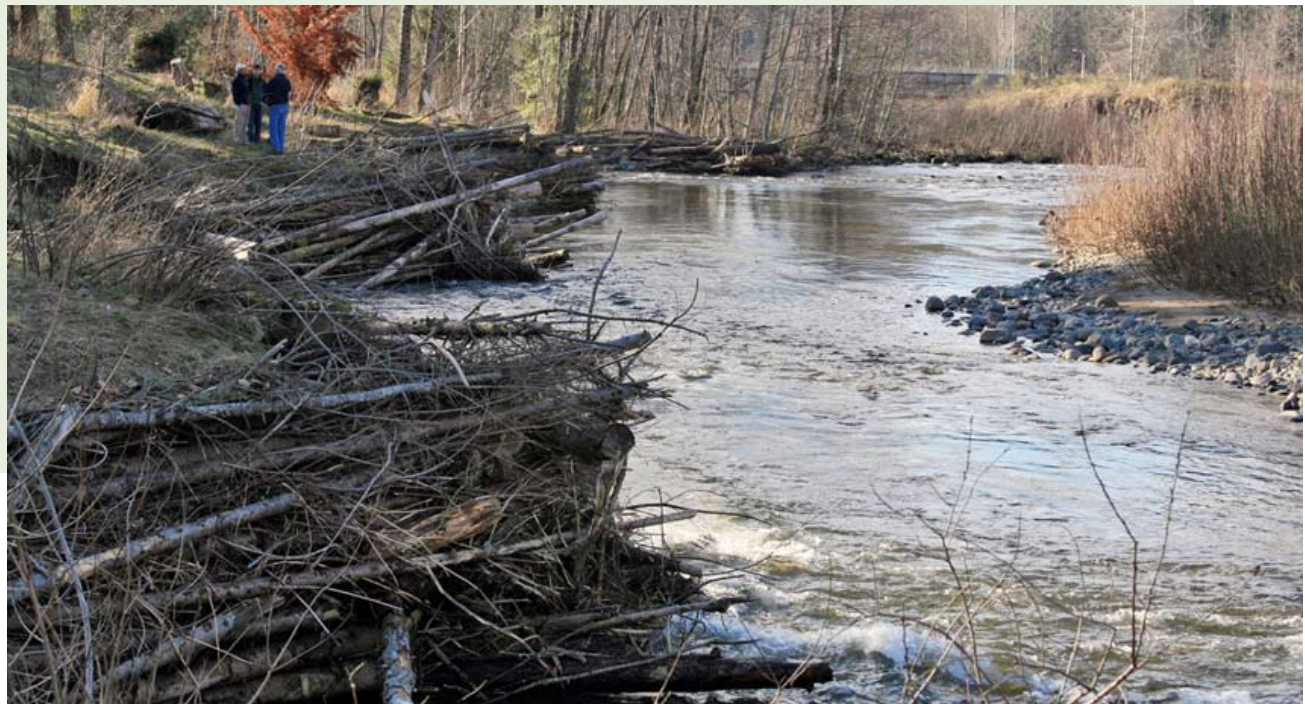
Four of the engineered logjams designed by Herrera Environmental Consultants on the Mashel River outside of Eatonville, WA.

The logs comprising the base of the logjam structures are driven deep into the riverbank, some as much as 15-30 feet in depth. A criss-crossed pattern of logs forms the core, which is likened to that of an eleva-

During the November 2006 flood (which was listed as a 25-year event) the sites suffered no damage, and no logjams were lost to high water. Additionally, the jams performed their intended function of providing protection, and no evidence of erosion was reported on either bank of the river.

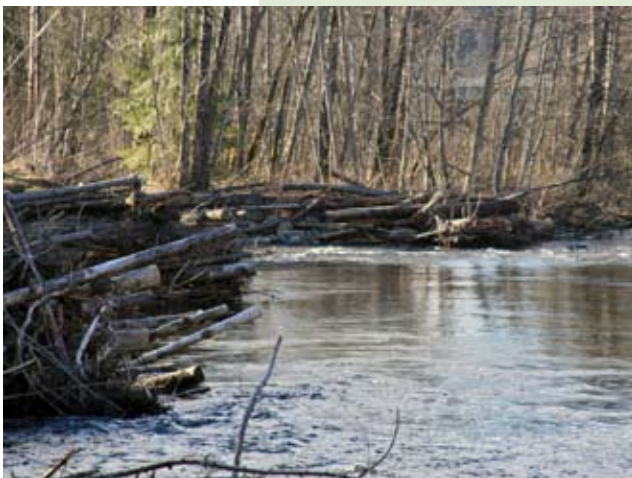
The complexity added by the logjams is important for slowing down water flow on the river.

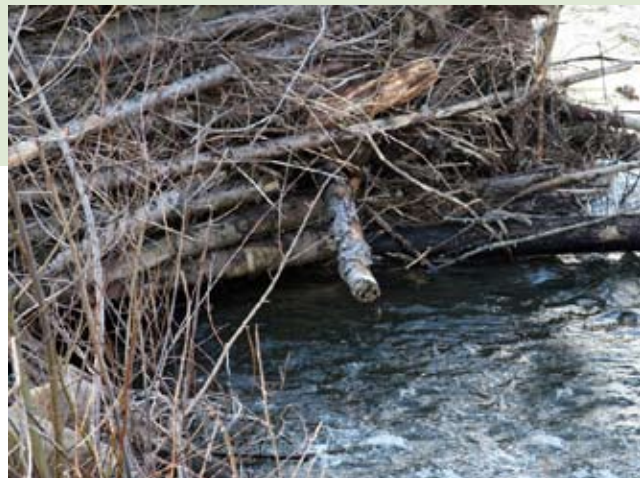
The pools established behind each jam provide much needed habitat and refuge for migrating fish.

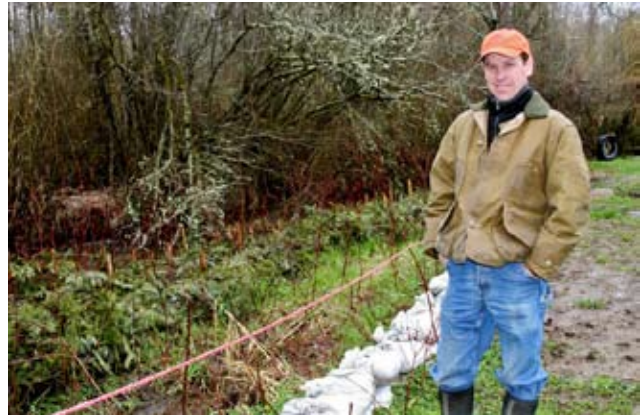
Rich Geiger standing by the brush mattress as it develops.

Geiger's solution was to design a brush mattress along 77 feet of the creek. The mattress was built by tying 6-foot long Douglas fir and Grand fir tree tops to 4-foot long, 2-inch by 2-inch cedar stakes, driven in a 1-foot by 2-foot pattern into the stream bank. The tree tops are placed with the butt upstream, with each piece tied to at least three separate stakes, and shingled so the upstream tree overlaps two-thirds

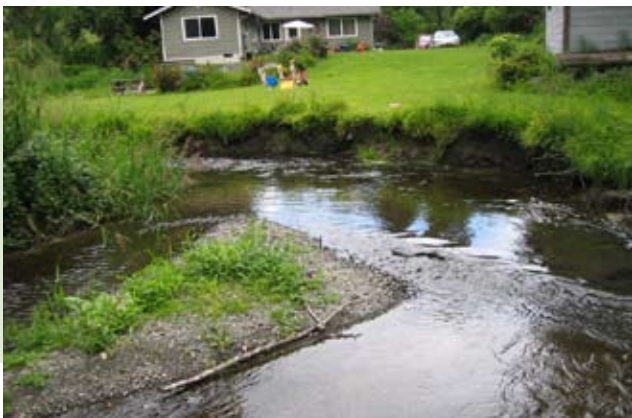
The eroding property prior to the start of the project.

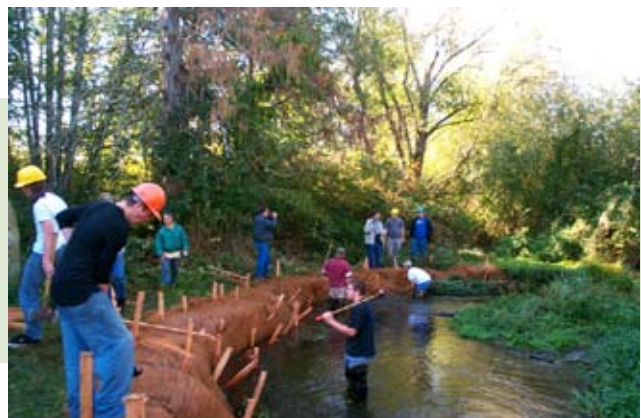
Construction of the brush mattress underway.

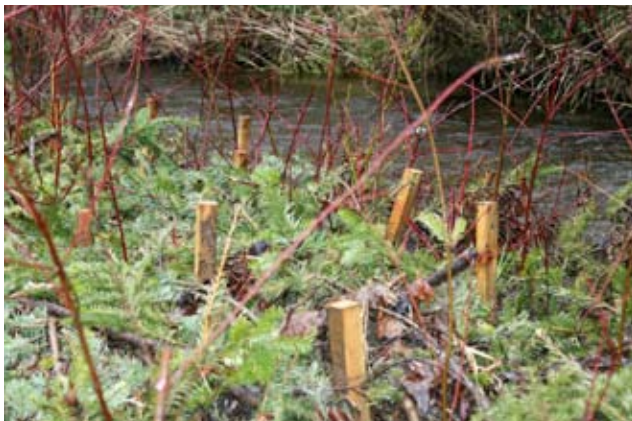
Cedar stakes driven into the creek bank provide additional soil retention.

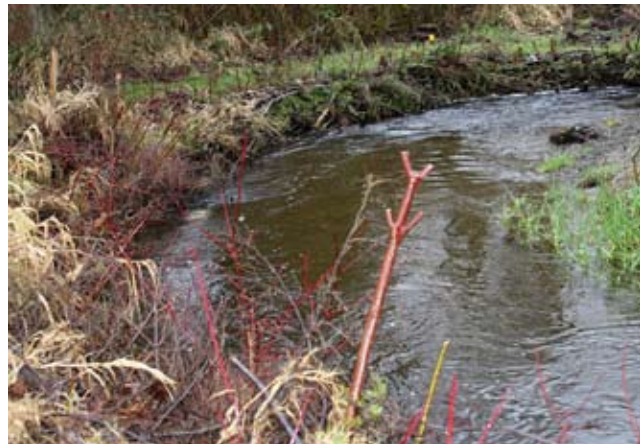
The added vegetation to the creek provides habitat and cover for fish.

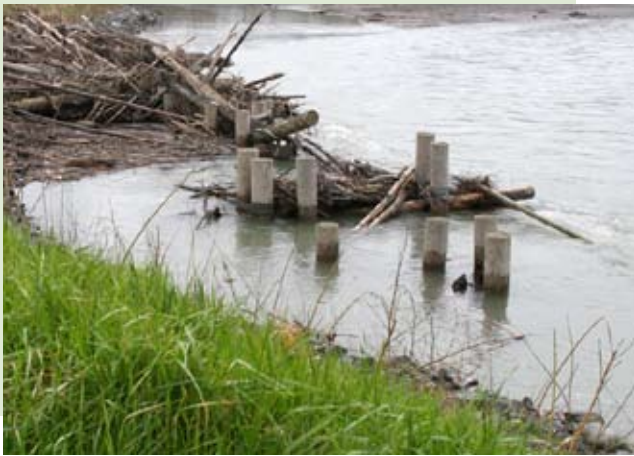
One of the scour holes being stabilized by the Overflow project. Woody debris has begun to collect and will be incorporated into the riverbank.

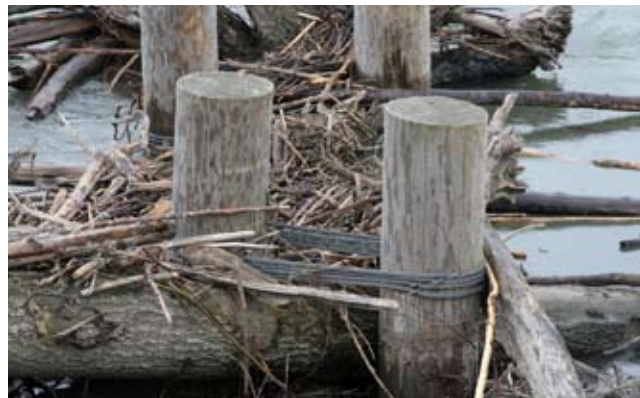
The timber piling structures capture woody debris, which provides roughness to the river, and ultimately establishes additional habitat.

“In terms of the bank stabilization project, the timber pilings are a stand-alone component,” said Lee. “This means that if some of the timber piling structures are damaged, the integrity of the entire bank stabilization design is not compromised. At the same time, there are bank stability benefits provided by these structures. They provide an incredible amount of roughness along the portions of the riverbank where they are located. This slows the water along the bank behind them, promoting deposition and the establishment of vegetation, which helps to further stabilize these areas.”

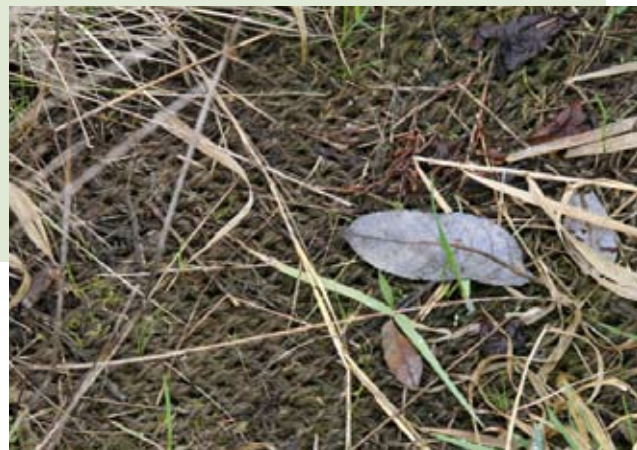
Coir fabric covers the upper bank.

“Using three-quarter-inch plywood that was eight feet long and 12 inches high, we built forms to aid in the construction of over a couple miles of soil lifts,” said Lee. “Basically, we laid down the coir fabric, planted the willow cuttings, and placed the dirt. The wooden form provided something for the dirt to push up against as you ran over it with the walk-behind compactor. Otherwise, if you just simply had coir fabric holding back the soil when you put the compactor on it, the fabric would bulge out and likely rupture. The forms allowed us to build the soil lifts in a uniform manner. As the crews got proficient, we started to make excellent production numbers per day. It really worked well.”

Because the coir fabric eventually decays, the live stakes are the source of long-term stability for the slope. For the Everson Overflow project, the Whatcom County Public Works Department planted 10,000 thriving willow cuttings. In addition, a twenty-foot wide buffer was designated along the top length of the project. The buffer is planted with a mix of native tree species such as cedar, fir and alder, providing a great improvement to this section of the bank which had previously been overgrown with an invasive, non-native blackberry species.

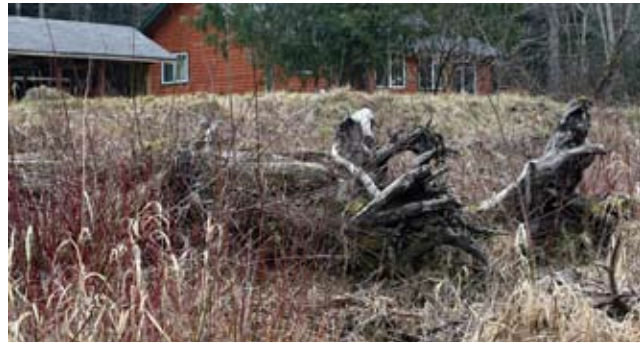
Downed trees claimed by the Forest Service provide the skeleton for the rock groin structure.

The first step in installing the groins involved temporarily blocking the river from entering the construction site. Since the project was undertaken while the river was at a seasonally reduced level, only a small area had to be coffered off with sandbags. Once the construction site was secured, three trenches extending 25 feet back into the bank were dug, and tapered down into the river channel. Multi-sized rocks similar to that used in riprap design were then carefully layered into the trenches.

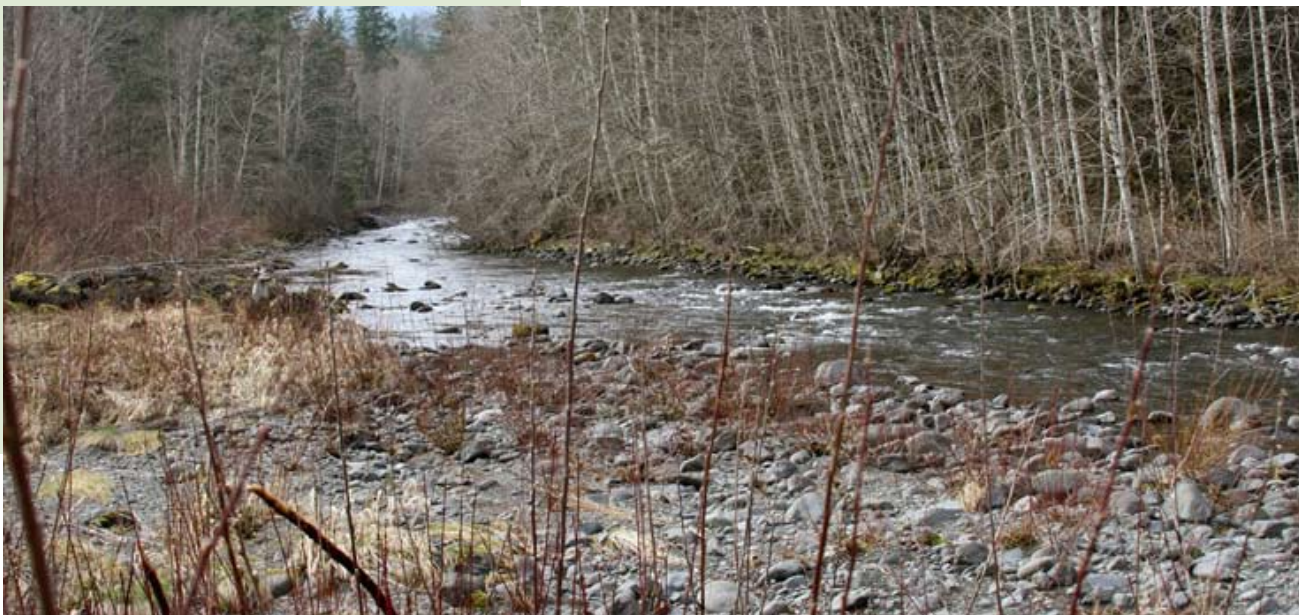
Planted willows, dogwoods, conifers and other trees will create a mat of roots to help stabilize the riverbank.

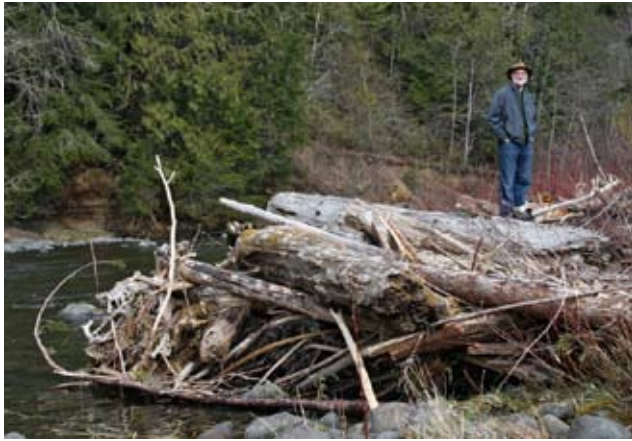
Al Latham stands on top of one the groins extended into the river.

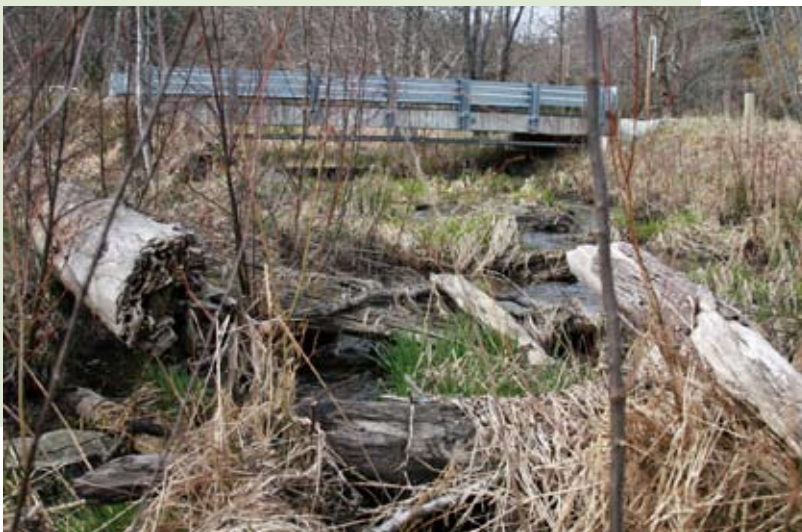
Wood positioned downstream of the bridge slows water flow and provides habitat for fish and other wildlife.

Another portion of the bank stabilization and habitat complexity involved the addition of wood in the creek immediately past the bridge, as well as further downstream. The wood establishes important habitat for fish traversing the stream, and causes flow to slow down considerably during periods of high water, further adding to the protection against erosion.

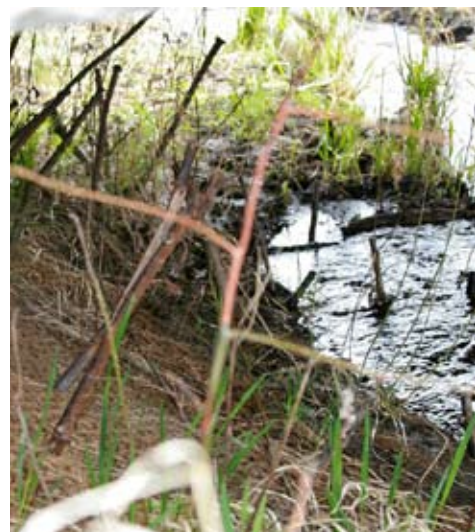
Coir matting and planted vegetation stabilize the creek banks under the bridge.

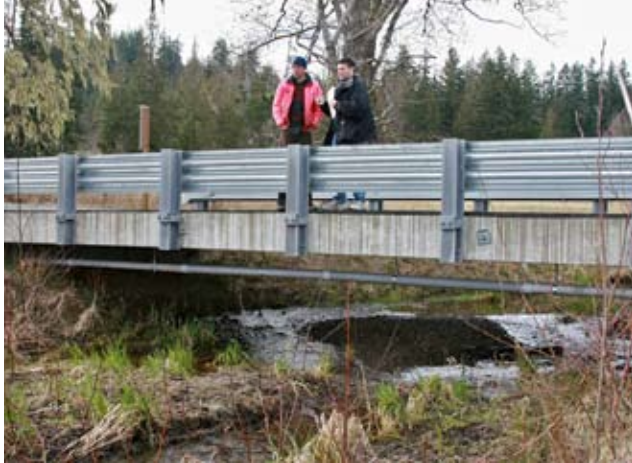
The extra wide design of the bridge ensures adequate room for water flow during flood conditions.

The bridge was installed with the use of concrete pilings driven approximately 20 feet into the ground, removing the threat of instability due to possible undercutting. Though the channel width was only 13 feet at its maximum, they designed the bridge to span over 40 feet in length.

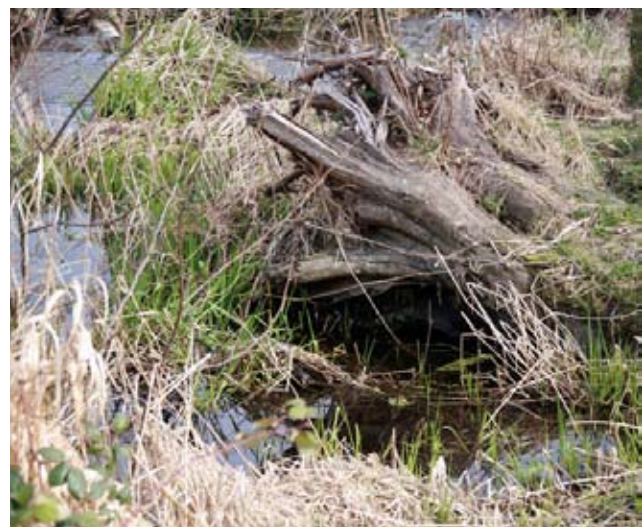
Many of the logs are actually buried in the banks.

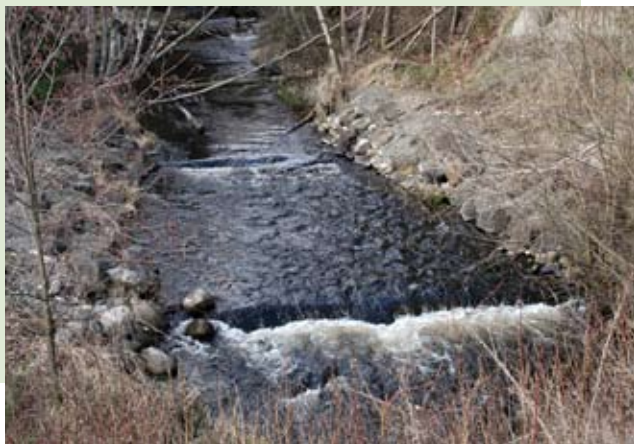
The restructured channel is now far easier for fish to traverse during migration.

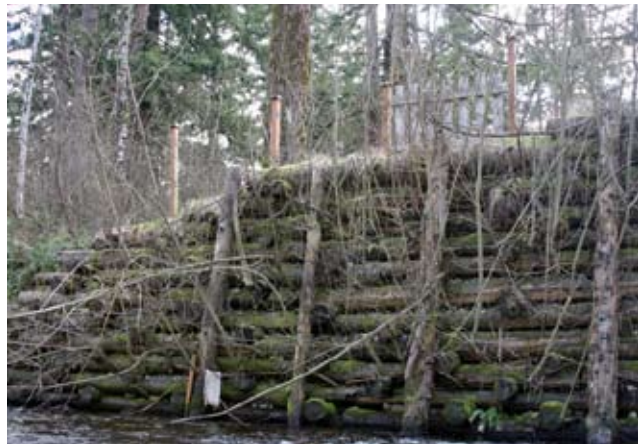
The crib wall will overgrow with vegetation, which will ultimately become the structure itself when the logs finally decay.

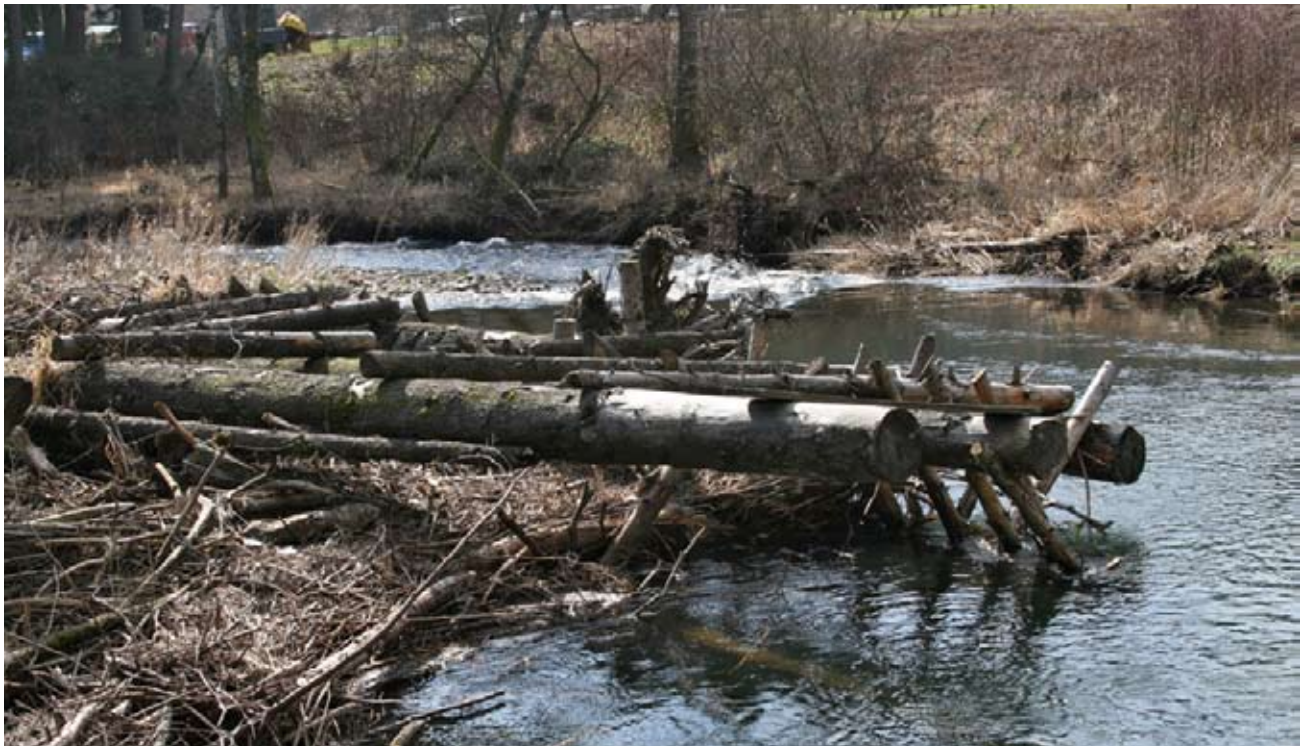
The porous design of the debris catcher allows fish to swim through the structure unimpeded.

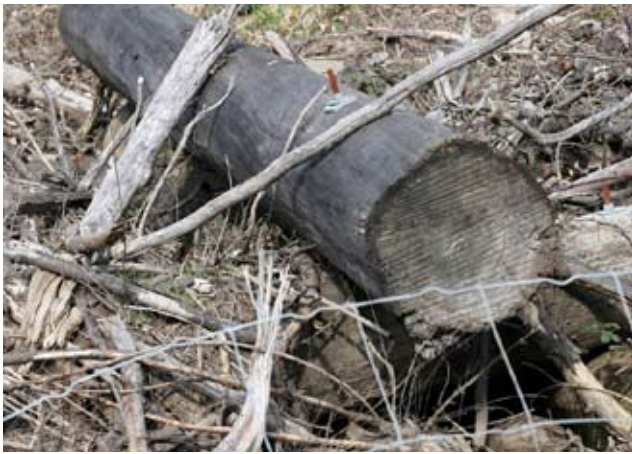
Steel bolts lock the log frames together providing stability and strength to the structure.

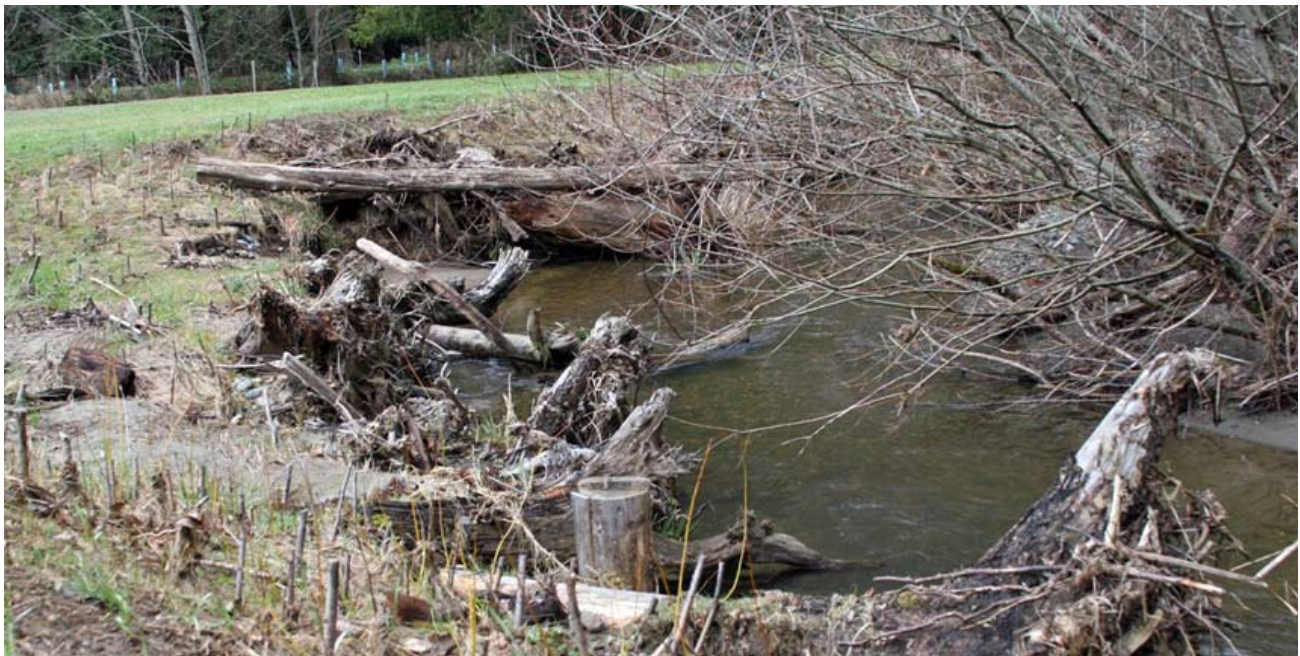
Wood added to the banks of Schneider Creek slows water flow and improves habitat diversity.

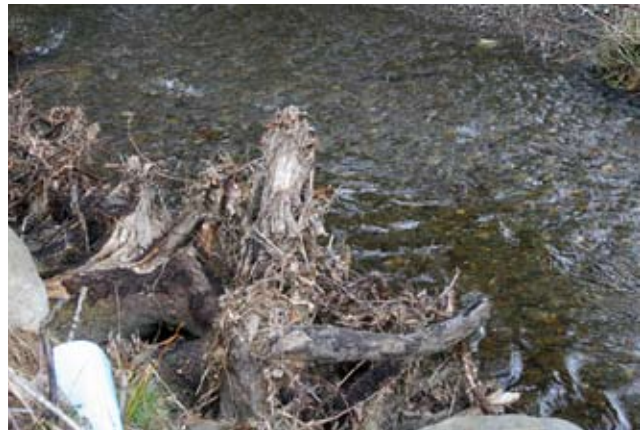
The logjams are extended into the water providing needed roughness.

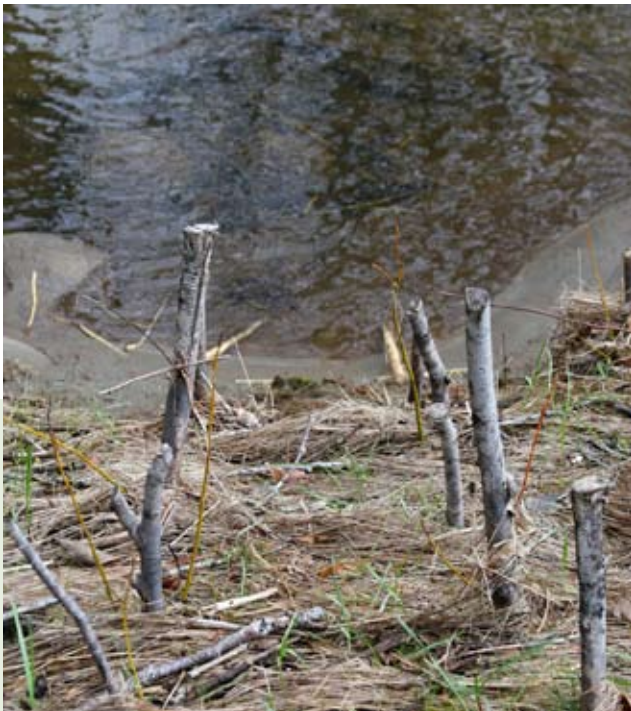
The entire bank is covered with willow cuttings for root strength.

Though it takes years for the plantings to grow, the designers prefer to use smaller willow cuttings, approximately 24-inches in height, to start. Once the

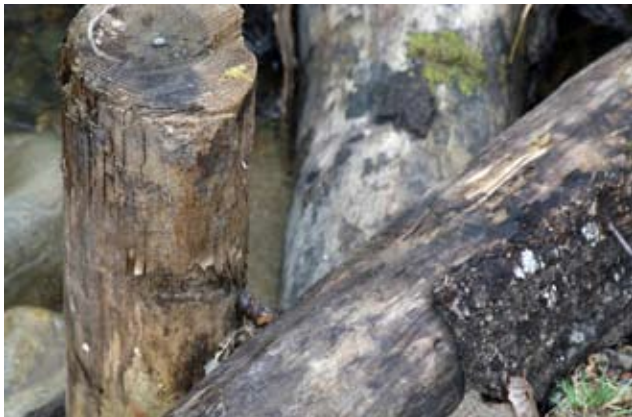
The logs in the jams are secured to each other with rebar.
