Guide to Tornado Protection - Refuge Areas in Buildings

**“Tornado Protection
Selecting Refuge Areas in Buildings”**

FEMA P-431

Selecting Refuge Areas in
Buildings

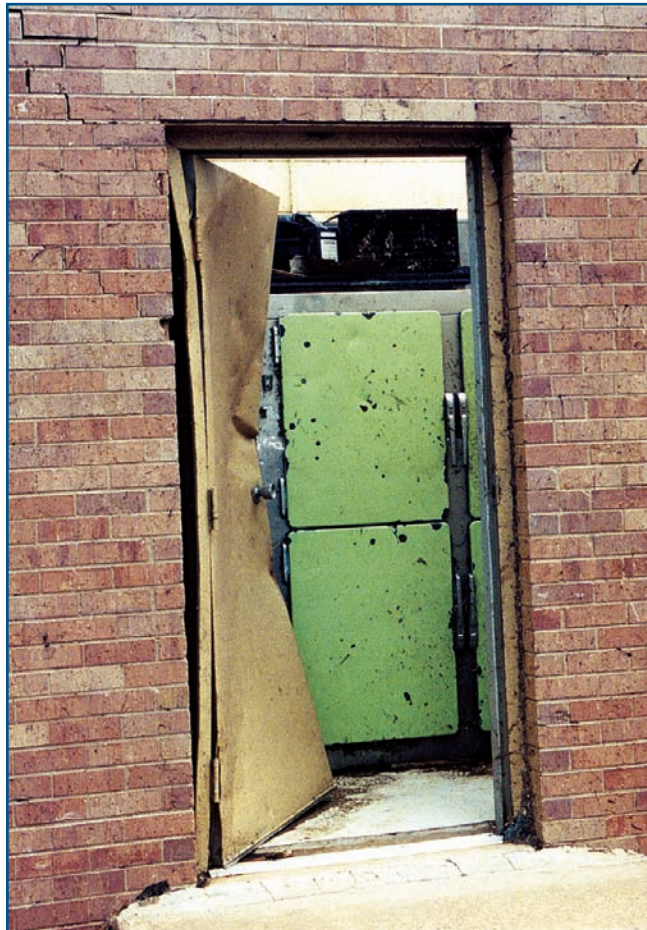
Figure 2-2
Example of damage from a windborne missile. A 2-inch by 6-inch board penetrated a refrigerator.

The extreme winds in tornadoes pick up and carry debris from damaged buildings and objects located in the path of the winds (see Figures 2-2 and 2-3). Even heavy, massive objects such as cars, tractor trailers, and buses can be moved by extreme winds and cause collateral damage to buildings. Light objects become flying debris, or missiles, that can penetrate doors, walls, and roofs; heavier objects can roll and cause crushing-type damage.

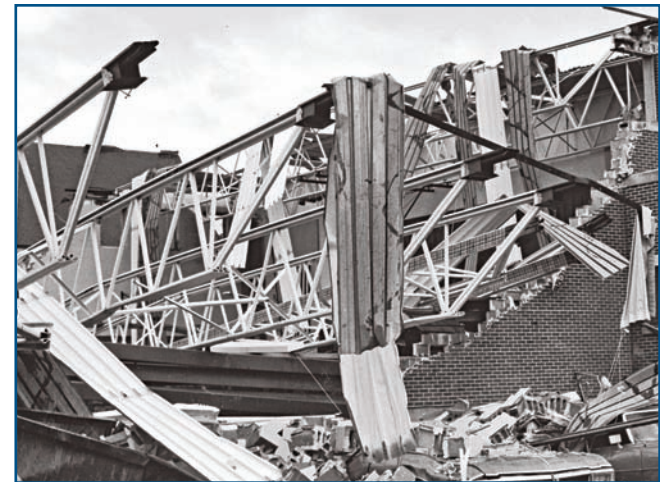
The unreinforced masonry walls combined with the lightweight roof structure in the building as well as the gymnasium building were vulnerable to collapse in windstorms. Gymnasium buildings are not considered suitable for occupant protection because they usually include tall walls and long-span roofs. Lightweight roof structures that are not adequately anchored can be lifted in windstorms. Except in violent (F4 and F5 in the Fujita scales or EF4 and EF5 in the Enhanced Fujita scales*) tornadoes, the lower floor (in two-story or higher buildings) generally provides good protection for occupants when there are two or more walls between the refuge area and the outside.

Figure 3-14
Collapsed St. Augustine Elementary School
Gymnasium building.

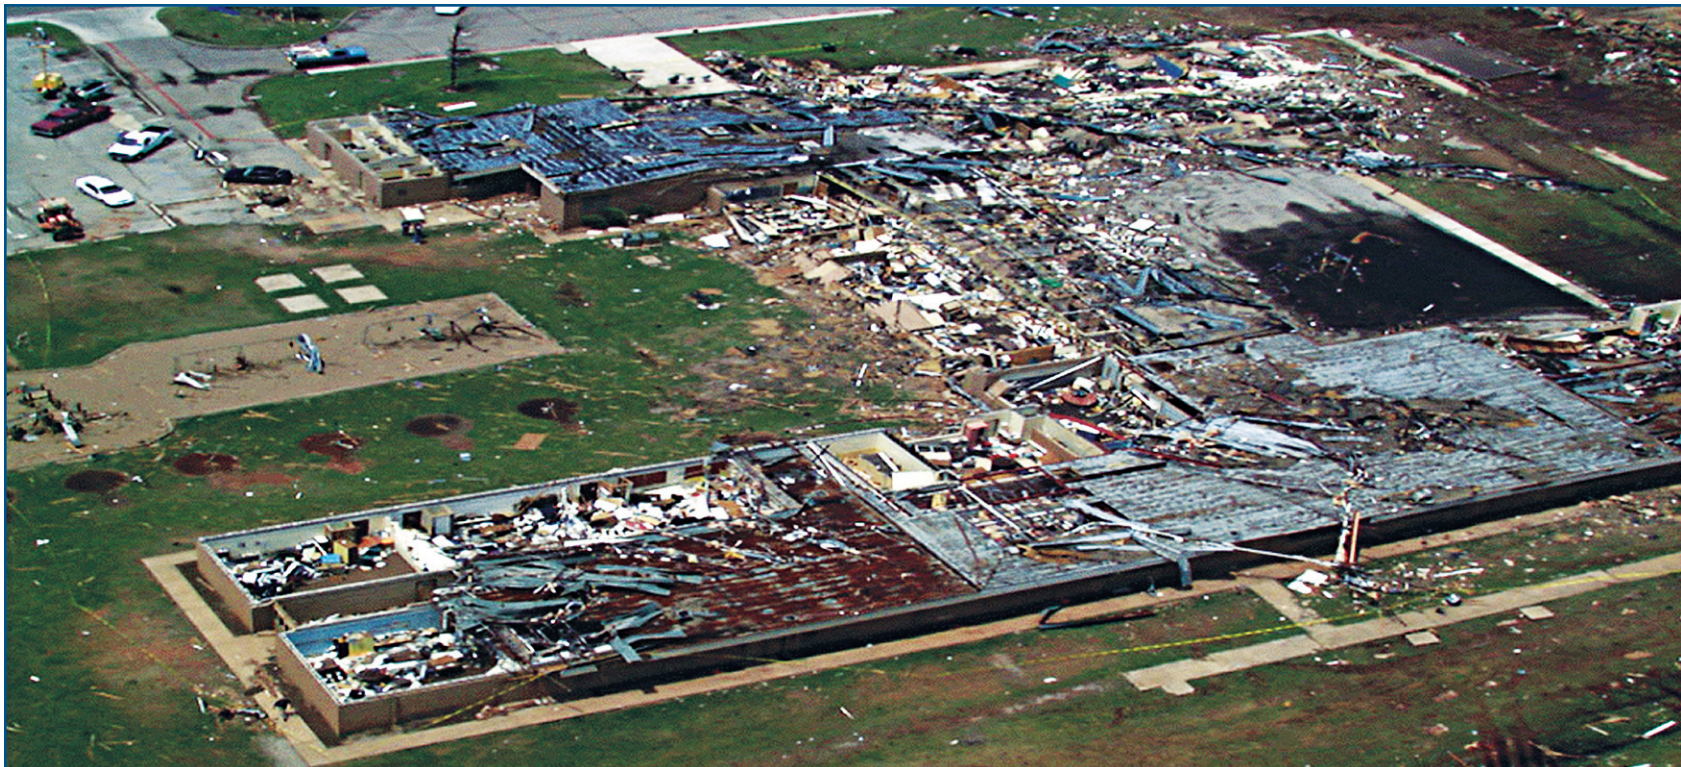
Figure 3-15 Kelly Elementary School, Moore, Oklahoma.

The tornado hit after school hours and passed just to the north of the site. Damage to the school building was both severe and extensive (Figure 3-15). As discussed in the Lessons Learned section in this case study, the remaining structure was demolished and the school was rebuilt. The new school includes structural elements designed to provide increased wind resistance.

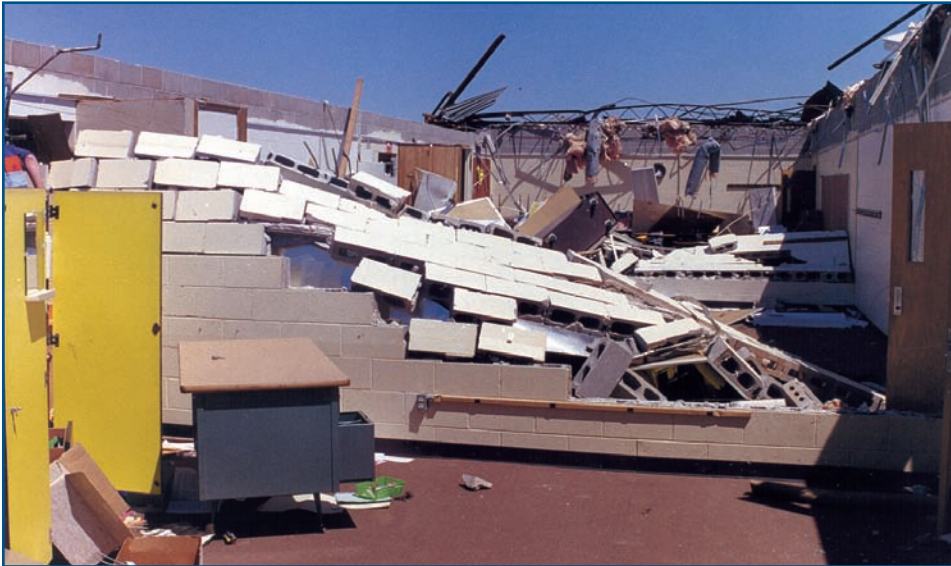
Unreinforced masonry walls failed when the roof system was lifted or removed by tornado winds (Figures 3-17, 3-18, and 3-19). Figures 3-17 and 3-19 show failed interior and exterior walls, respectively. Figure 3-18 shows the separation of the reinforced bond beam (indicated by circles) from the upper part of a corridor wall. The inclusion of clerestory windows in some corridor walls contributed to their failure under loads imposed by tornado winds (Figure 3-20).

Figure 3-17
Interior and exterior unreinforced masonry walls were damaged when reinforced bond beams failed.

The improvements discussed here are designed to prevent the types of damage to interior corridor walls and roofs shown previously in Figures 3-17, 3-18, 3-20, and 3-21. The reconstruction of the Kelly Elementary School is a good example of how refuge areas can be incorporated into new construction.

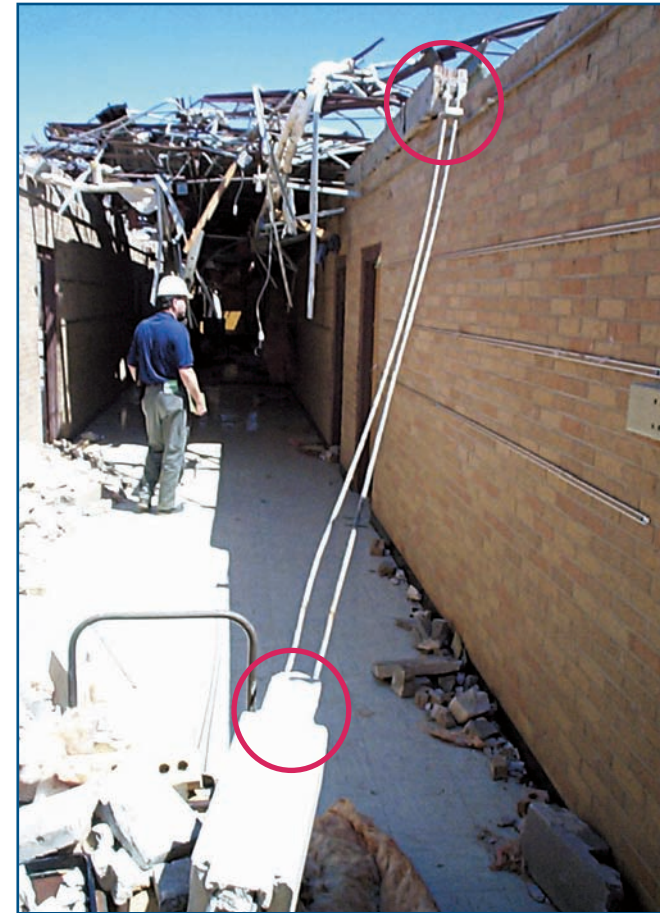
Figure 3-18
Corridor area. Separation of reinforced bond beam (indicated by circles) from supporting wall.

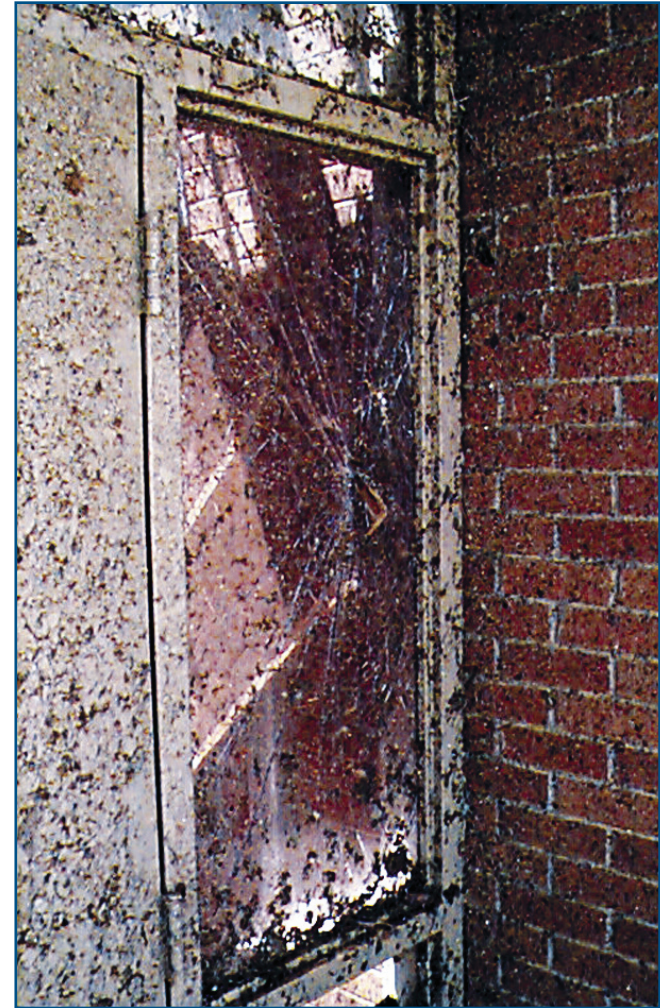
Figure 3-22
Impact performance of laminated glass. The corner of a table penetrated this laminated glass window, but the glass remained in its frame.

Damage was also caused by the impact of windborne missiles. Figure 2-3, in Chapter 2, shows a steel door that appeared to have been opened by the impact of a heavy object. This door led into an area where the roof was missing. The opening created by this breached door may have allowed wind to enter the building and create internal pressure that increased the load on the building envelope. Figure 3-22 shows damage to a laminated glass window hit by a table.

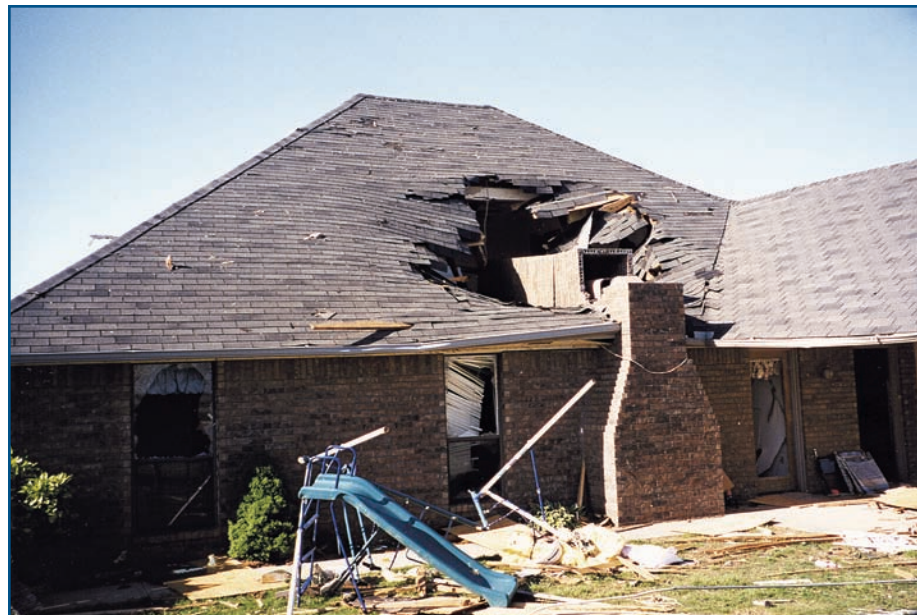
Figure 4-3
Failure of brick chimney under tornado winds damaged the room of this house in Moore, Oklahoma.

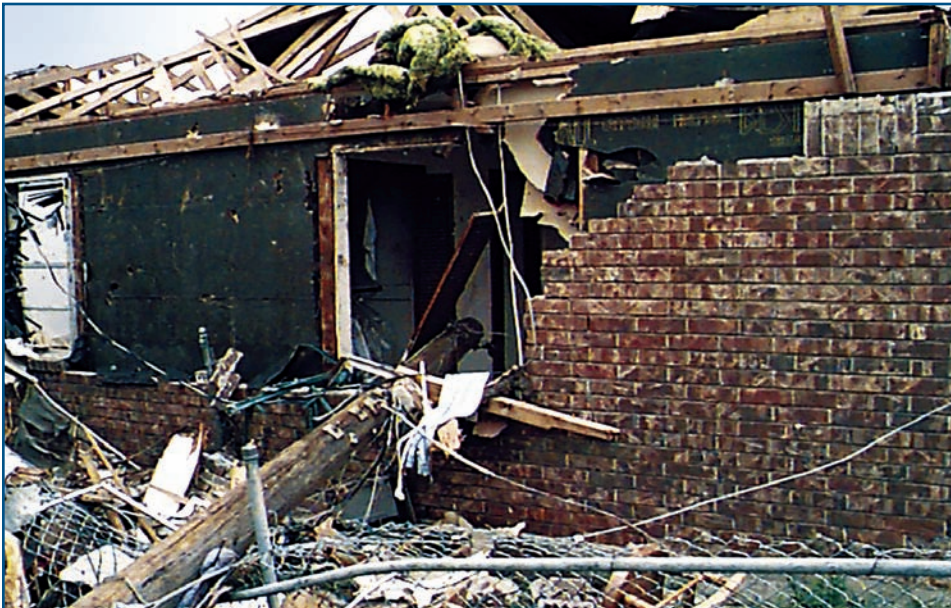
Figure 4-4
This power pole penetrated a window and extended several feet into the house after being blown 40 feet from its original location.

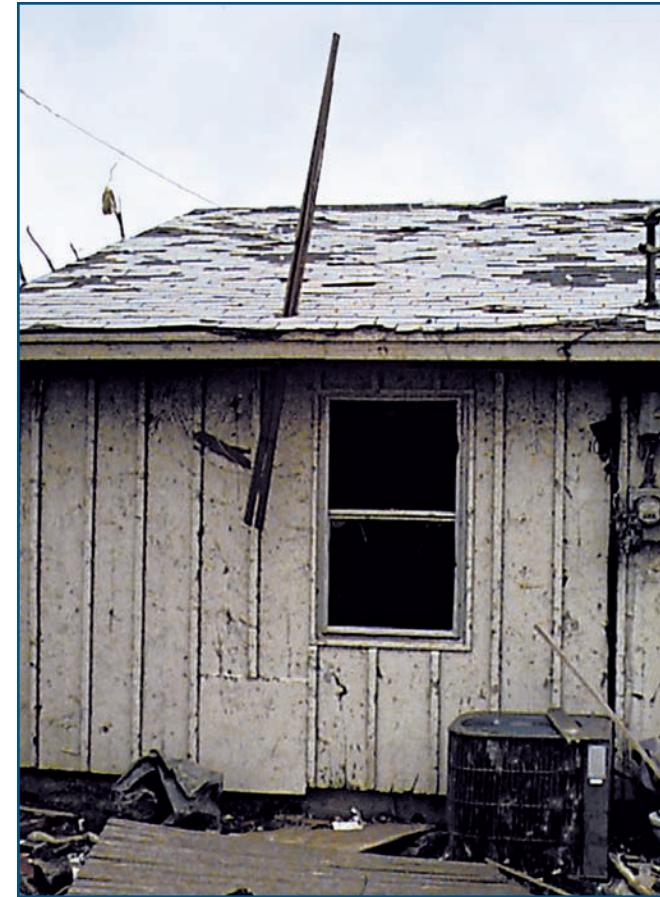
Figure 4-5
This photograph illustrates the importance of overhead protection in refuge areas. The missile shown here fell nearly straight down.

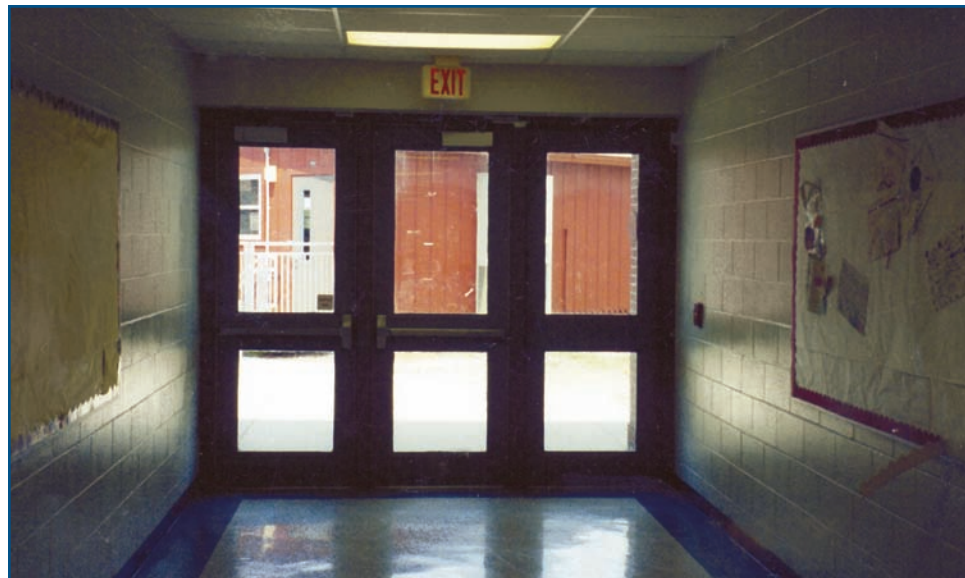
Figure 4-14 Exterior corridor doors in the example school.

The exterior windows in all eight buildings have aluminum frames and tempered glass. The exterior doors—including the exterior corridor doors in Buildings 200, 400, 600, and 800 (Figure 4-14)—are insulated metal-framed units with large windows. The doors from the corridors to the classrooms in these four buildings are wood with small windows (Figure 4-15).
