Steel Bridge Design Handbook

Corrosion Protection of Steel Bridges

Publication No. FHWA-HIF-16-002 - Vol. 19

December 2015

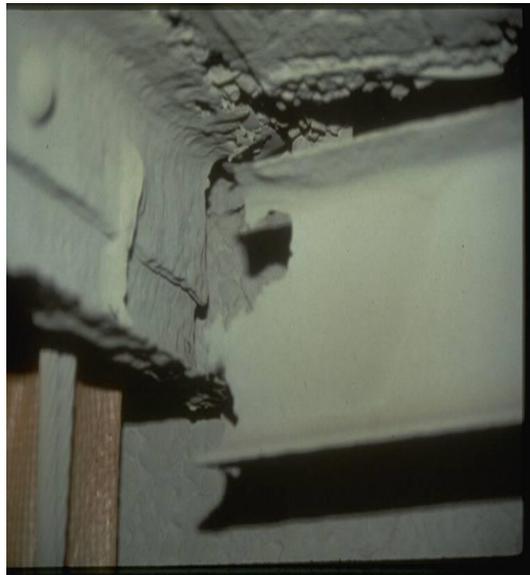
Figure 1. Photo. Photograph of a severed connection due to corrosion.

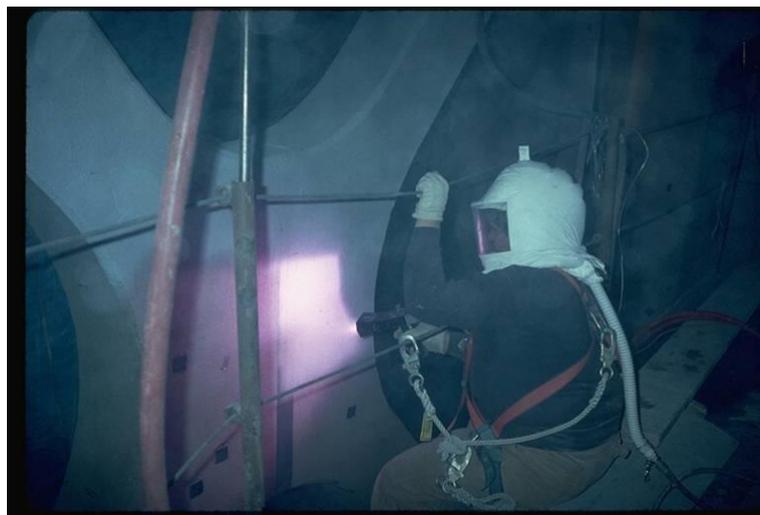
Figure 5. Photo. Metalizing of a bridge member in the field (photo courtesy of R. Kogler).

far the dominant choices for bridge steel are pure zinc, 85 percent zinc/15 percent aluminum alloy, and pure aluminum. Metalized coatings are applied using a heat source to melt a metal feedstock (typically in a wire or powder form) at the tip of a spray gun that uses compressed air to propel the molten metal onto the target steel. The heat source can be either flame or electric arc, similar to the heat sources for welding equipment. Once the molten metal hits the steel surface, it immediately re-solidifies into a solid sacrificial coating. The coating is built up with a series of overlapping “splats” of metal. Achieving proper specified thickness is important to mitigate the possibility of porosity through the coating.⁽²³⁾ Figure 4 shows a depiction of this application. Figure 5 illustrates a typical field metalizing application.

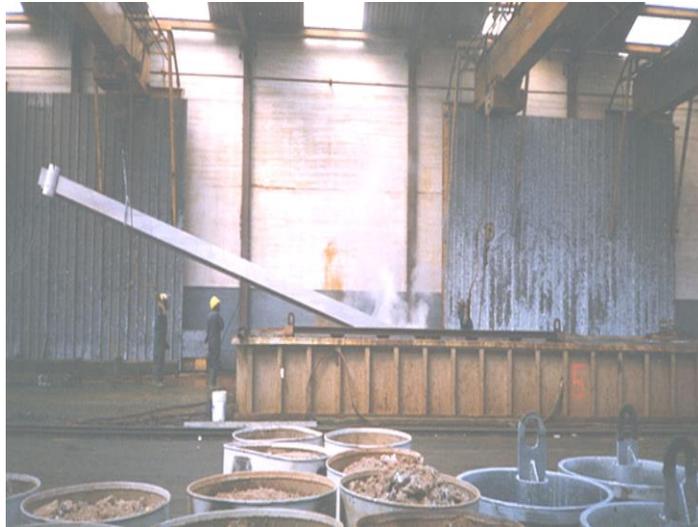
Figure 7. Photo. Hot dip galvanizing kettle with long beam being dipped at one end.

or kettles (as seen in Figures 6 and 7). The final dip in the process is immersing the component into molten kettle of pure zinc, typically at temperatures between 820 and 900 °F. These kettles are typically around 40 feet long, but kettles up to 60 feet long exist. The heat from this zinc dip creates a metallurgical bond between the zinc and steel, and creates a layer of sacrificial zinc. The composition of zinc layer depends on the chemistry of the steel and largely plays into the thickness of the coating, therefore a designer cannot specify a desired coating thickness for a hot-dipped galvanized component. When the silicon level in the steel is between 0.04 and 0.15 percent or above 0.22 percent the steel is considered “reactive”.⁽²⁶⁾ For reactive steels, the entire galvanized layer is zinc/iron intermetallics that can be excessively thick (generally thicker than 10 mils) and also brittle. The other problem with reactive steels is the intermetallic layer can continue to grow, and overall galvanized thickness is controlled by dwell time in the tank, but this can be mitigated by abrasive blasting in lieu of acid pickling. For non-reactive steels, the intermetallics form with a gradient in the zinc/iron ratio being more iron bearing near the steel and decreasing through the thickness to the outer layer that is pure zinc. The nonreactive steels develop a thickness that is on the order of 4 mils thick, and dwell time in the tank does not cause coating thickness to increase. Most of the time, the galvanizer does not know the chemistry of the steel being dipped, and therefore through experience has developed a knowledge of dwell time the piece should be immersed to get a galvanized coating that meets the quality control requirement of ASTM A123 for both reactive and nonreactive steels. ASTM A123 defines the sampling requirements for hot-dipped pieces by which coating thickness is assessed and accepted by.⁽²⁷⁾ For the typical thickness of plate used in bridges, ASTM A123 generally would require a minimum galvanized coating thickness of 3.9 mils or thicker.

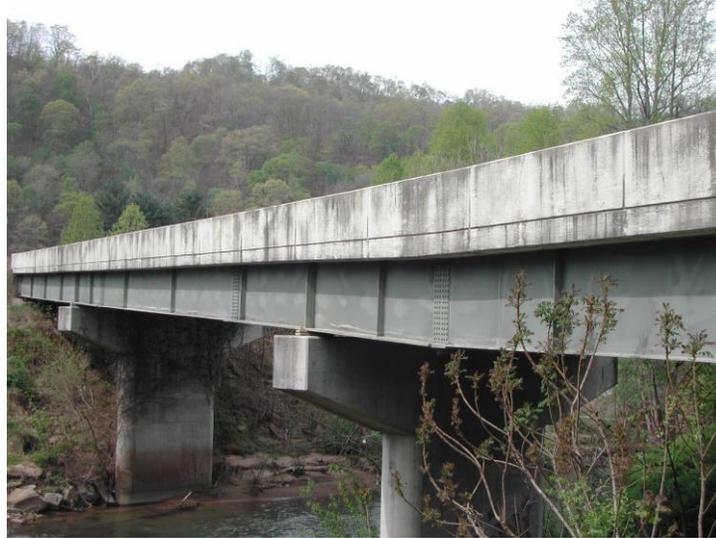
Figure 14. Photo. Bridge in West Virginia with a single-coat inorganic zinc-rich paint system after 25 years.

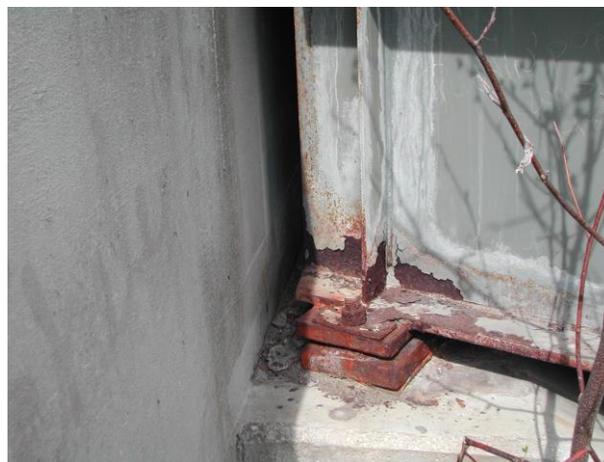
Figure 15. Photo. Deterioration of bearing area beneath a leaking joint with only single-coat inorganic zinc-rich paint.

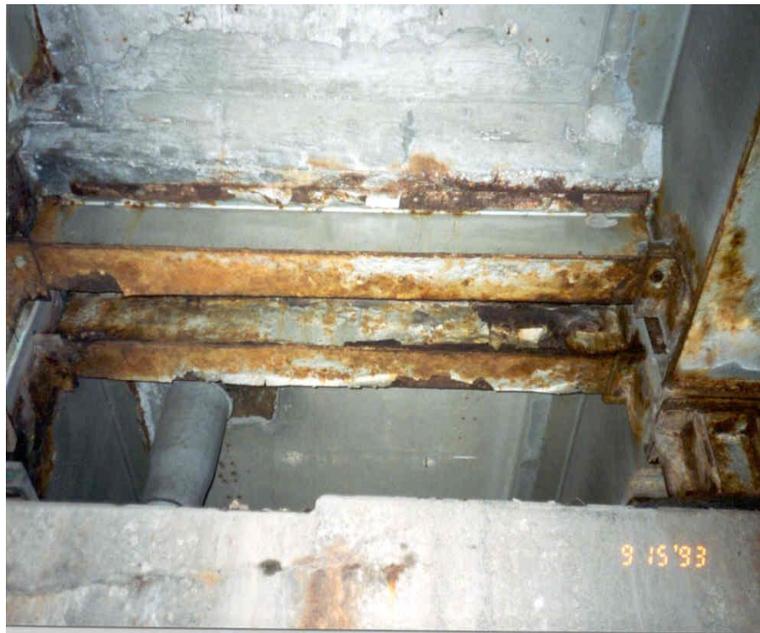
Figure 16. Photo. Steel directly beneath transverse expansion joints that have leaked corrosive runoff from the deck.

debris over time, limiting their effectiveness. Consider use of sealed modular joints in place of multiple single compression seal joints.⁽⁷¹⁾ Figure 16 and Figure 17 depict corrosion due to water leakage and entrapment.

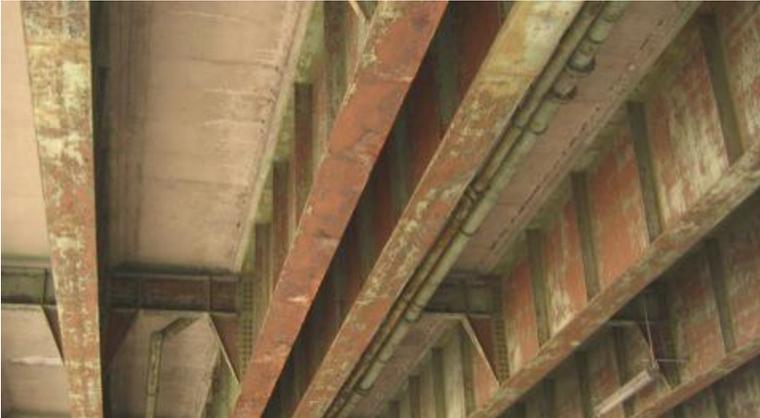
Figure 19. Photo. Closely spaced girders lead to difficult access for maintenance activities.

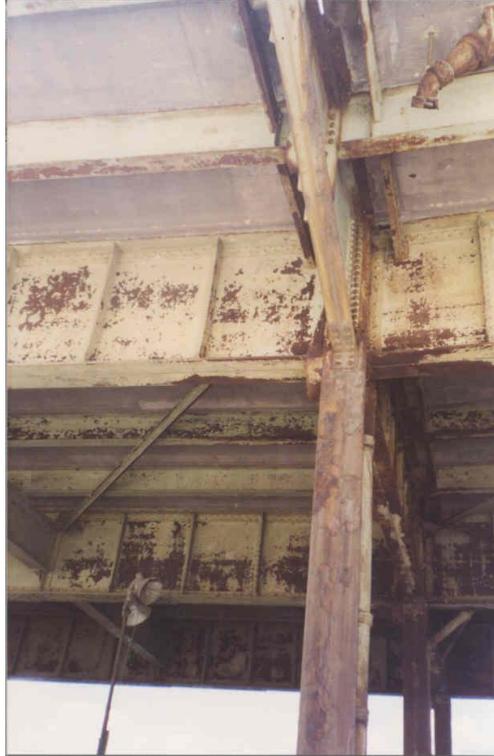
Figure 21. Photo. Missing portion of deck drain downspout.

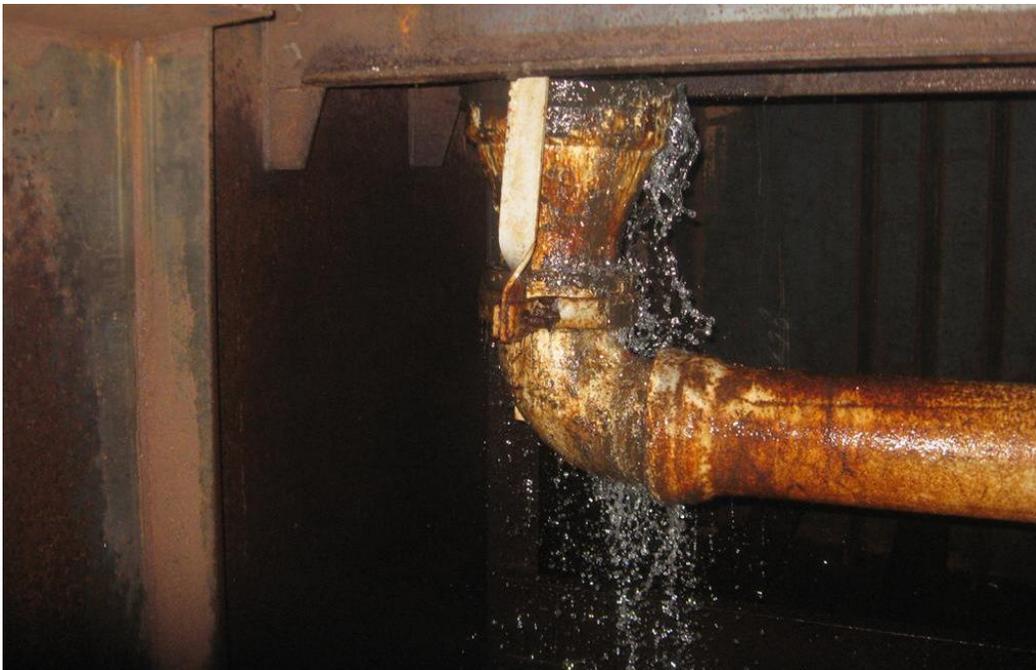
Figure 22. Photo. Clogged drain leaking water onto superstructure.

Certain areas of the steel structure below the roadway surface will see the majority of drainage and runoff from the deck above. These areas will have a higher time of wetness than the rest of the steel structure. They will also receive an increased level of dirt and debris from the roadway. This is critical in areas that receive significant amounts of deicing salt. These areas will often have a much higher corrosion rate relative to the rest of the bridge. Designed, directed drainage is often inadequate and deck-mounted expansion joints often leak as well. An example of corrosion due to drainage can be seen in Figure 21 where a drain pipe can be seen coming from deck, but there is a missing section of pipe between the portion coming from the deck to the vertical drain pipe attached to the steel column, thus allowing water to directly splash the vertical steel column. Figure 22 illustrates a drain that has clogged and is leaking directly on the structural steel.

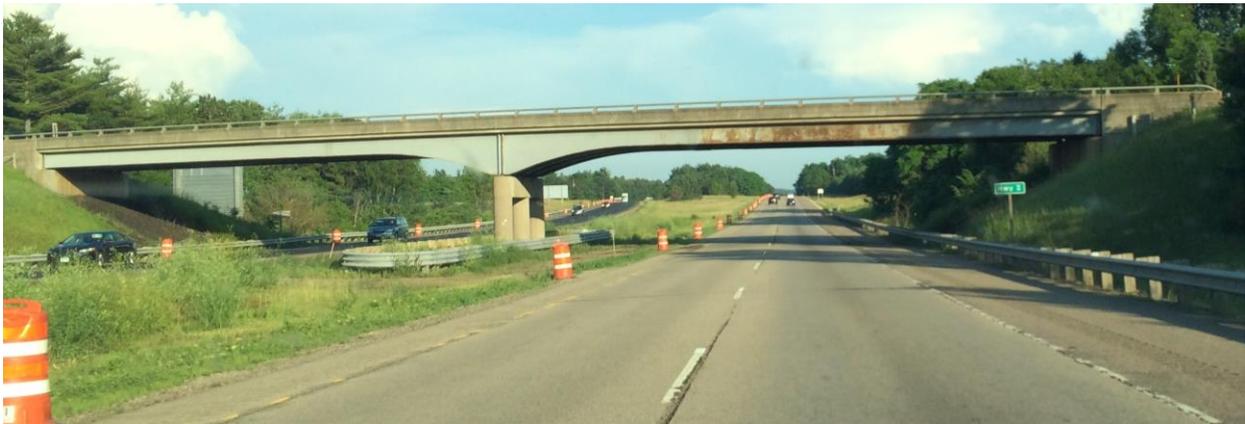
Figure 26. Photo. Accelerated corrosion on the inbound fascia girder of a grade separate structure, particularly over the right travel lane.

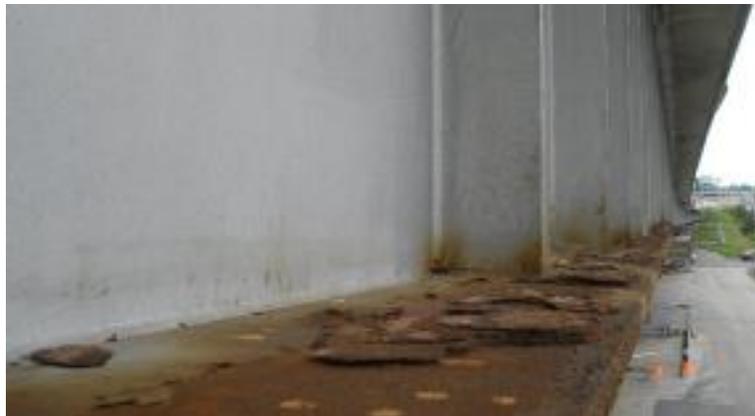
Figure 27. Photo. Corrosion localized to upper surface of lower flange, the rest of the bridge is fine.

Commonly it is observed that the upper surface of I-shaped bottom flanges will corrode before the rest of the I-shape, as seen in Figure 27 and Figure 28. The lower portions of flanged structures corrode early due to higher times of wetness for these parts relative to the rest of the bridge, because they are likely horizontal and can pond water. The higher time of wetness is also caused by preferential condensation on the lower portions of a steel element. While not a recommendation of this handbook, an ideal solution would be to curve the lower flange such that water could not pond on it. This is illustrated in Figure 29 where the right-hand girder in the zoomed in view has a transversely curved lower flange. Certainly, there are logistical issues with the concept; such as how to bend the flange, cutting transverse connection plates to fit, and making bearings to accept the curved surface. However, it illustrates that prevention of ponding water is the goal, but it is not always attainable (unless the entire bridge has a vertical grade). In the case of lower flanges, designing away the problem is not possible and only more durable protection schemes can be specified.

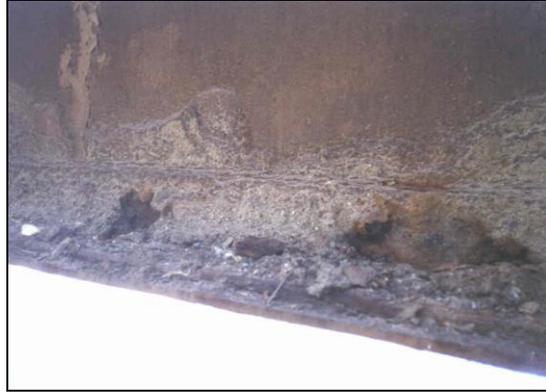
Figure 28. Photo. Heavy corrosion of bottom flange and web due to collection of poulitice.

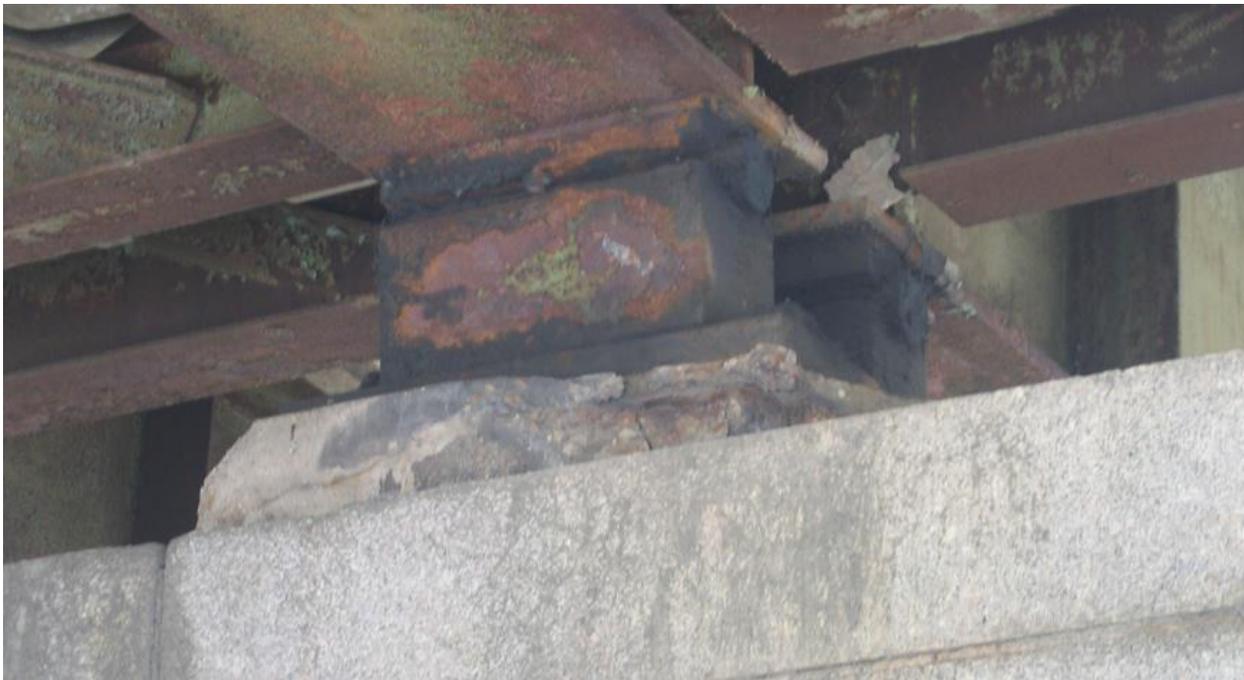
Figure 30. Photo. Corroded bearing.

These elements are difficult and inefficient to paint in the traditional manner. Bearings represent the lowest point on the superstructure, and as such are likely subject to the highest time of wetness, and typically are difficult to protect from corrosion. An example of a corroded bearing is shown in Figure 30. Consideration should be given to galvanize, metalize or fabricate these types of elements from inherently corrosion-resistant alloys.

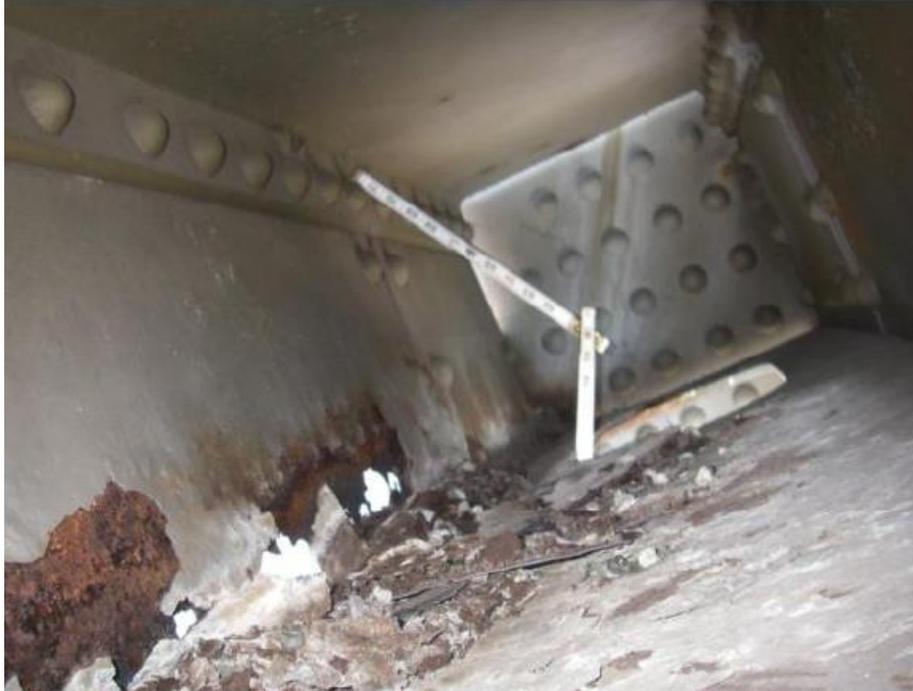
Figure 33. Photo. Inside of built-up box member.

Figure 33 shows the inside of a closed, built-up box member from a truss. The picture was taken through an access hole and not oriented with respect to gravity, but the member was horizontal. Because the member was horizontal, water ponded on the inside atop the bottom box cover plate, and caused through-thickness corrosion in the box web plate over an approximate four-foot length. Small box members also pose maintenance and corrosion remediation challenges due to limited access.

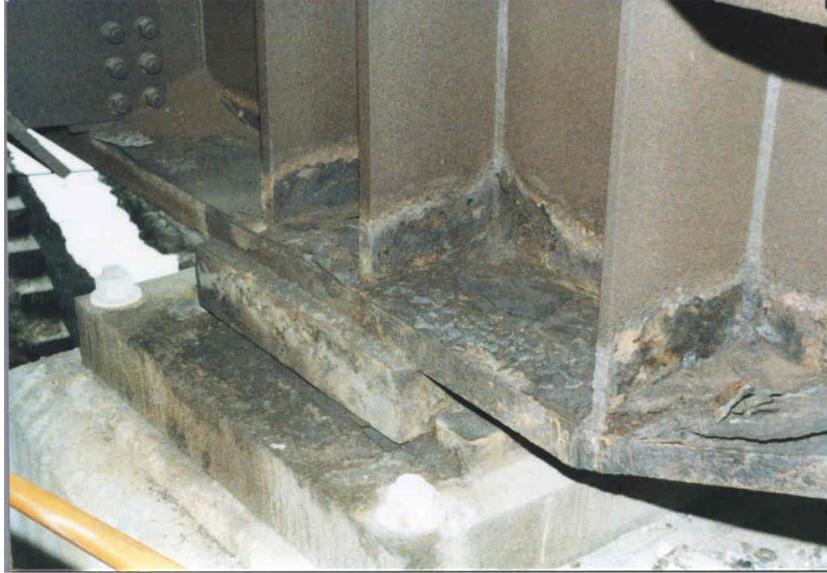
Figure 34. Photo. Girder end on a bearing below a leaking deck joint. Horizontal flange and vertical stiffeners create an excellent trap for debris and moisture.

Water traps are the hardest details to identify in design. Figure 34 illustrates a bearing stiffener detail that was below a leaking joint. Since the flange is horizontal, water can become trapped near each of the stiffeners because it cannot flow away from the area. This also has cascading consequences because as rust product develops in this area, the rust itself begins to hold moisture that further exacerbates the corrosion. Also note in the background of this picture is the connection plate detail bolted to a transverse element; there is an accumulation of dirt and rust between the girder flange and connection plate.

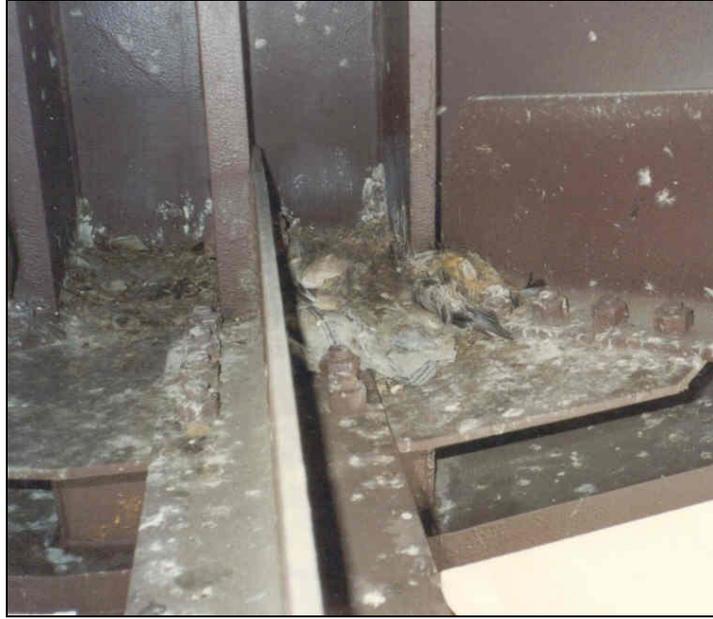
Figure 37. Photo. Debris accumulation at a lateral gusset plate detail.

Figure 37 shows a picture of a lateral gusset plate detail and the accumulation of dirt, bird guano, and even a dead bird. Since the lateral plate is horizontal, poulitice tends to collect on it and not freely drain away, causing localized high times of wetness, leading to corrosion. Figure 38 shows a lateral gusset plate detail that has mostly corroded away because it was perfectly horizontal and ponded water. It is not practical to slope these plates, but drainage holes can be provided to help mitigate any ponding. Where members such as horizontal gusset plates must be used, consider using a high level of corrosion protection (duplex galvanizing/painting or metalizing) for these specific elements.

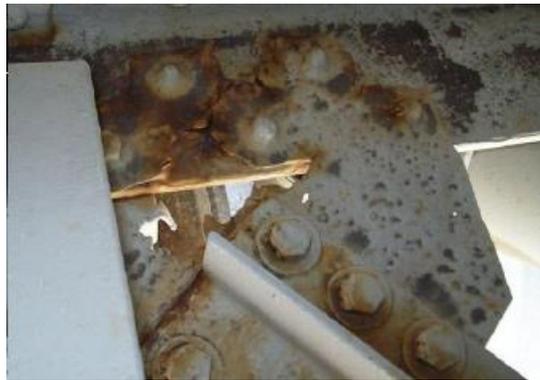
Figure 38. Photo. Corroded lateral gusset plate detail.
