# Engineering Failure Case Study: The Morandi Bridge Collapse

Engineering Continuing Education

Don Parnell, PE

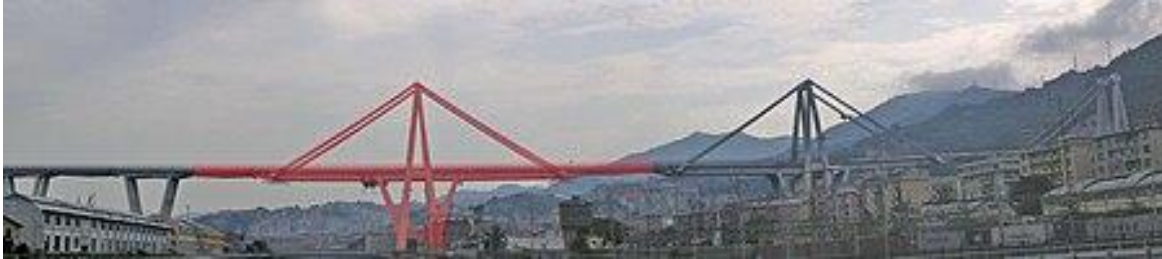
Image: (Wikipedia) collapsed segment of bridge in red

At approximately 11:36 a.m. local time, during a period of heavy rainfall, a 210-meter section of the bridge, including one of its three main towers (Tower 9), suddenly gave way. The failure sent vehicles and debris plunging approximately 45 meters into the Polcevera River, and the surrounding industrial areas below.
