Engineering Ethics Case Study: The Taum Sauk Reservoir Failure

"Taum Sauk Upper Dam Breach:

Technical Reasons for the Breach of December 14, 2005"

Taum Sauk Upper Dam Breach FERC No. P-2277

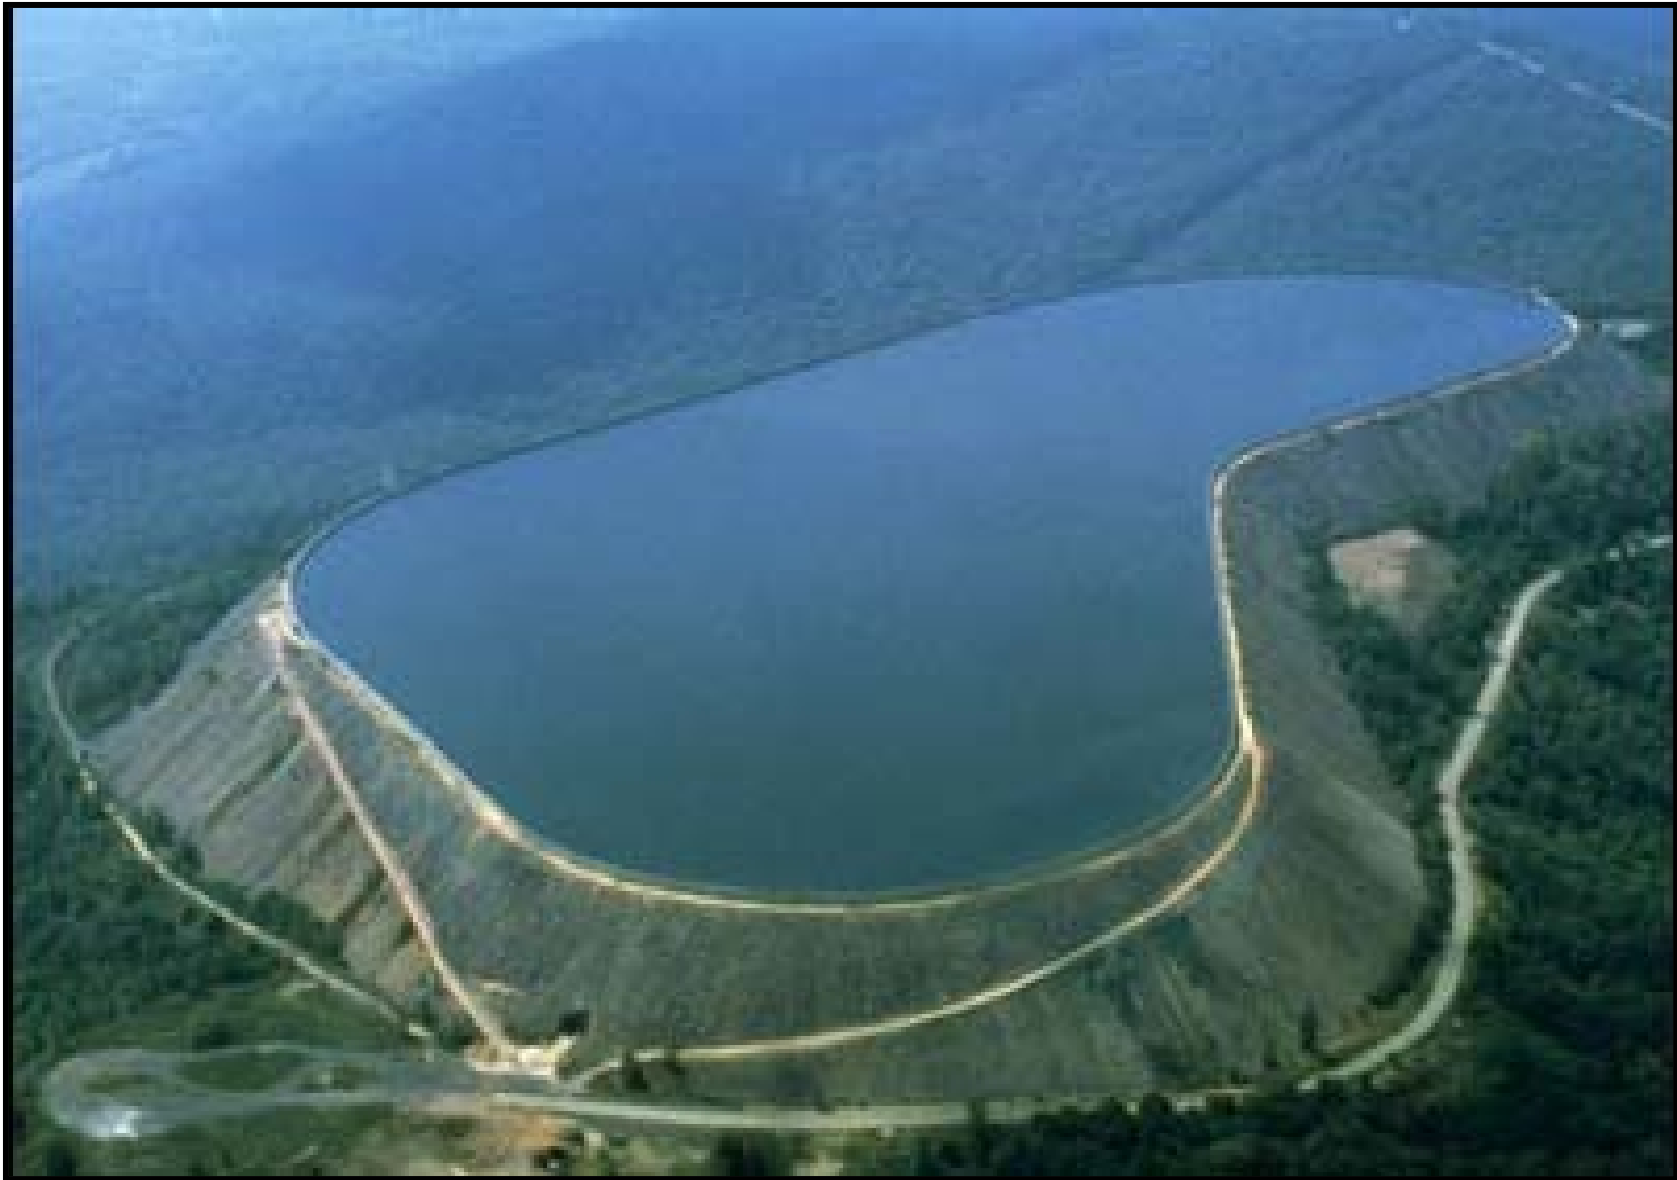
Taum Sauk – Upper Reservoir Full
Figure 1-1

The Upper Dam is a continuous hilltop dike 6,562-ft long forming a kidney-shaped reservoir as shown in Figure 1-1. The dike is a concrete-faced dumped rockfill dam (CFRD) from the foundation level to elevation 1570.0 ft and a rolled rockfill between Elevations 1570 and 1589. The upstream slope is 1.3:1 (horizontal:vertical) and the downstream slope is at the natural angle of repose of the material, approximately 1.3:1, as shown in Figure 2-1. The crest is 12- feet wide. A 10-foot high, 1-foot thick reinforced concrete parapet wall atop the fill extended the crest to elevation 1,599 feet, as originally constructed. Since 1963, the settlements of the rockfill embankment at various points have varied between 1 to 2 feet; the low point at the top of the parapet wall, as surveyed by AmerenUE on November 6, 2004 was elevation 1596.99 feet at Panel 72.

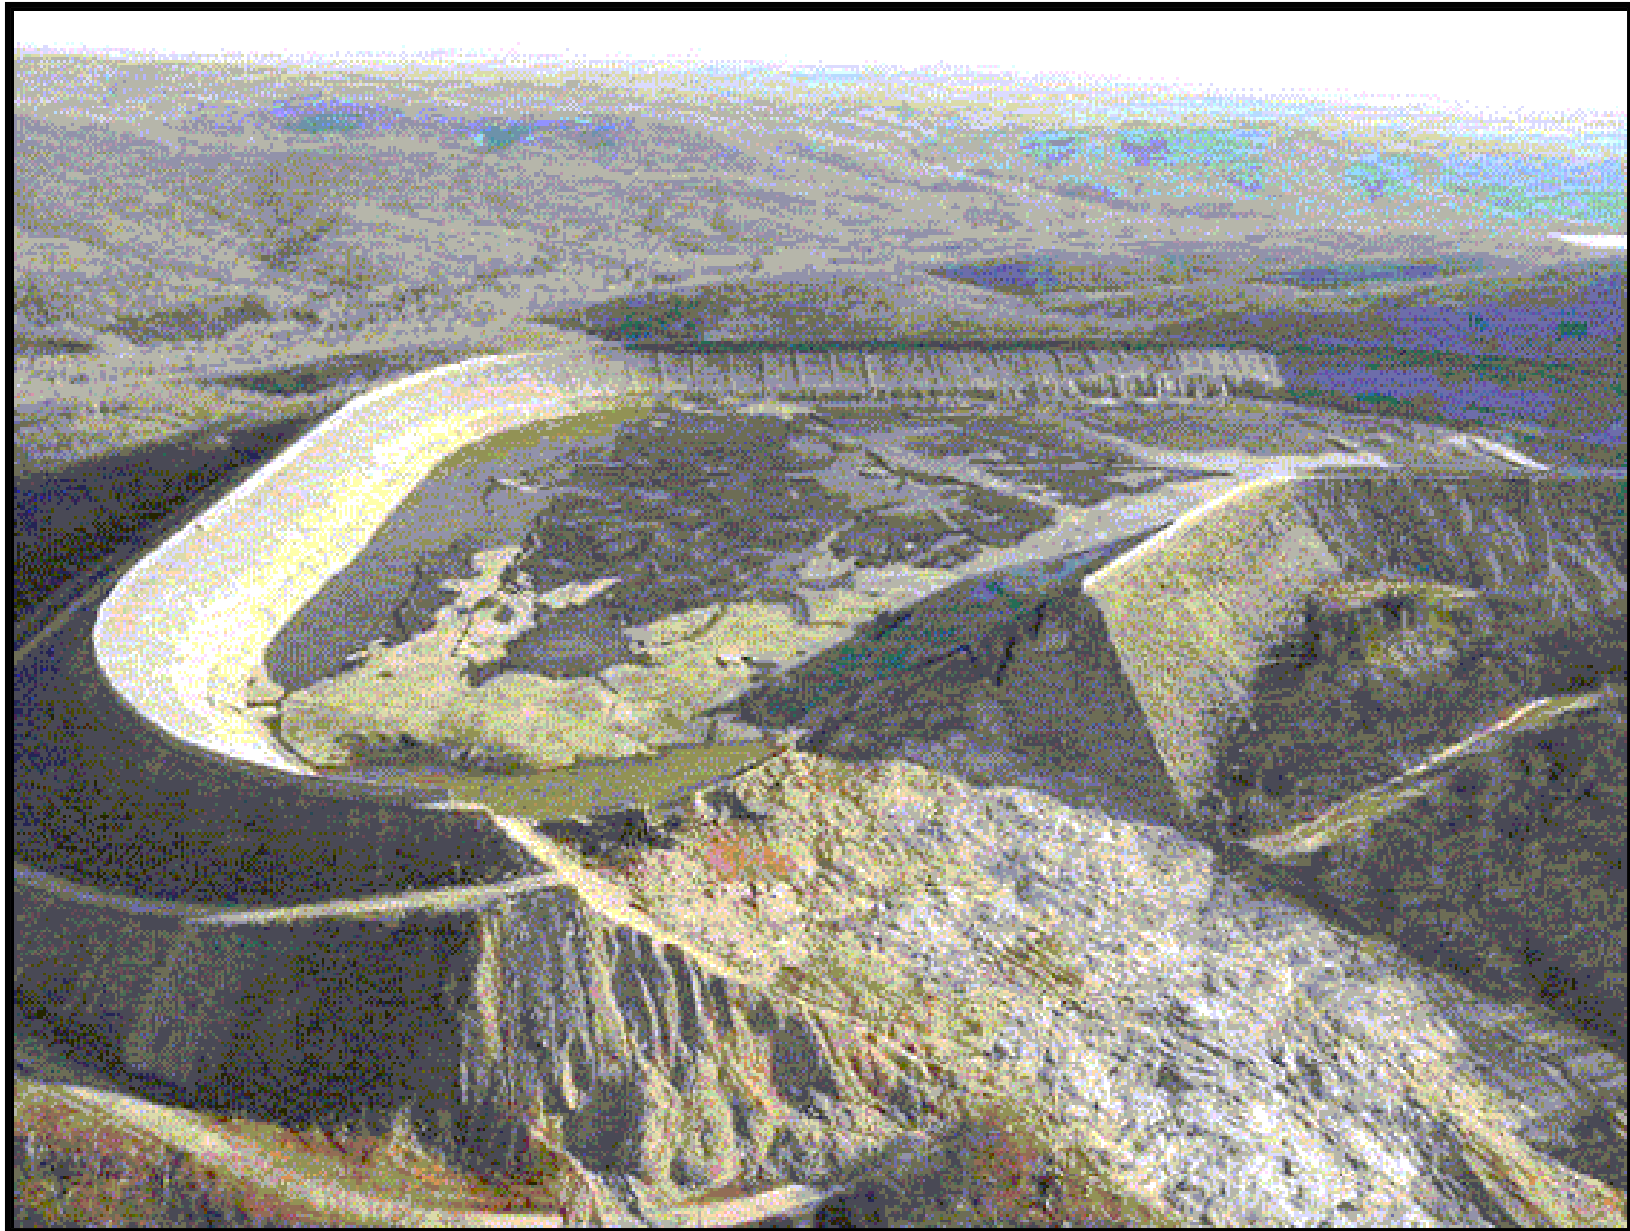
Figure 1-2

Taum Sauk Upper Reservoir Breached

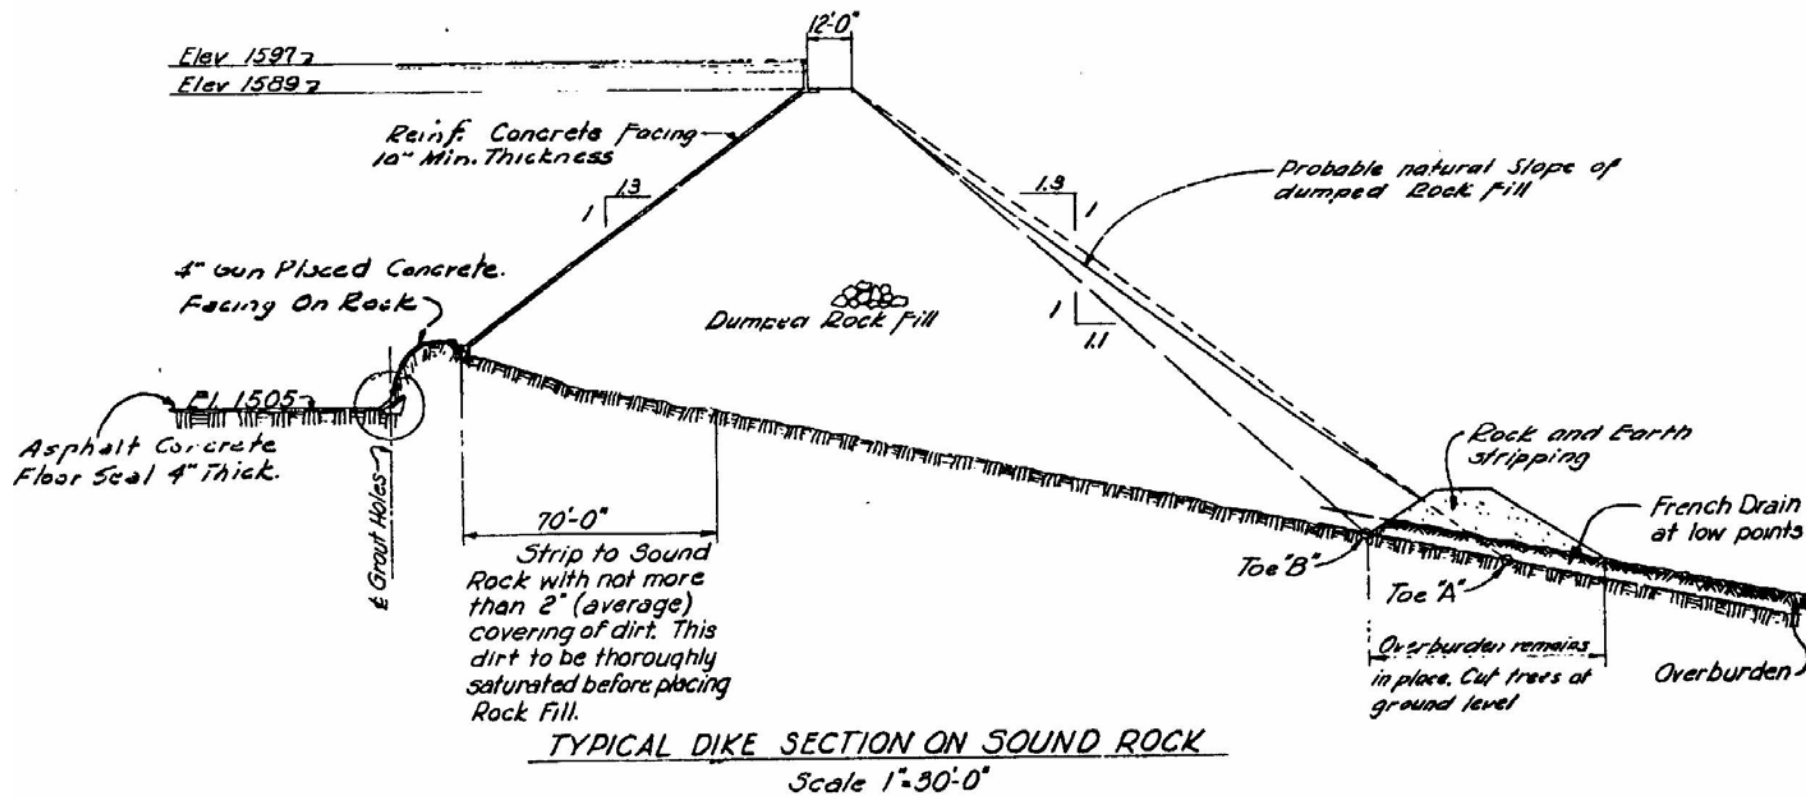
Figure 2-1 Cross section from original design drawings

The pneumatically placed upstream reinforced concrete face slab has a design thickness of 10 inches, and had joints (with copper waterstops) located at the junctures with the parapet wall, the foundation cutoff-slab and with adjacent face panels. The face slab was placed in panels, 60 feet wide at their widest dimension.

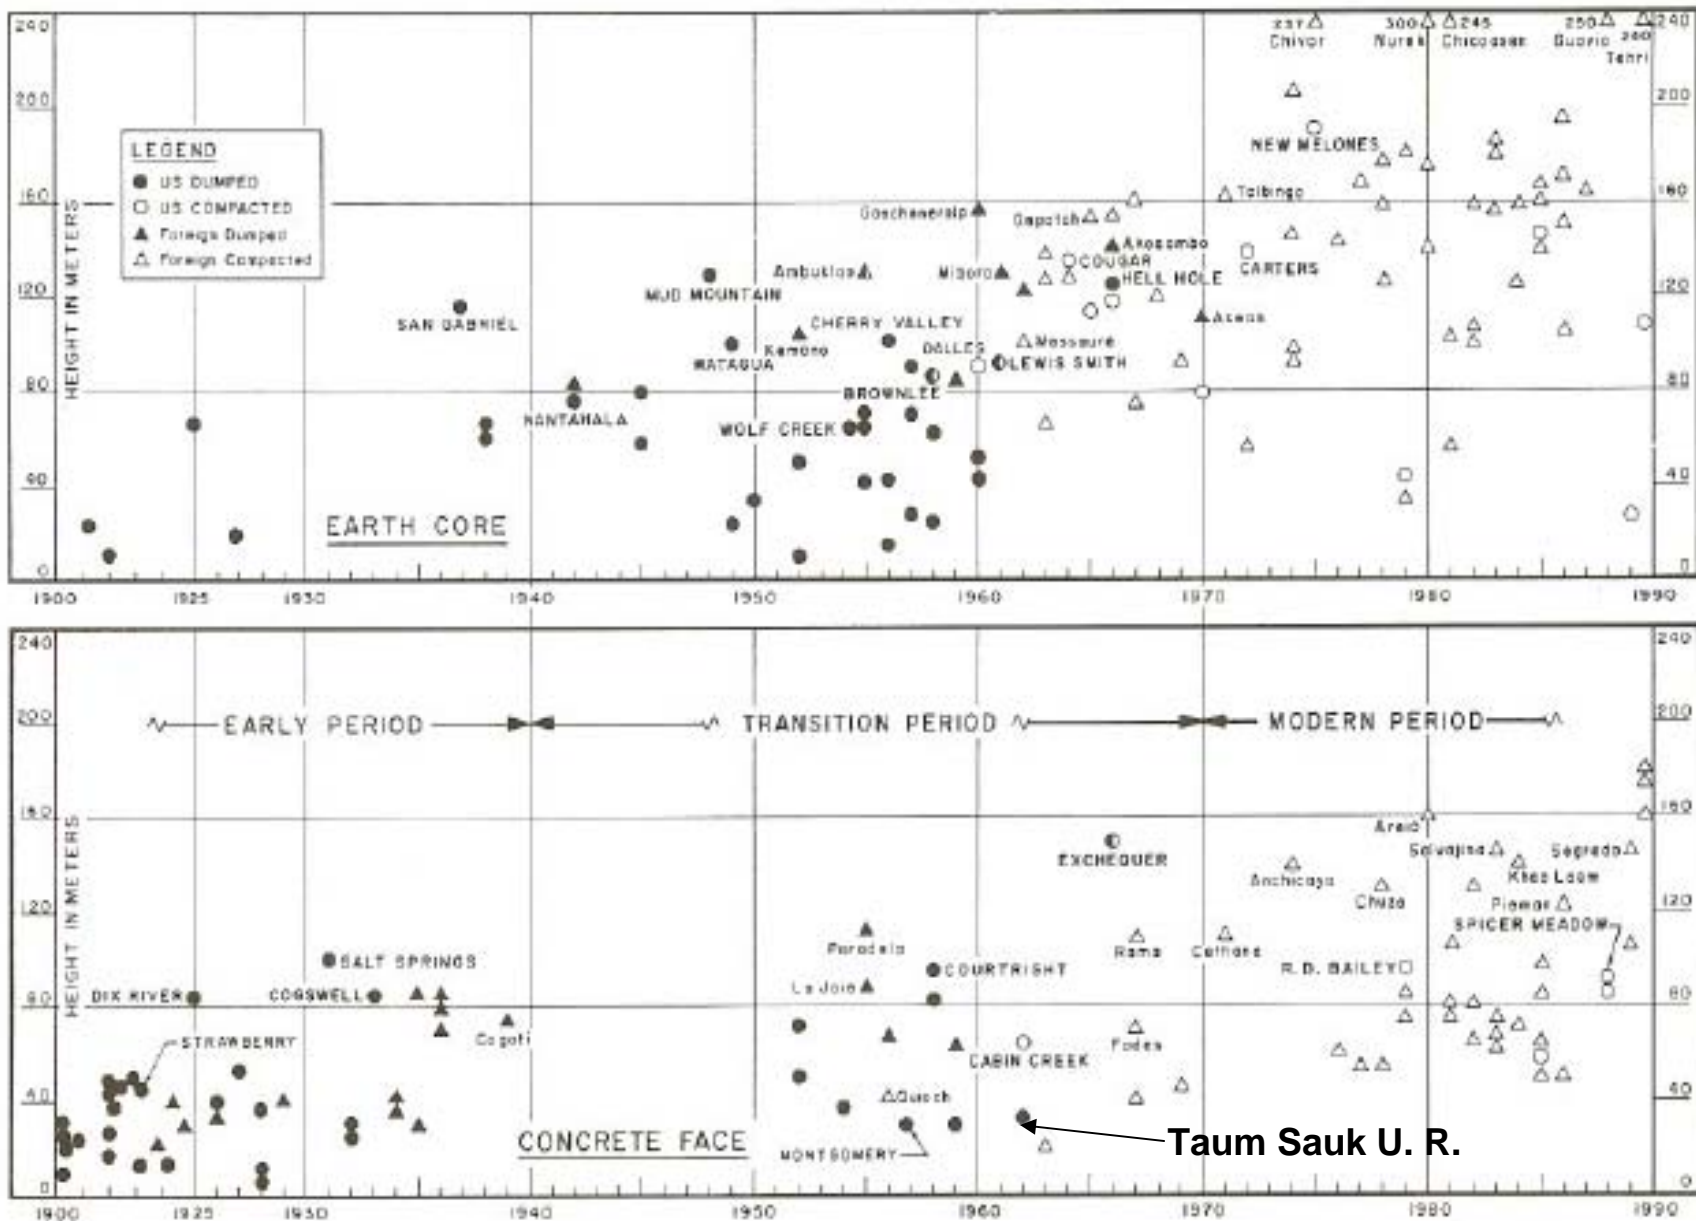
The design and construction of the CFRD for the Taum Sauk Upper Reservoir Dam followed the pattern of older CFRD's constructed in California such as Strawberry Dam and Salt Springs Dams. These dams were dumped rockfill CFRD's with slopes ranging from 1.3:1 to 1.4:1. Each of these dams have parapet walls for reflecting waves at normal maximum water storage level; but the maximum water storage levels are always about 1 to 2 ft below the crest of the rockfill. But water levels could possibly encroach on the parapet walls in times of floods. The design decision made for Taum Sauk Upper Reservoir Dam to routinely store water 6 to 8 ft high on a 10 ft high parapet wall during daily operations made the Taum Sauk dumped rockfill CFRD "Unprecedented" as compared to the previous CFRD's, as summarized by Cooke, 1988 (Figure 3-1).

It is noted from Figure 3-1 that nearly 100% of the CFRD's prior to 1963 were dumped and many had cracked face slabs and high leakage. Because of this behavior there were no CFRD's built between 1940 and 1950. As shown on Figure 3-1 Taum Sauk was the last newly constructed dumped rockfill CFRD in the USA; it is also shown in Figure 3-1 that Cabin Creek CFRD was designed at about the same time, but was designed as a compacted rockfill CFRD. Cabin Creek was compacted in 2 ft thick lifts to a height of 70 m (230 ft.) and was an Upper Reservoir Dam for a pumped storage project in Colorado. The maximum section of Cabin Creek Dam is shown in Figure 3-2 which shows an upstream slope of 1.3:1 and a downstream compacted slope of 1.75:1. It is especially important to note that the maximum operating level is 6 ft below the rockfill crest of the dam, and 9 ft below the top of a 3 ft high parapet wall on the crest of the dam. The differences in the Taum Sauk and Cabin Creek CFRD designs represent differences in risk tolerances for different engineering firms and individual consultants during the same time frame taking into account the state of the art for CFRD design in the middle 1960's. It should also be noted that Cabin Creek Dam was overtopped by pumping, but did not fail.

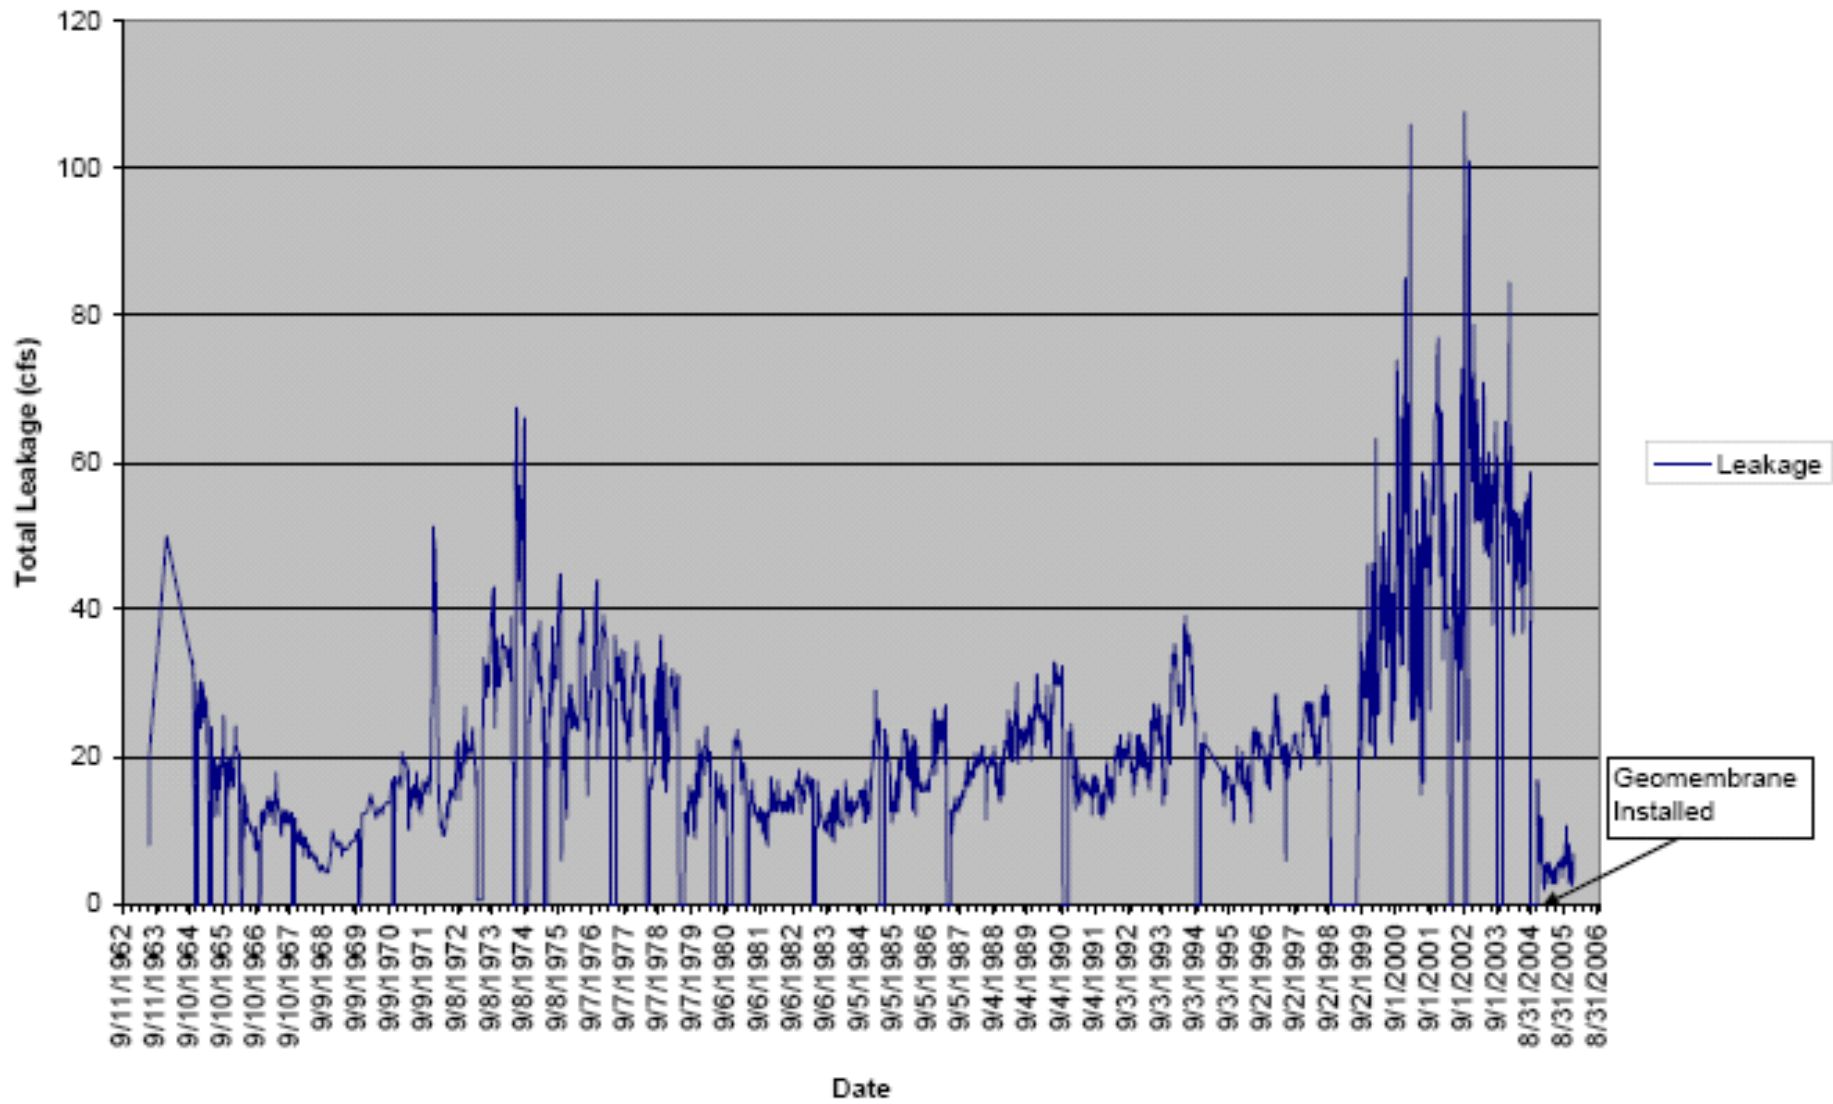
The leakage from the Upper Reservoir has been a continuing problem and concern beginning in September 1963. As an example, during that time a sudden increase in seepage to 103 cfs was experienced and emergency measures were taken to repair with concrete plugging in two holes in the floor at panels 91 and 92. Three days later, another episode of increased leakage caused another shut-down and repair. The repair consisted of excavating a 230 ft. long by 4 ft. wide trench, excavated to "rock" and backfilled with concrete at Panels 90 to 93 and 95. A number of repairs were made throughout subsequent years focusing more on leakage through the horizontal and vertical joints in the concrete facing. Particular emphasis was on the joints between the concrete facing and bedrock, the joint at the toe of the parapet section, and the joint between the concrete facing and plinth. Higher rates of leakage (40 to 100 cfs) began in 1999 following an extended outage. It is shown in Figure 3-6 that the leakage increased significantly after 1999 as the plant was used more extensively after replacing the runner and increasing the Plant efficiency. Thus, the project suffered from several episodes of seepage concerns throughout its history. The effects of all of the leakage on the embankment cannot be exactly

determined; however, it surely had an effect on increasing the settlement up to 1987 and potential movement of materials. A geomembrane liner was subsequently installed in 2004, which significantly reduced the leakage to about 5 cfs for the 12 months prior to the breach. Figure 3-6 shows the history of leakage and the periods of repairs. A chronology of events dating from submittal of the geomembrane liner design in January 2002 through the breach event of December 14, 2005 is given in Appendix B, which is taken from the FERC Report of Findings on the Taum Sauk Upper Dam Failure.

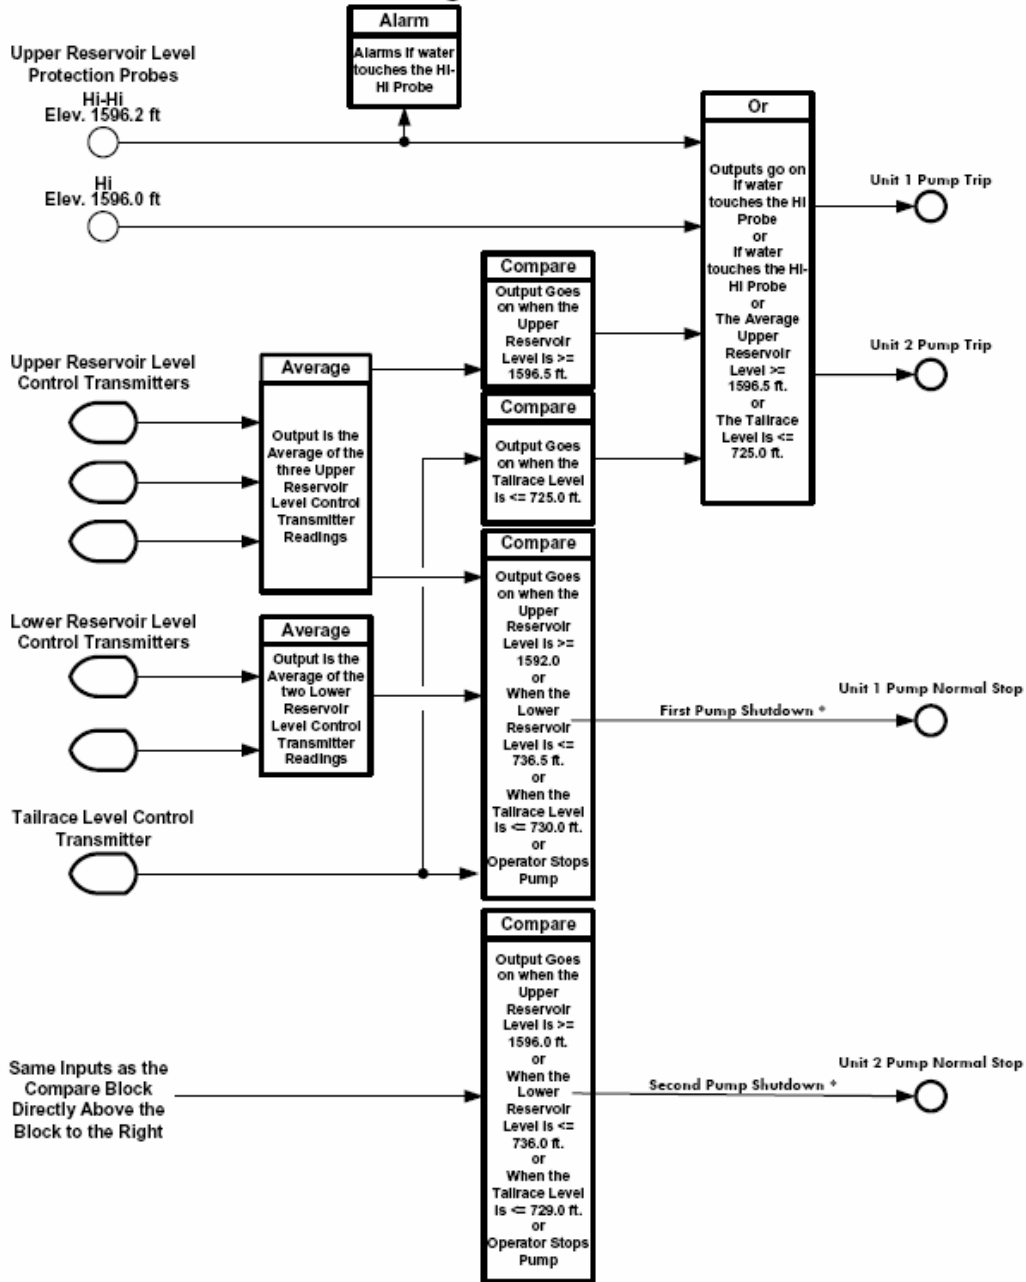
This system, commissioned in the fall of 2004, uses five Warrick conductivity probes with associated relays. Figure 5-1 is a diagram of the system as designed (11/01/2004). One of the probes is placed near the bottom of the upper reservoir and serves as the reference probe for the other four probes. The Hi and the Hi-Hi probes were placed at Elevations 1596.0 and 1596.2 respectively in November 2004. The top of the parapet at the probe location is Elev. 1598.

As shown in Figure 5-1, operation of either the Hi relay or the Hi-Hi relay provides a signal to the plant to stop the pumps and activate an alarm. AmerenUE reported that the Hi and Hi-Hi probes were tested at commissioning in the fall of 2004 as follows:

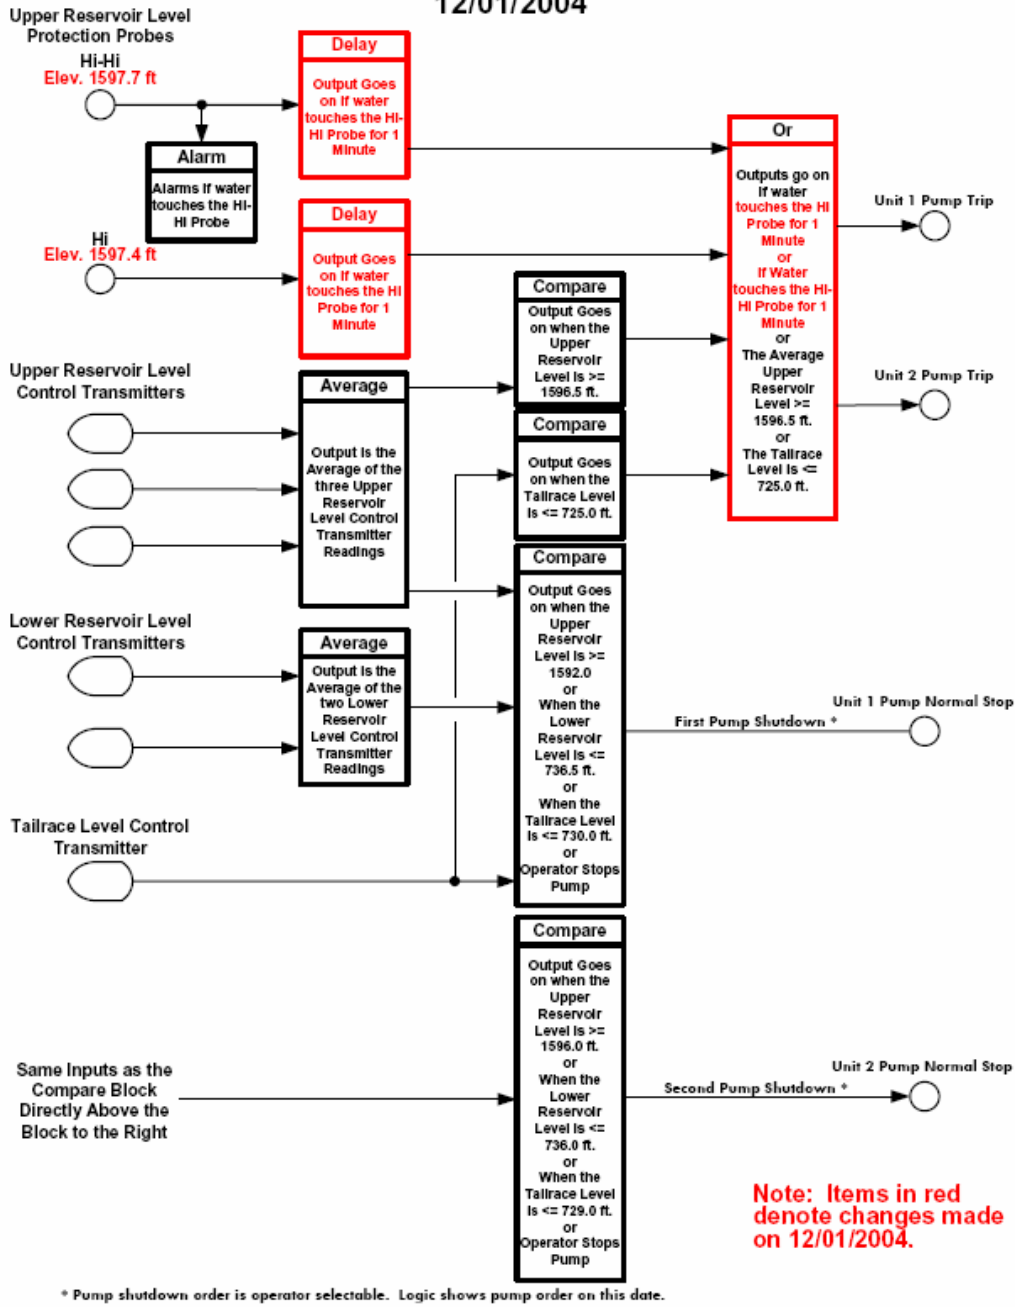
Figure 5-2

In December 2004, the PLC logic was changed so that both relays had to be energized for sixty seconds to provide a signal to stop the pumps and activate an alarm. In addition, both the Hi and Hi-Hi probes were reportedly raised to Elevations 1596.7 and 1596.9 respectively as shown on Figure 5-2. These changes were documented in comments within the PLC code and as revision 15 to drawing 8303-P-26648.

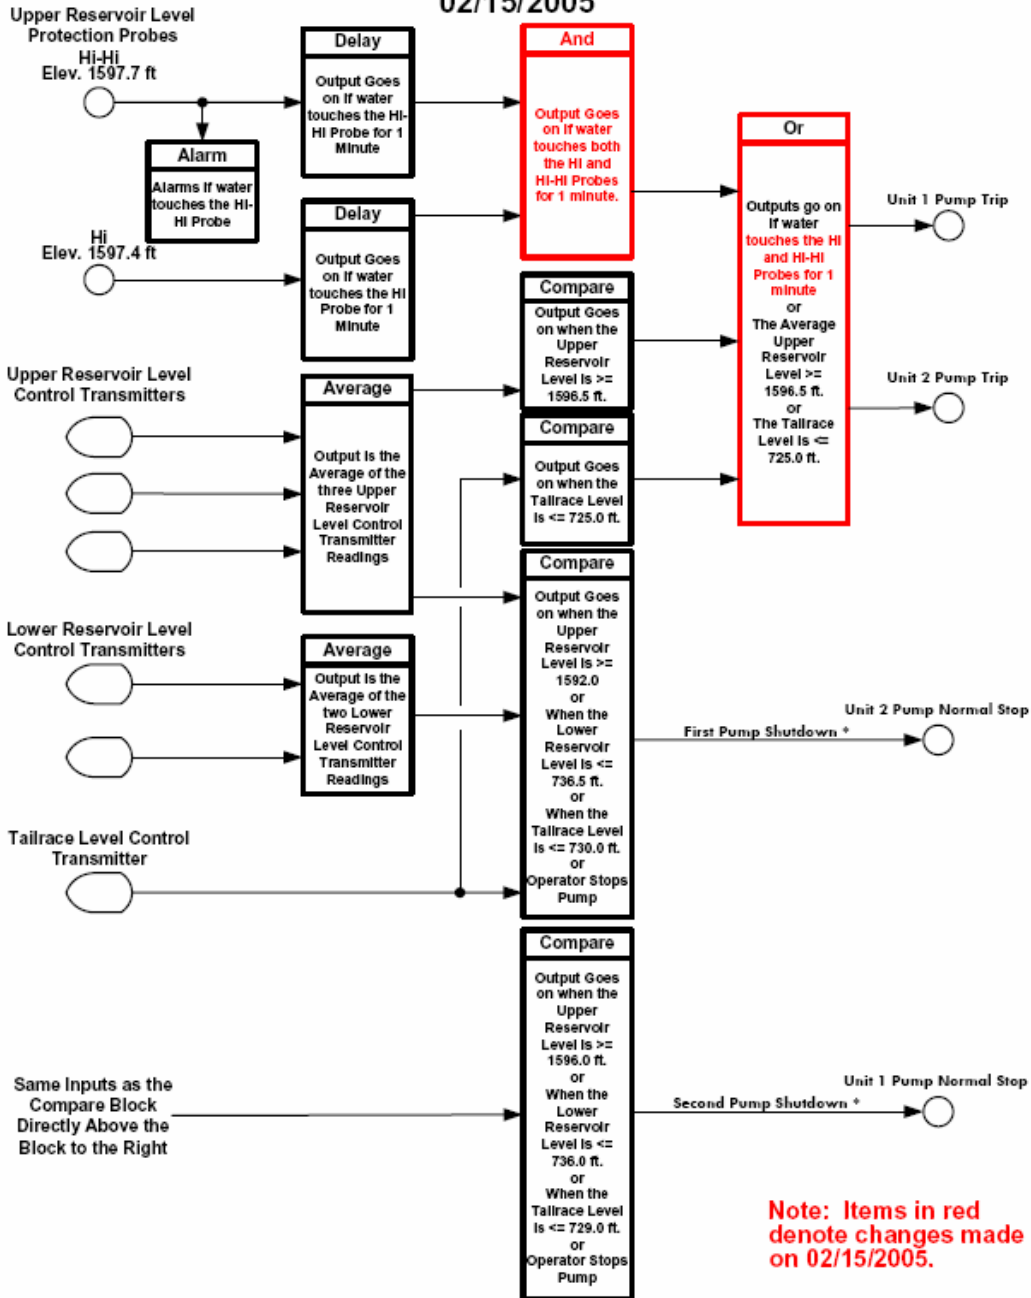
Figure 5-3 (02/15/2005) shows a logic change requiring both, rather than either, the Hi and the Hi-Hi probe to be wet for sixty seconds in order to initiate a pump shutdown.

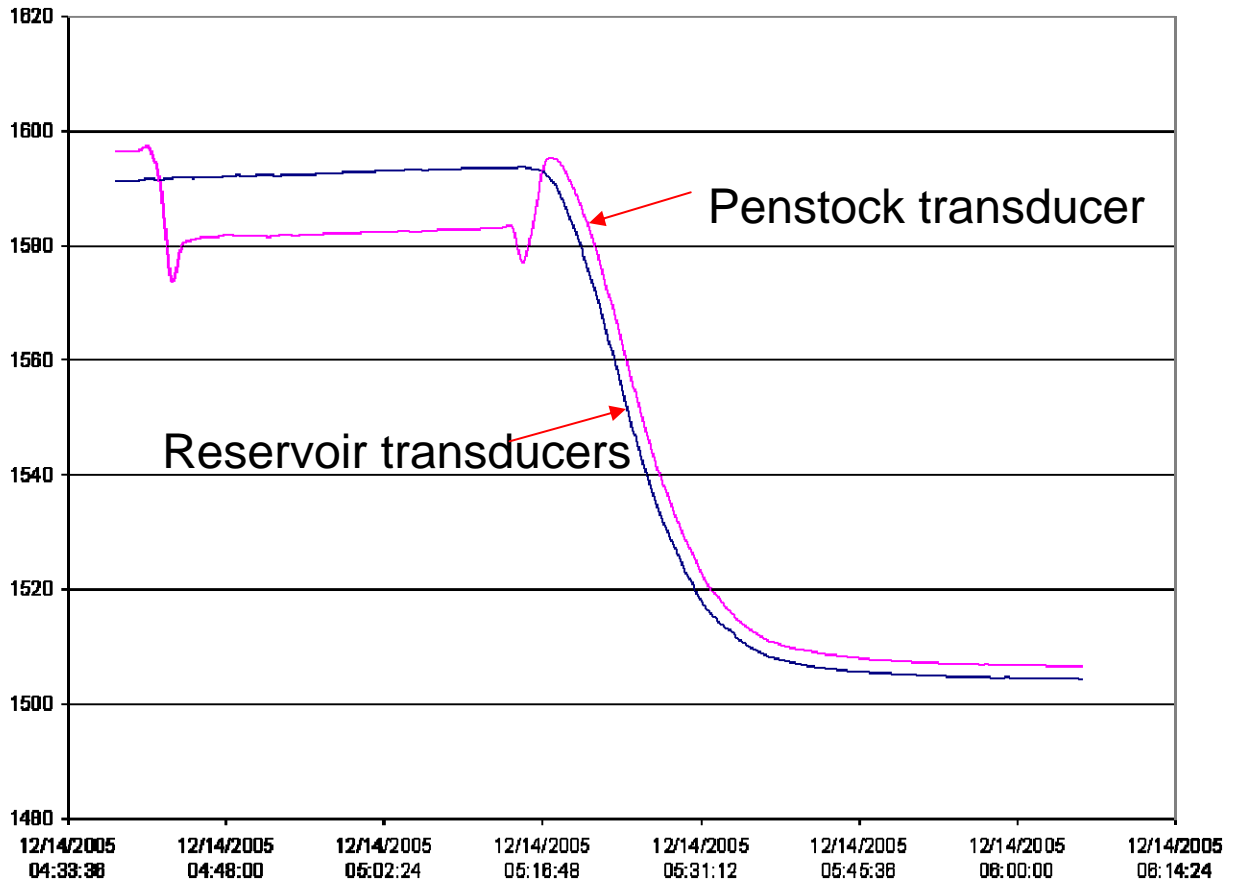
Figure 6-3

Dec. 14th breach.

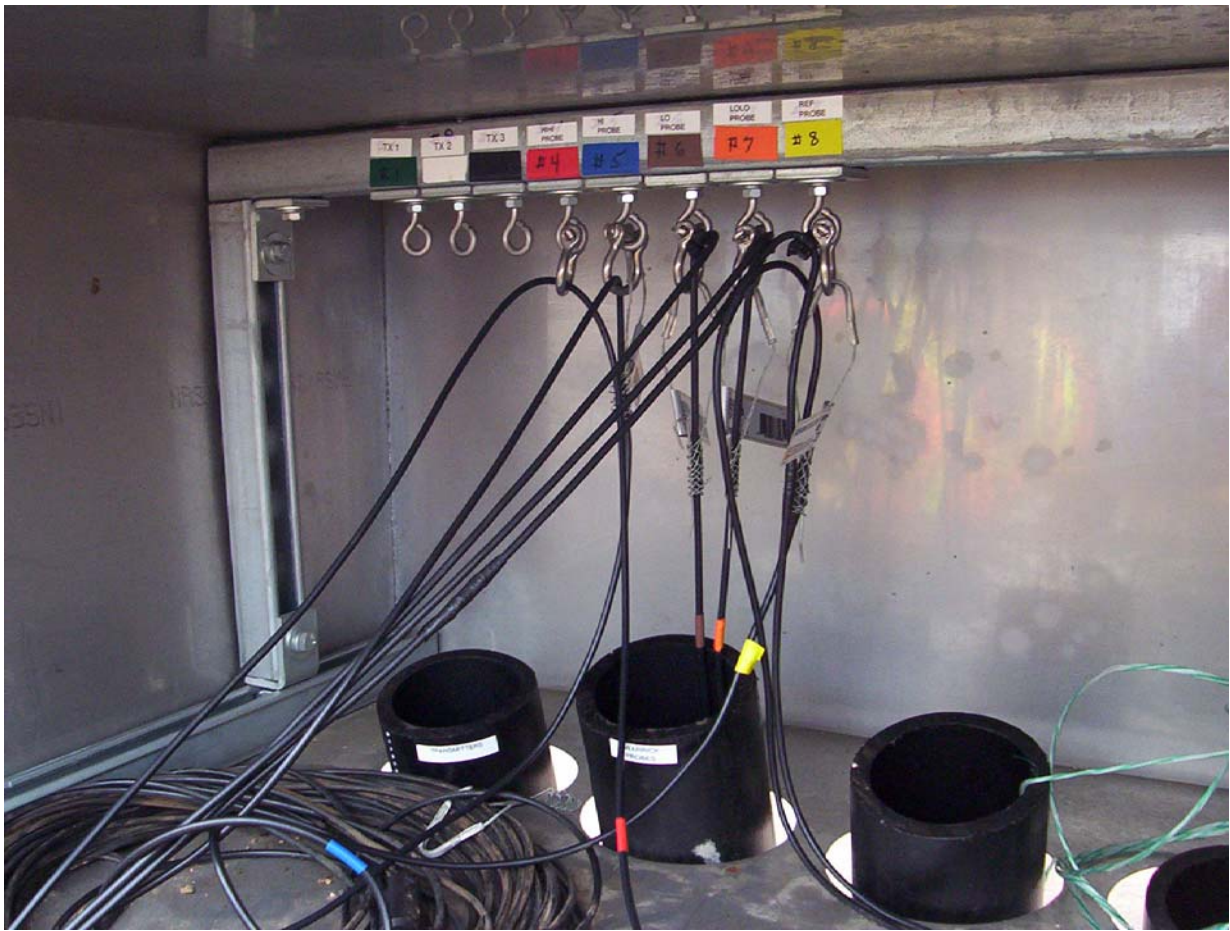
Figure 7-6

**Upper ends of protective pipes
with instrument cables in enclosure on parapet.
Pressure transducers use left pipe
and conductivity probes use the second pipe from left.**

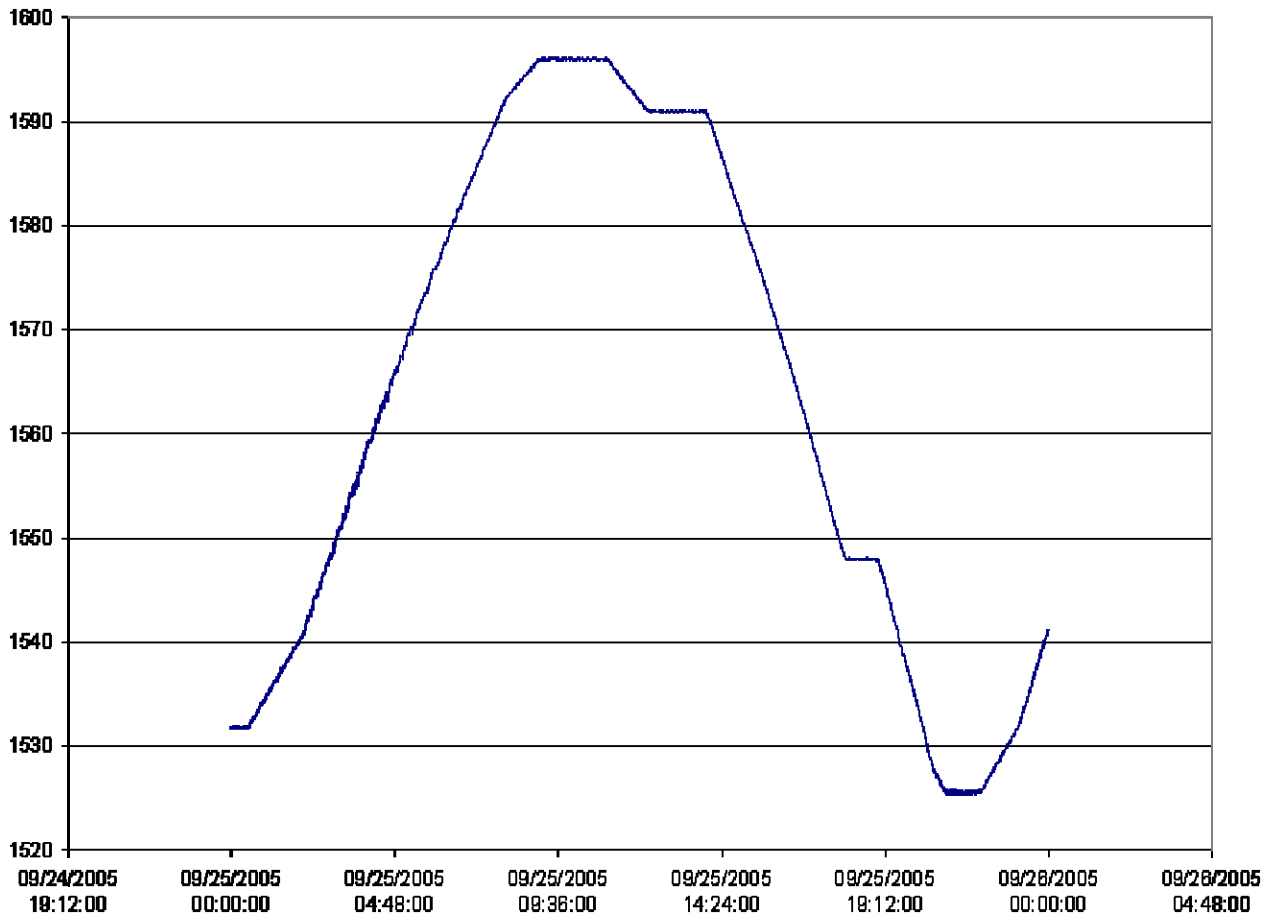
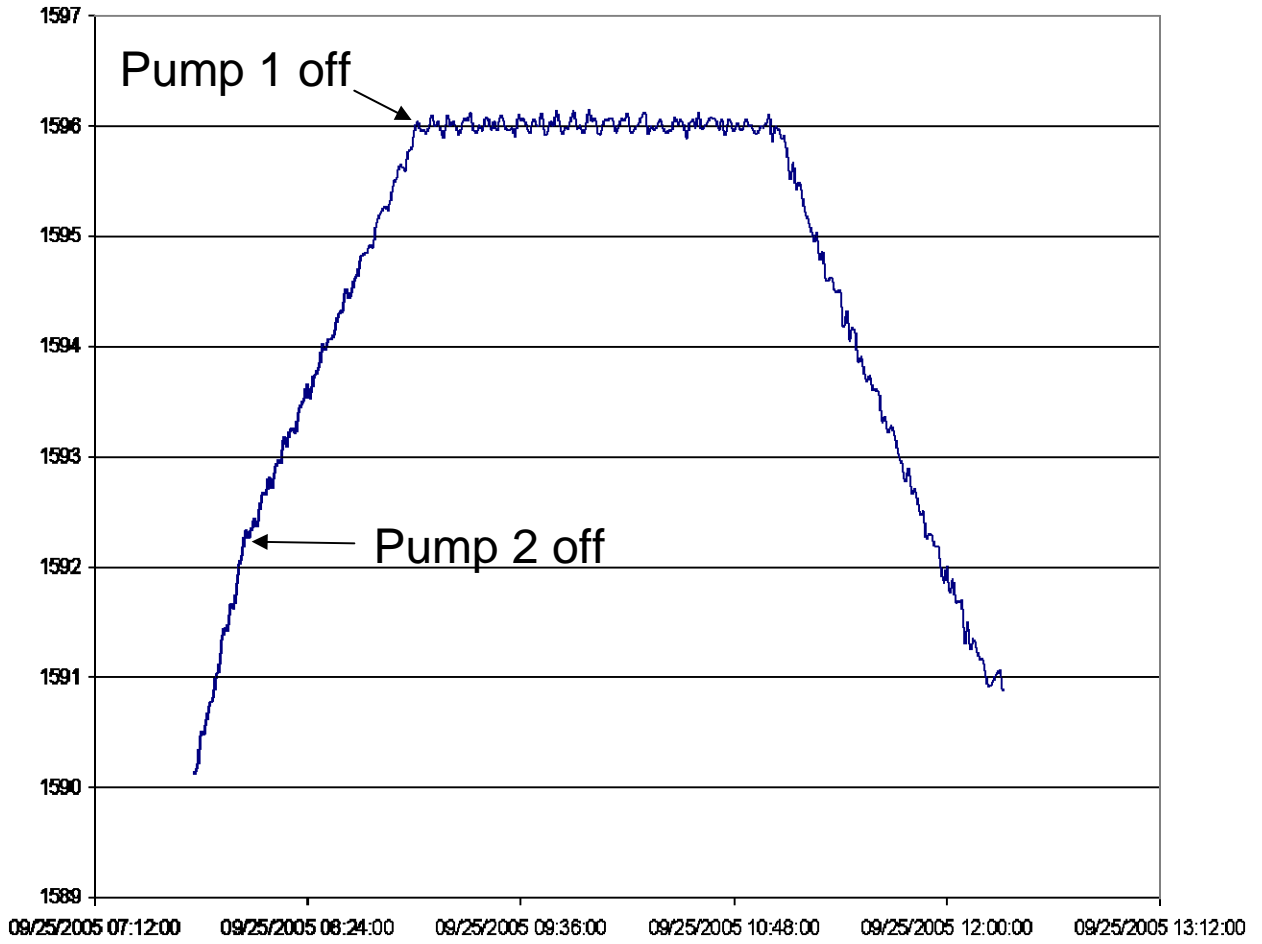
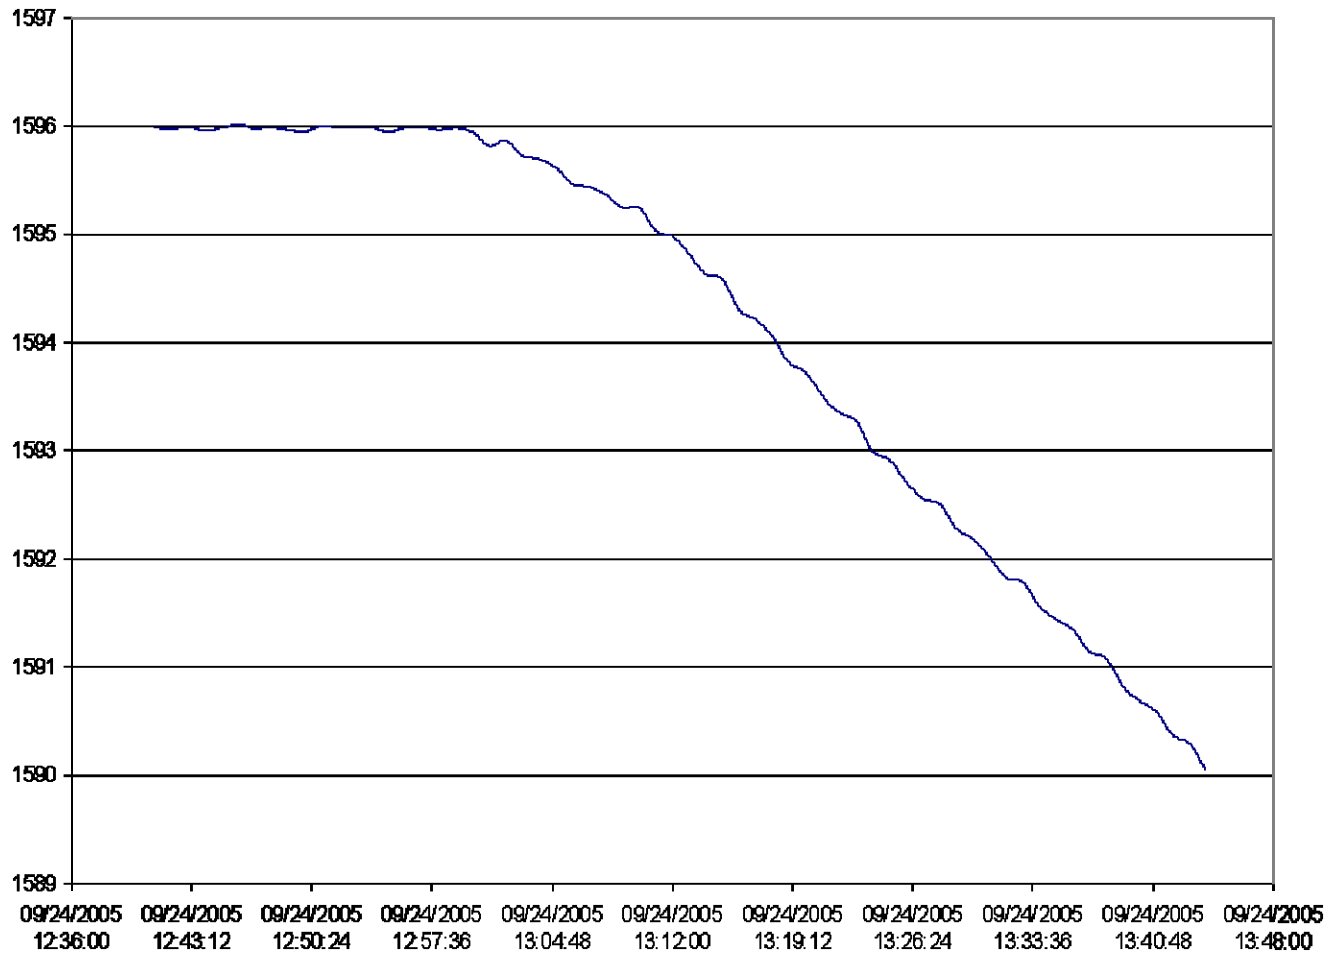
Figures 7-9 through 7-11 show upper reservoir water level readings taken during and prior to the Hurricane Rita event.

Generation start on day prior to Hurricane Rita. Note smaller level variations compared to next day.

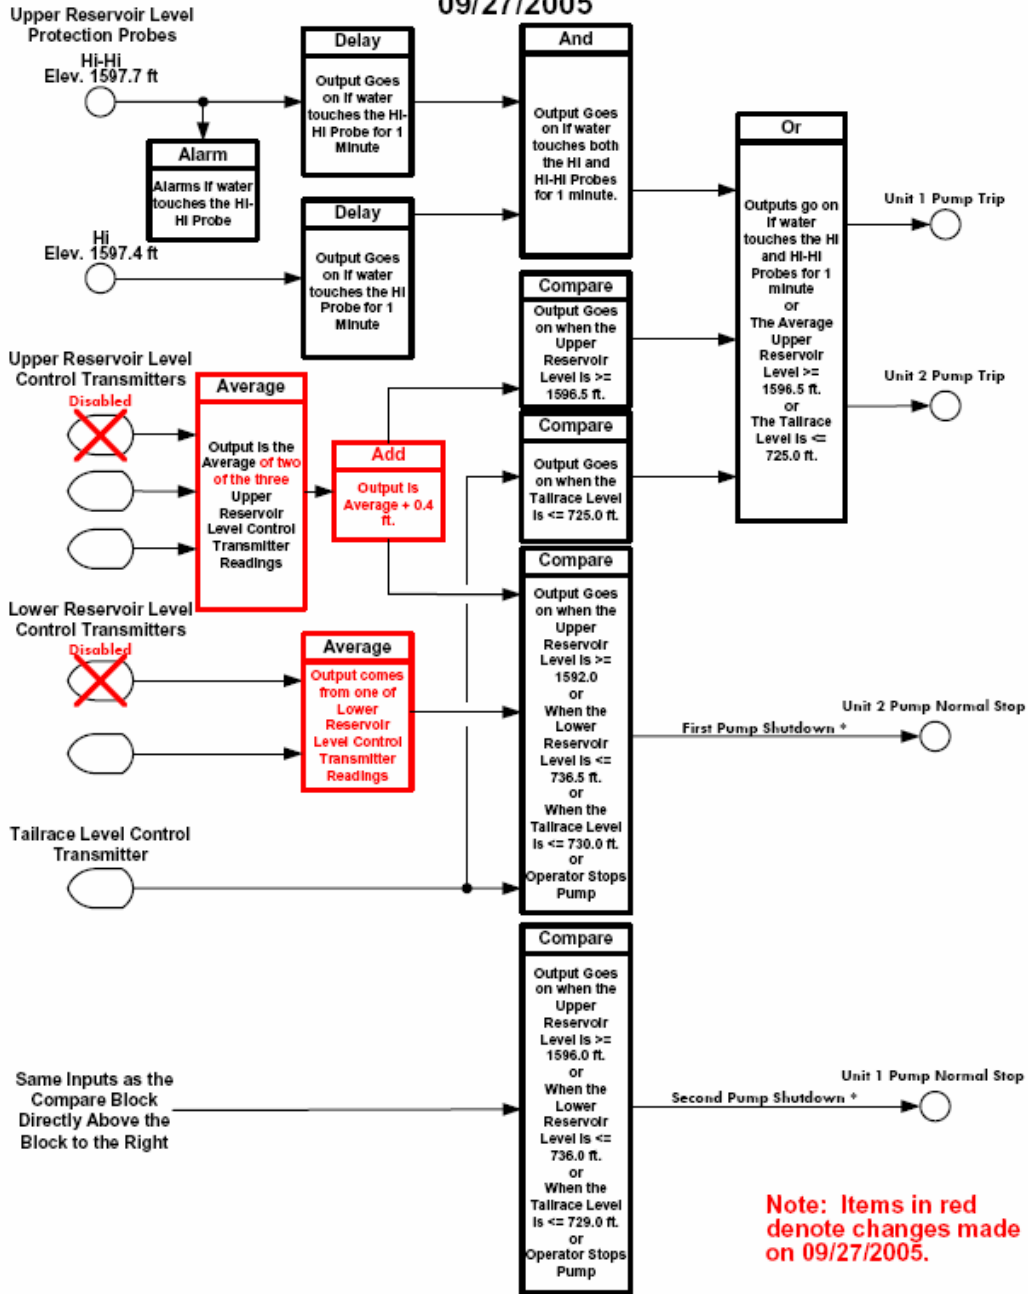
Figure 7-12

Note: Items in red denote changes made on 09/27/2005.
