Engineering Ethics Case Study: The Taum Sauk Reservoir Failure

"Taum Sauk Upper Dam Breach:

Technical Reasons for the Breach of December 14, 2005"

Taum Sauk Upper Dam Breach FERC No. P-2277

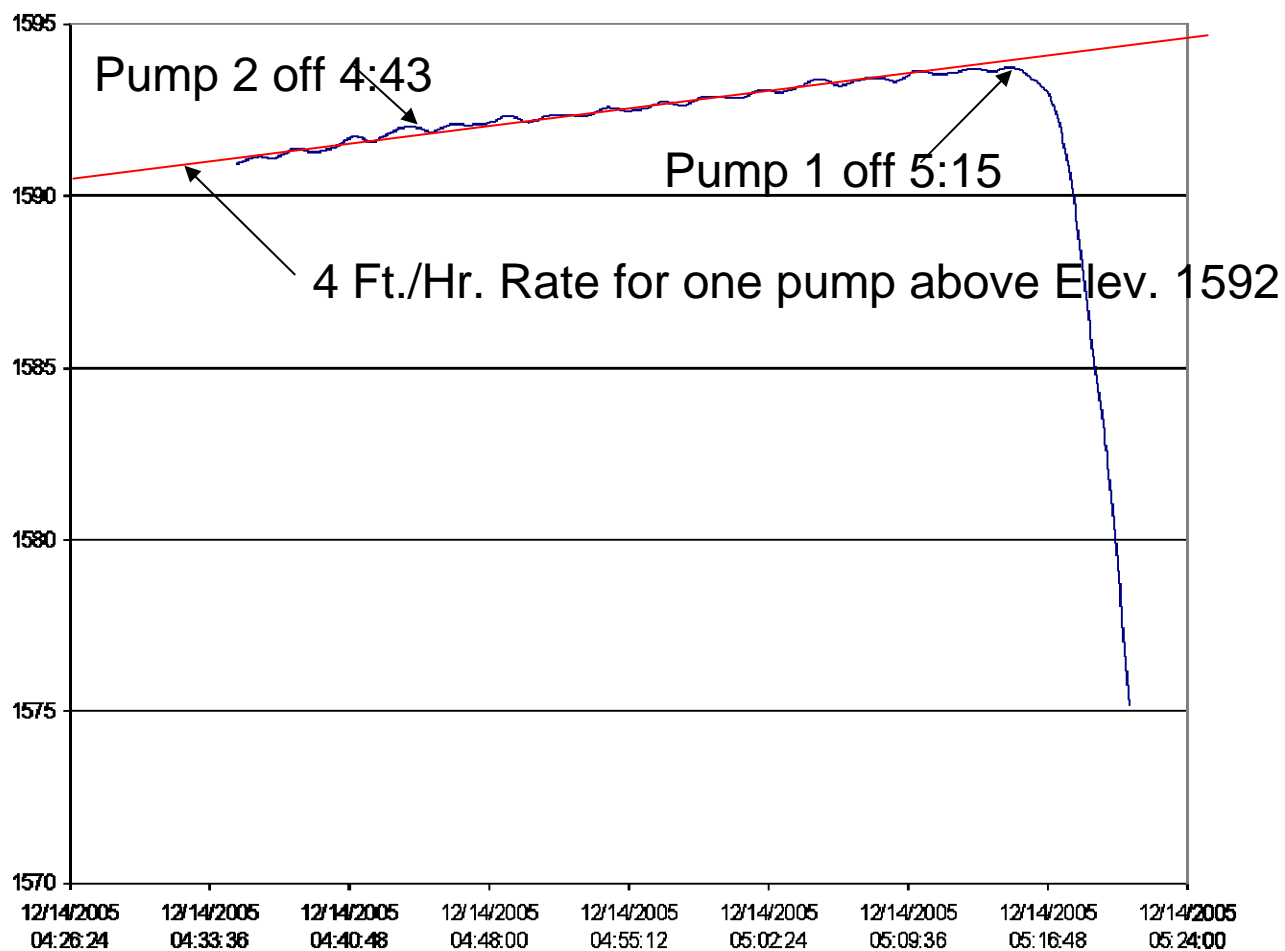
Figure 7-25

Water level indications at breach event.

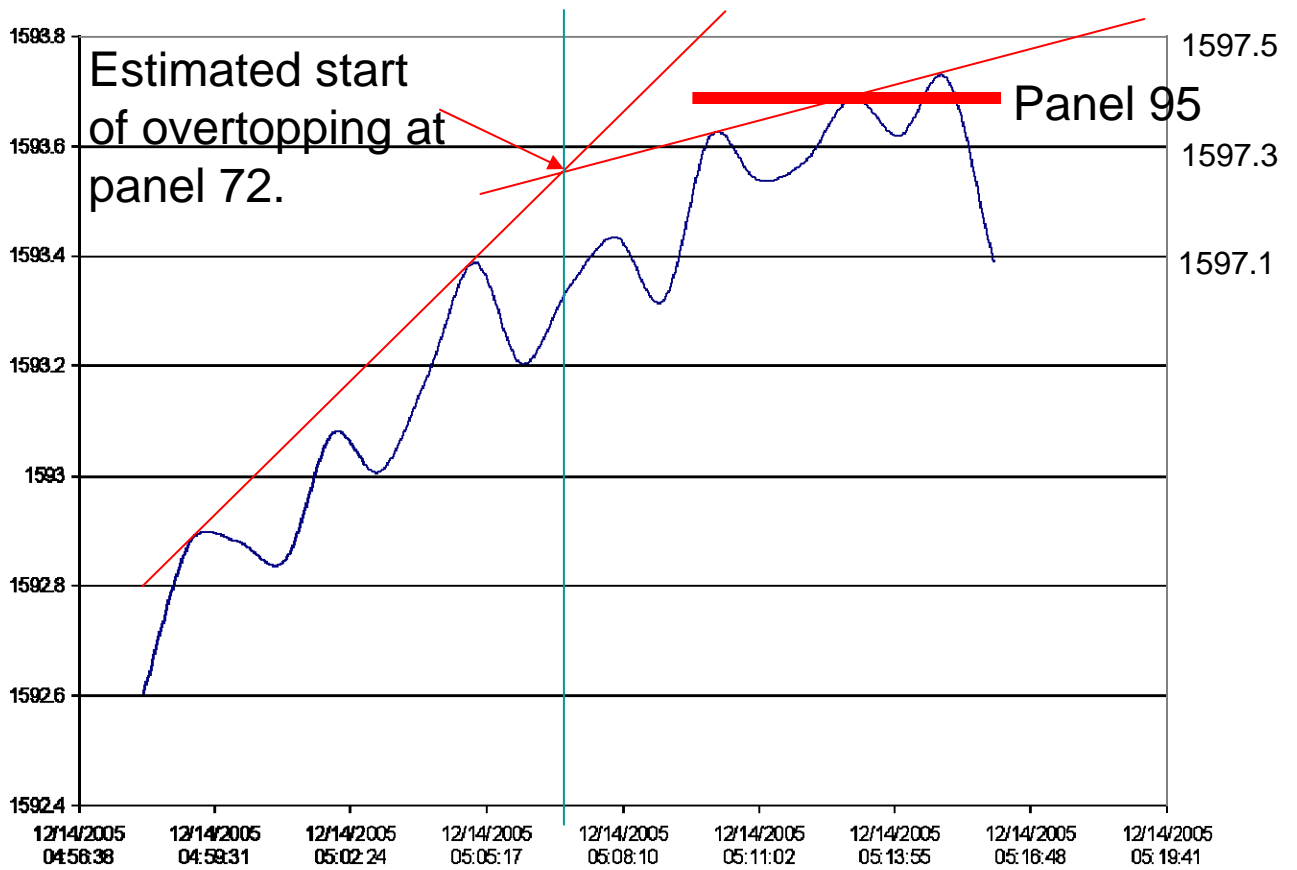
Figure 7-26

Water level indications (left scale)
and adjusted (right scale) prior to breach event.

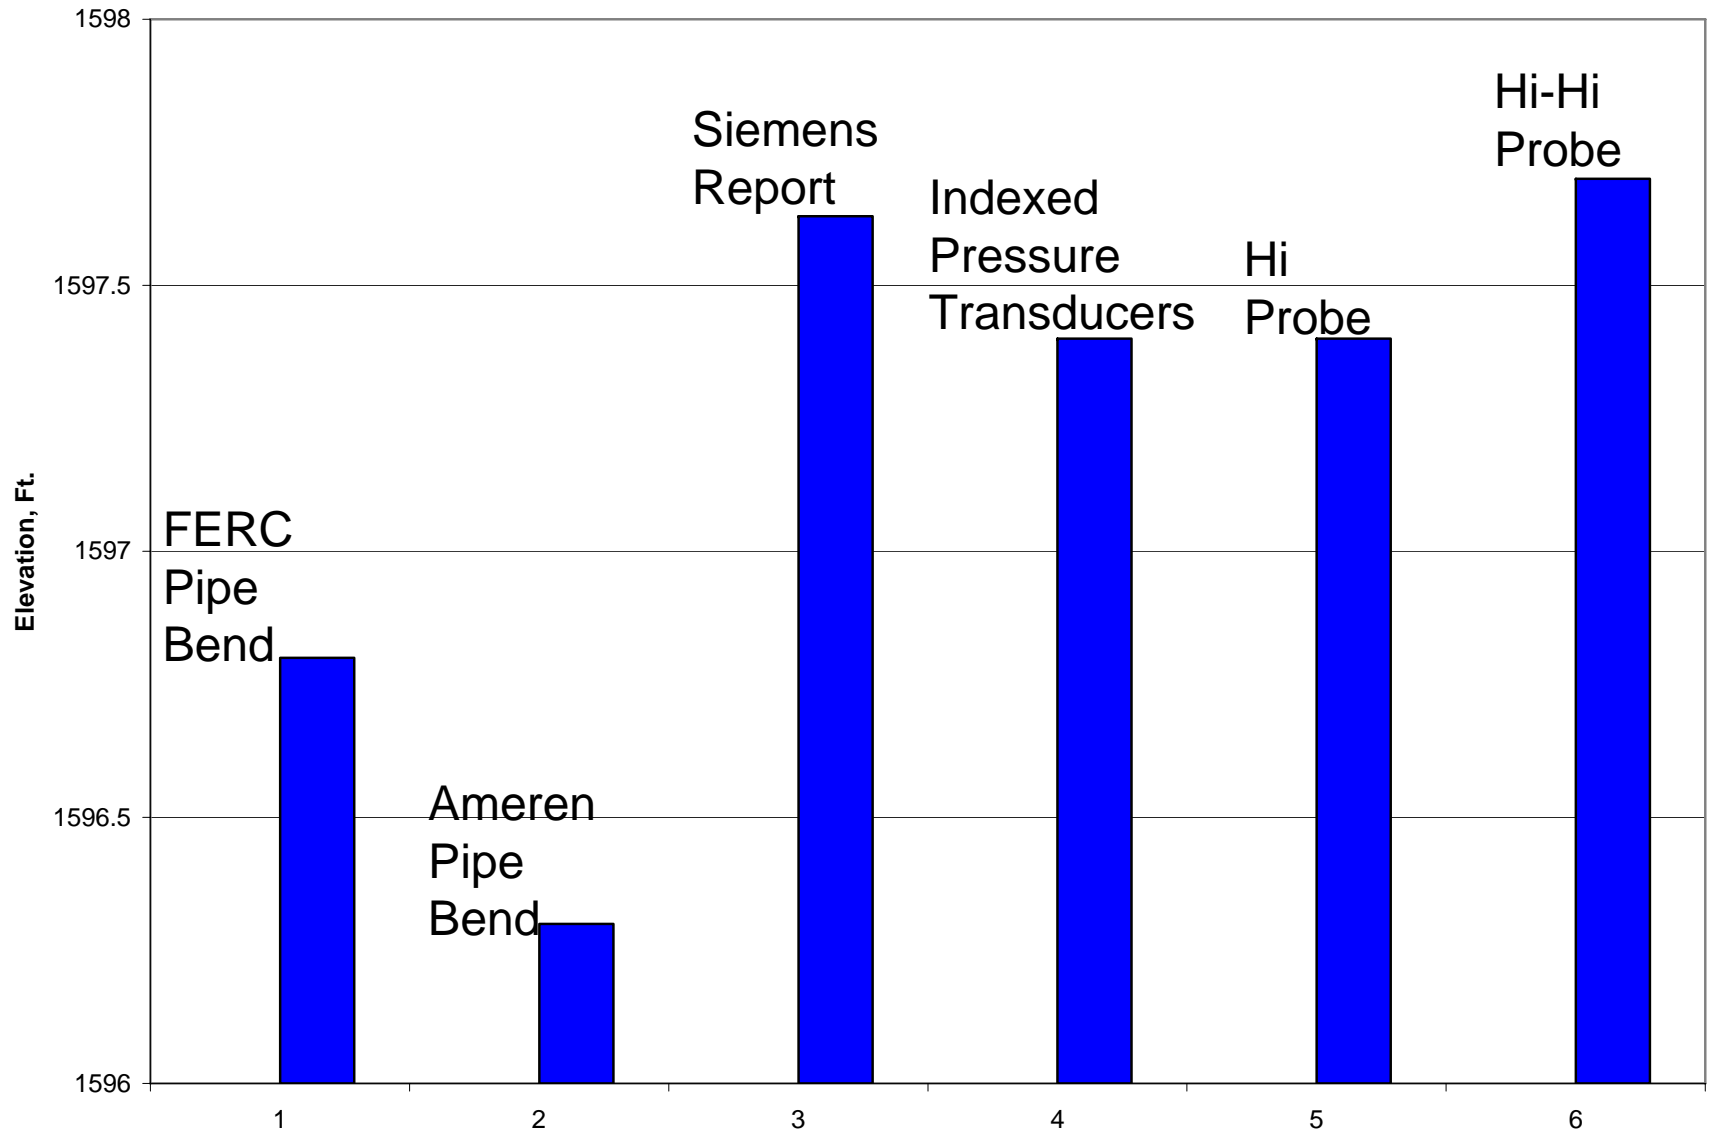
Estimates of Maximum Reservoir Level Before Breach
