# ENGINEERING FAILURE CASE STUDY: THE SURFSIDE CONDOMINIUM COLLAPSE

Engineering CE Courseware

This course examines the engineering failures that contributed to the catastrophic collapse of the Champlain Towers South condominium in Surfside, Florida, in June 2021. Through an analysis of the event, the course explores structural deficiencies, maintenance lapses, and engineering design flaws that led to the disaster. By evaluating the technical findings and key contributing factors, participants will gain insights into how similar failures can be identified and prevented in future engineering projects. This course is applicable across disciplines involved in structural engineering, forensic analysis, and safety compliance.

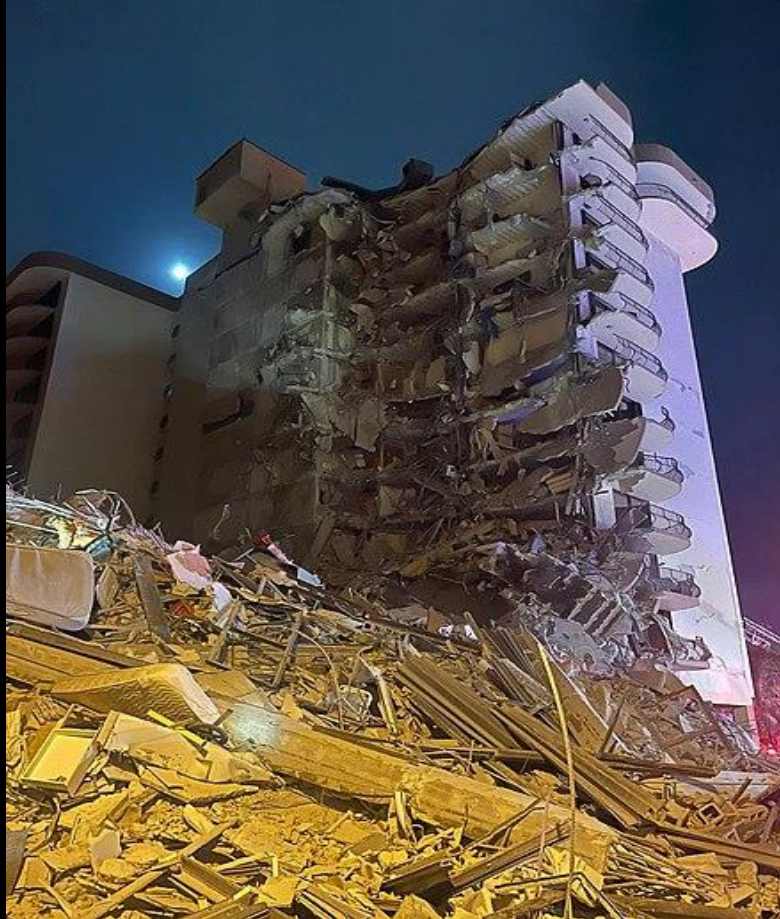
The Champlain Towers South collapse highlighted critical failures in maintenance and inspections, which compounded the building's vulnerabilities over time. Despite warnings from structural assessments conducted years before the collapse, insufficient action was taken to address the growing concerns.
