FHWA Bridge Inspections: Common Timber Superstructures

“Bridge Inspector's Reference Manual: Section 6,
Inspection and Evaluation of Common Timber Superstructures”

Section 6 Inspection and Evaluation of Common Timber Superstructures

Topic 6.1 Solid Sawn Timber Bridges

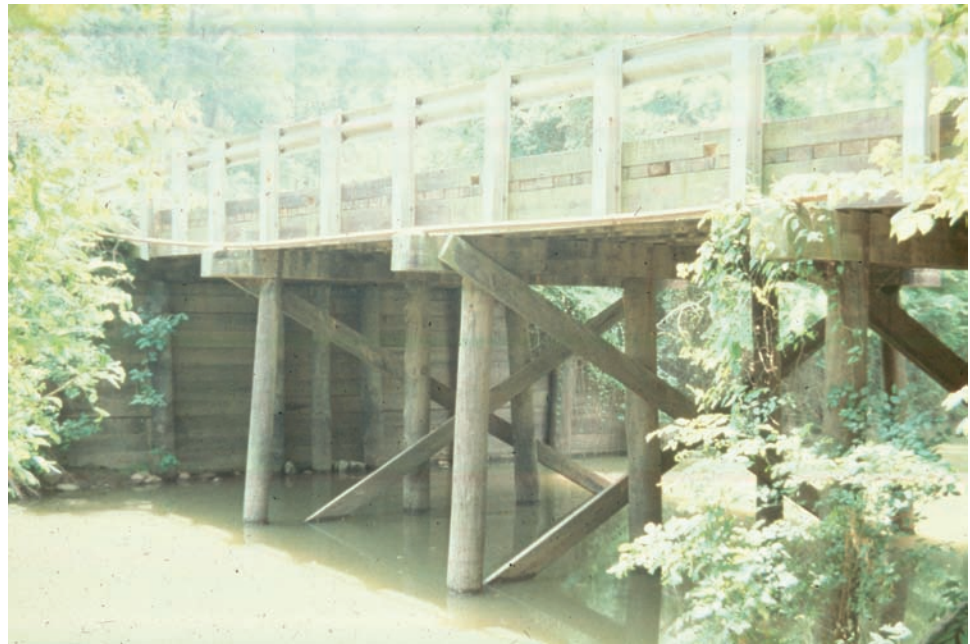
Timber bridges are gaining a resurgence in popularity throughout the United States. There are two basic classifications in timber construction: solid sawn and glued-laminated (glulam). A solid sawn beam is a section of tree cut to the desired size at a saw mill. Solid sawn multi-beam bridges are the simplest type of timber bridge (see Figure 6.1.1).

Figure 6.1.1 Elevation View of a Solid Sawn Multi-Beam Bridge

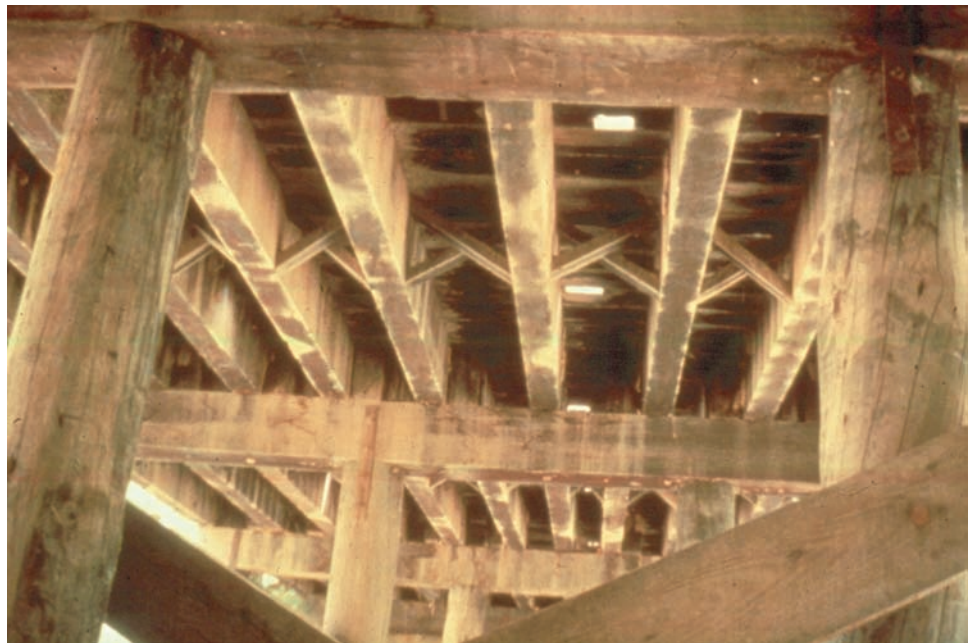
Solid sawn multi-beam bridges consist of multiple solid sawn beams spanning between substructure units (see Figure 6.1.2). The deck is typically comprised of transversely laid timber planks, and longitudinally laid planks called runners which are supported by the beams. Sometimes a bituminous wearing surface is placed on the deck planks to provide a skid resistant riding surface for vehicles, as well as a protective surface for the planks. Beam sizes typically range from about 150 mm by 300 mm (6 inches by 12 inches) to 200 mm by 400 mm (8 inches by 16 inches), and the beams are usually spaced about 600 mm (24 inches) on center.

Figure 6.1.2 Underside View of a Solid Sawn Multi-Beam Bridge

The primary members of solid sawn multi-beam bridges are the beams, and the secondary members are the diaphragms or cross bracing if present (see Figure 6.1.2). These bridges usually have timber diaphragms or cross bracing between beams at several locations along the span.

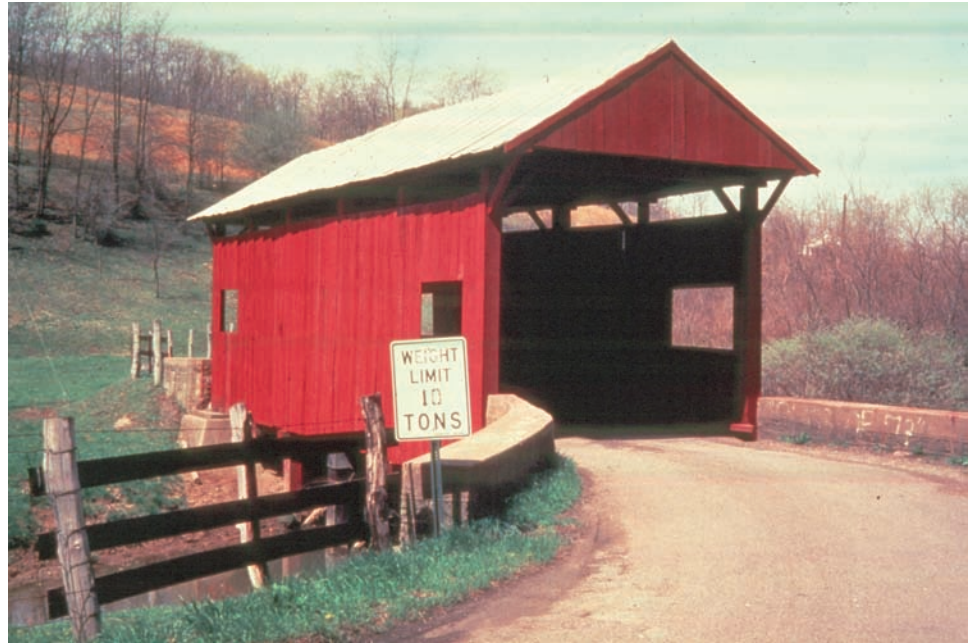
Covered bridges are generally found along rural roads and get their name from the walls and roof which protect the bridge superstructure (see Figures 6.1.3 and 6.1.4). Covered bridges are usually owned by local municipalities, although some are owned by states or private individuals. Some still carry highway traffic, but many are only open to pedestrians or light weight vehicles. While most covered bridges were built during the 1800's and early 1900's, there are a number of covered bridges being built today as historic reconstruction projects.

Figure 6.1.3 Elevation View of Covered Bridge

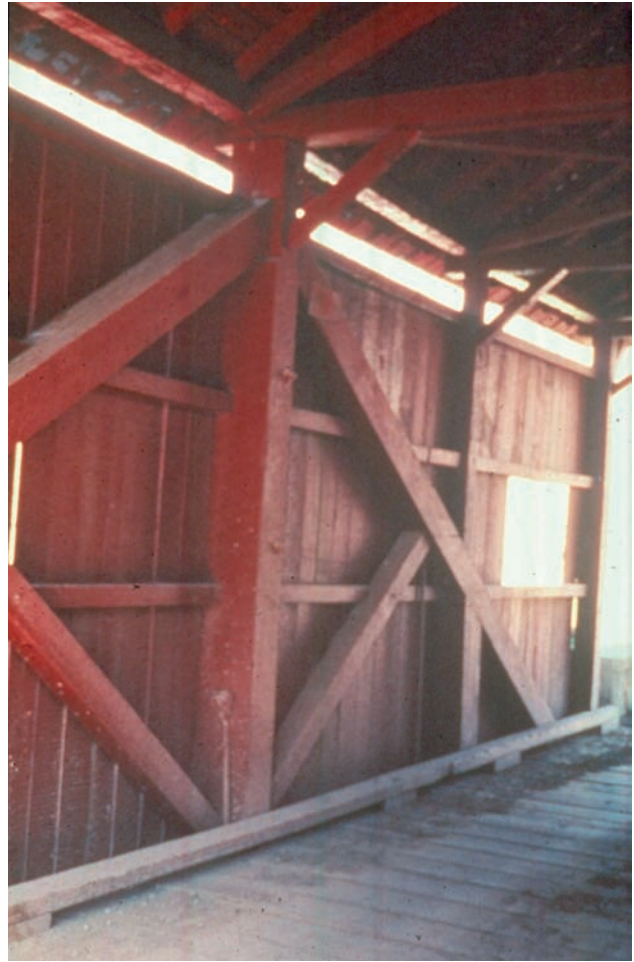
Figure 6.1.4 Inside View of Covered Bridge Showing King Post Truss Design

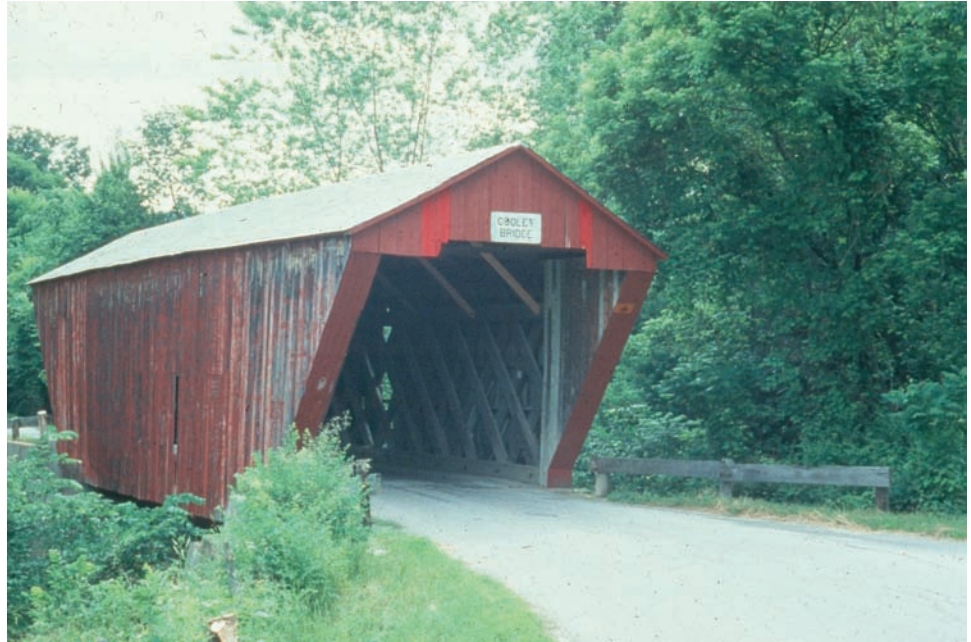
The majority of covered bridges are essentially truss bridges (see Figure 6.1.5). Solid sawn timber members make up the trusses of these historic structures. The covers on the bridges prevent decay of the truss and are responsible for their longevity. Typical truss types for covered bridges include the king post, queen post, Town, Warren, and Howe (see Figure 6.1.6). The floor system consists of timber deck planks, stringers, and floorbeams. The span lengths of covered bridges generally range from 15 to 30 m (50 to 100 feet), although many are well over 30 m (100 feet) and some span over 61 m (200 feet).

Figure 6.1.5 Town Truss Covered Bridge

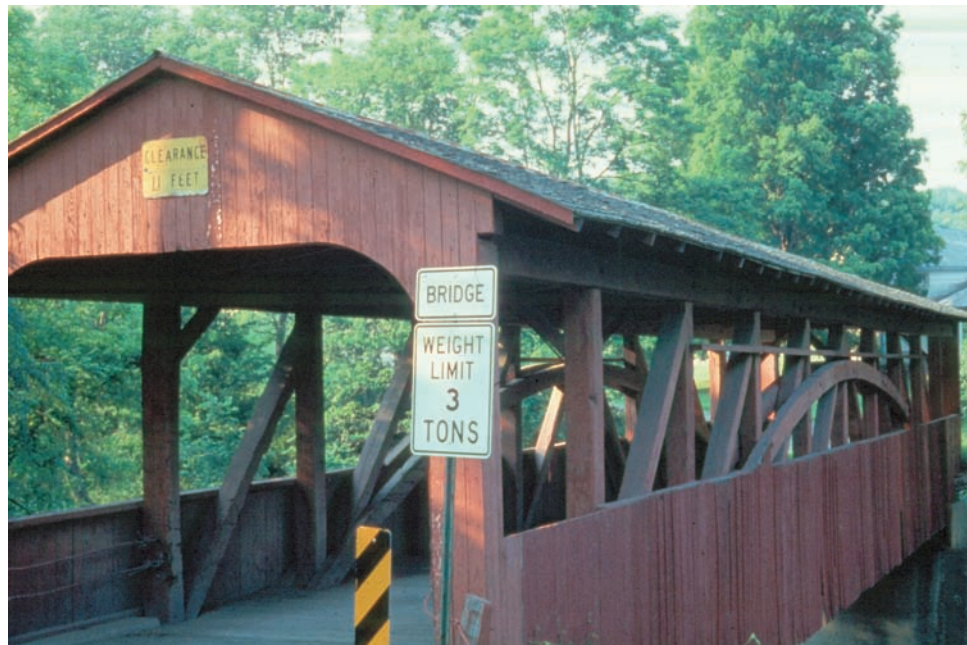
Timber arches were first used in covered bridges by Theodore Burr to strengthen the series of truss configurations normally used in covered bridges. These became known as Burr arch-trusses (see Figures 6.1.7, 6.1.8 and 6.1.9). The arch served as the main supporting element, and the king posts simply strengthened the arch. The span lengths for Burr-arch truss bridges generally range from 15 to 53 m (50 to 175 feet). Because of their greater strength, many of these structures still exist today.

Figure 6.1.8 Burr Arch-truss Covered Bridge

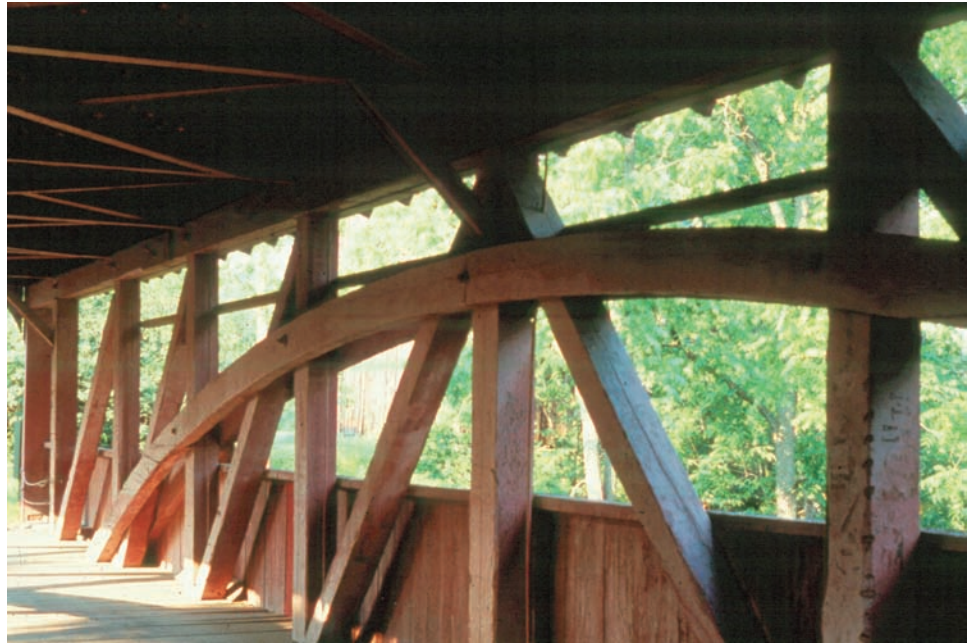
Figure 6.1.9 Inside View of Covered Bridge with Burr Arch-truss Design

The primary members in truss and arch structures are the truss members (chords, diagonals, and verticals), arch ribs, stringers, and floorbeams (see Figures 6.1.9 and 6.1.10). The secondary members are the diaphragms and cross bracing between stringers, the upper and lower lateral bracing, sway bracing, and the covers on the roof and sides when present.

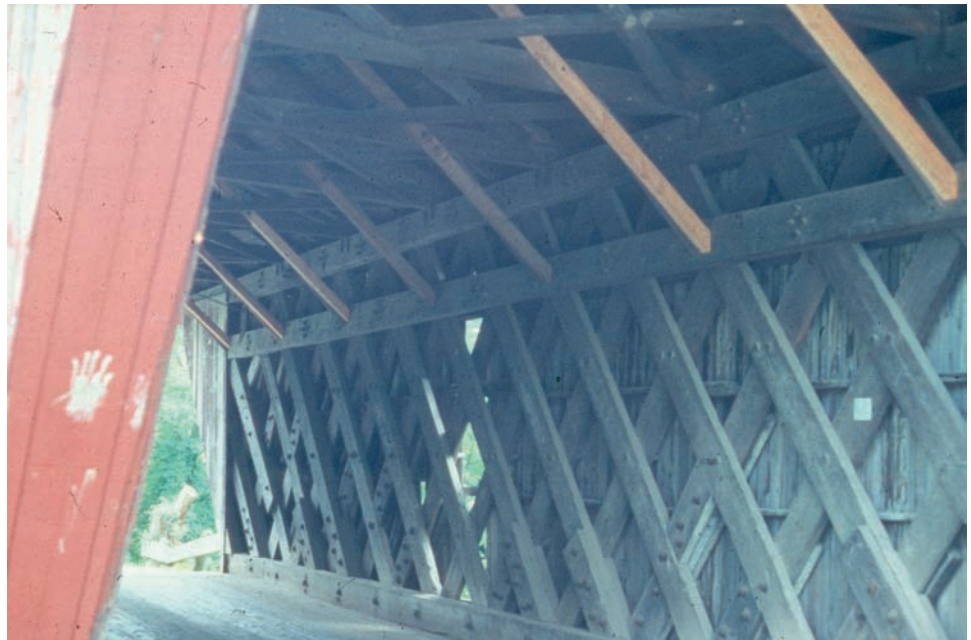
Figure 6.1.10 Town Truss Design

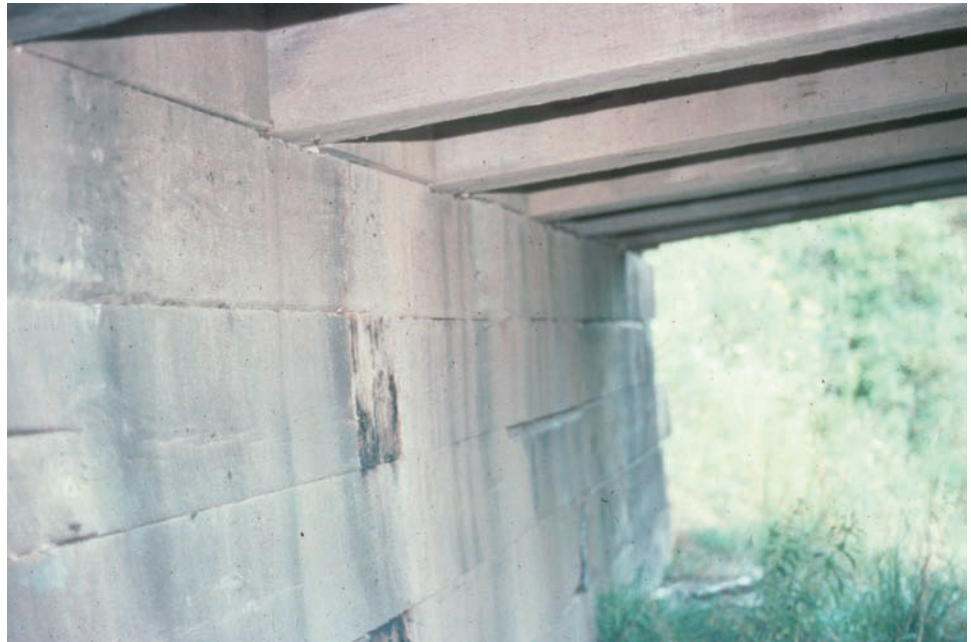
Check the bearing areas for crushing of the beams near the bearing seat (see Figure 6.1.11). Investigate for decay and insect damage by visual inspection and sounding and/or probing at the ends of the beams where dirt, debris, and moisture tend to accumulate. Also verify the condition and operation of the bearing devices, if they are present (see Topic 9.1).

Figure 6.1.11 Bearing Area of Typical Solid Sawn Beam

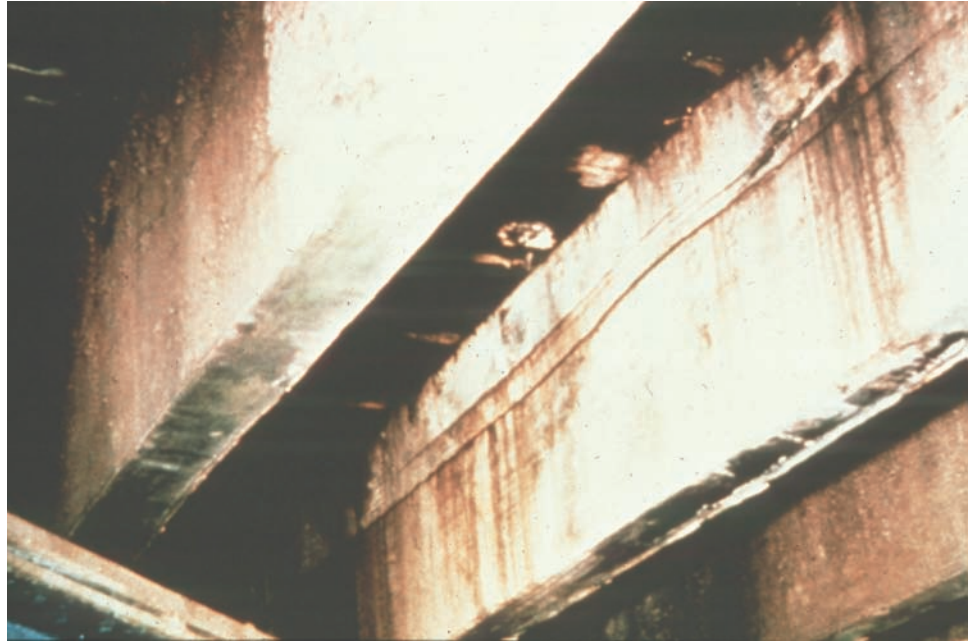
Investigate the area near the supports for the presence of horizontal shear cracking. The presence of transverse cracks on the underside of the girders or horizontal cracks on the sides of the girders indicate the onset of shear failure. These cracks can propagate quickly toward midspan and represent lost moment capacity of up to 75% (see Figure 6.1.12). Measure these cracks carefully for length, width, and if possible, the depth.

Figure 6.1.12 Horizontal Shear Crack in a Timber Beam

As discussed in Topic P.2, maximum shear occurs near supports. A horizontal shear force of equal magnitude accompanies the vertical shear component of this force. Because of timber's orthotropic cell structure, it has excellent resistance against vertical shear but low resistance against horizontal shear. The failure of a solid sawn timber member due to load is generally preceded by horizontal shear cracking along the grain. A horizontal shear "crack" is effectively a longitudinal split.

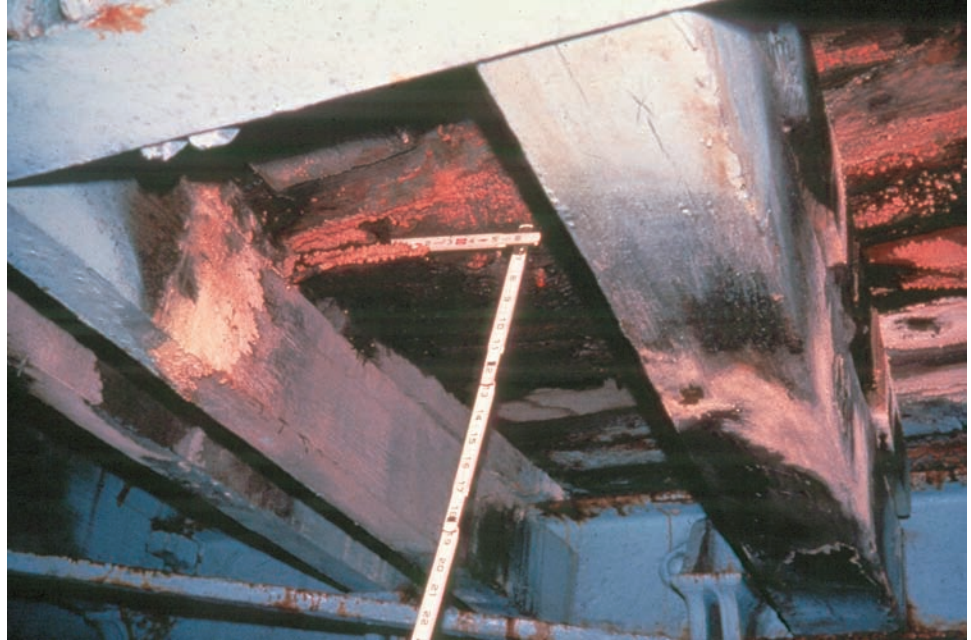
Investigate for signs of decay along the full length of the beam but especially where the beam is subjected to continual wetness and areas that trap moisture. These include member interfaces between deck planks and stringers, deck planks and beams, beams and bearing seats, stringers and floorbeams, floorbeams and trusses, truss member connections, arch connections, and all fastener locations. (see Figure 6.1.13).

Decay and chemical attack may be evidenced by discolored wood, brown and white rot, the formation of fruiting bodies (the result of fungal attacks, which

Figure 6.1.13 Decay in a Timber Beam

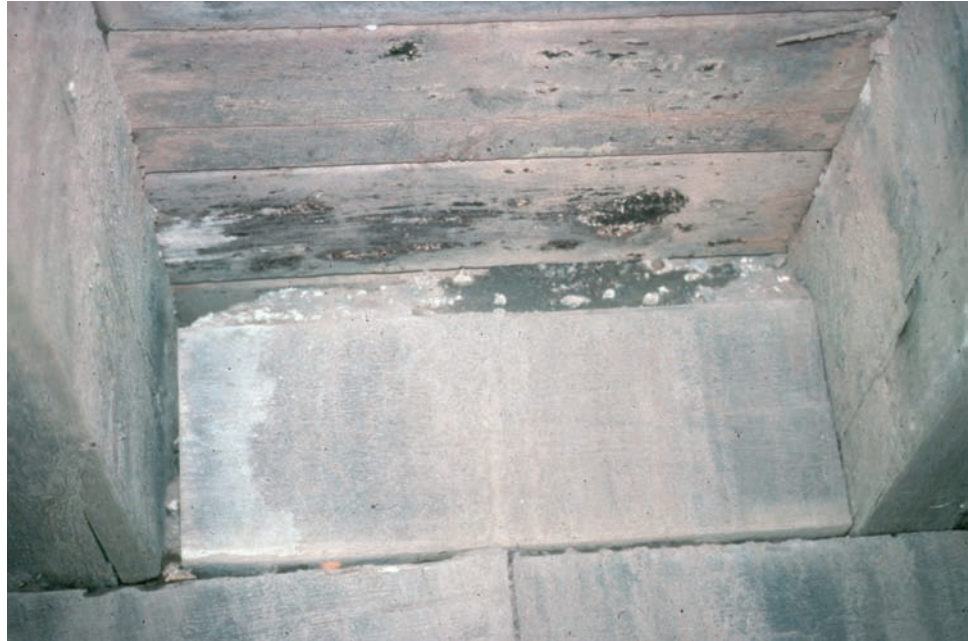
Inspect bracing members for decay and fire damage. Examine connections of bracing to beams for tightness, cracked or split members, and corroded, loose, or missing fasteners (see Figure 6.1.14). Deteriorated secondary members may indicate problems in the primary members.

Figure 6.1.14 Typical Timber End Diaphragm

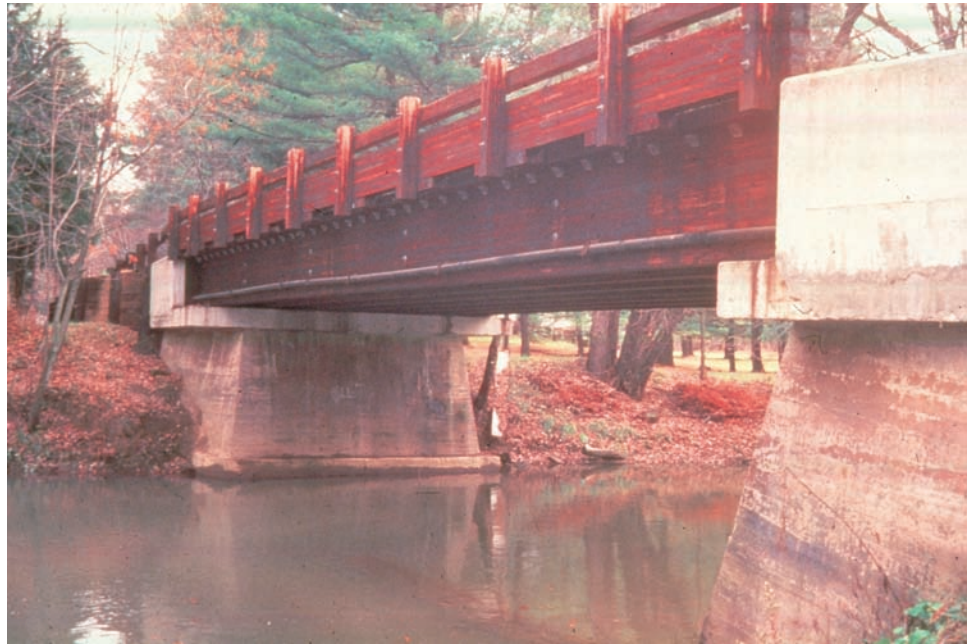
A glued-laminated (glulam) member is made by gluing strips of wood together to form a structural member of the desired size. An advantage of glulam members is that they allow for a higher utilization of the wood, since a lower grade of material can be used in of lower stress. Many strength reducing characteristics of wood, such as knots and checks, are minimized due to relatively small laminate dimensions. Also, the size and length of a glulam member is not limited by the size or length of a tree. Strips of wood used in glulam members are generally 20 to 40 mm (3/4 to 1-1/2 inches) thick (see Figures 6.2.1 and 6.2.2).

Figure 6.2.1 Elevation View of a Glulam Multi-beam Bridge

Glulam multi-beam bridges are very similar to solid sawn multi-beam bridges, but they generally use larger members to span greater distances. Glulam multi-beam bridges are typically simple span designs (see Figure 6.2.1). They usually support a deck consisting of glulam panels with a bituminous wearing surface. Beam sizes typically range from 150 mm by 610 mm (6 inches by 24 inches) to 310 mm by 1525 mm (12-1/4 inches by 60 inches), and the beams are usually spaced 1.7 m to 2.0 m (5'-6" to 6'-6") on center (see Figure 6.2.2).

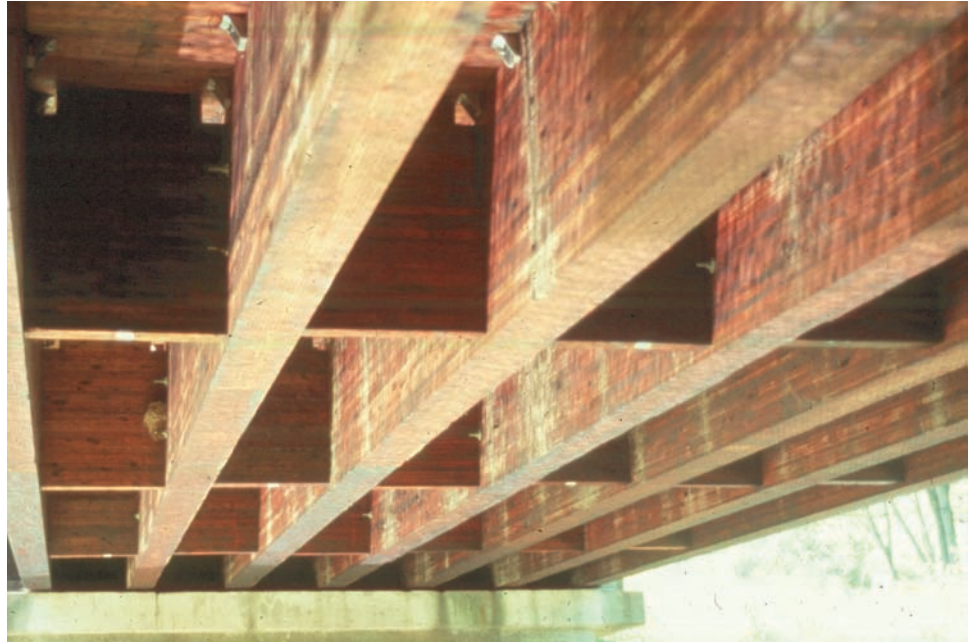
Figure 6.2.2 Underside View of a Glulam Multi-beam Bridge

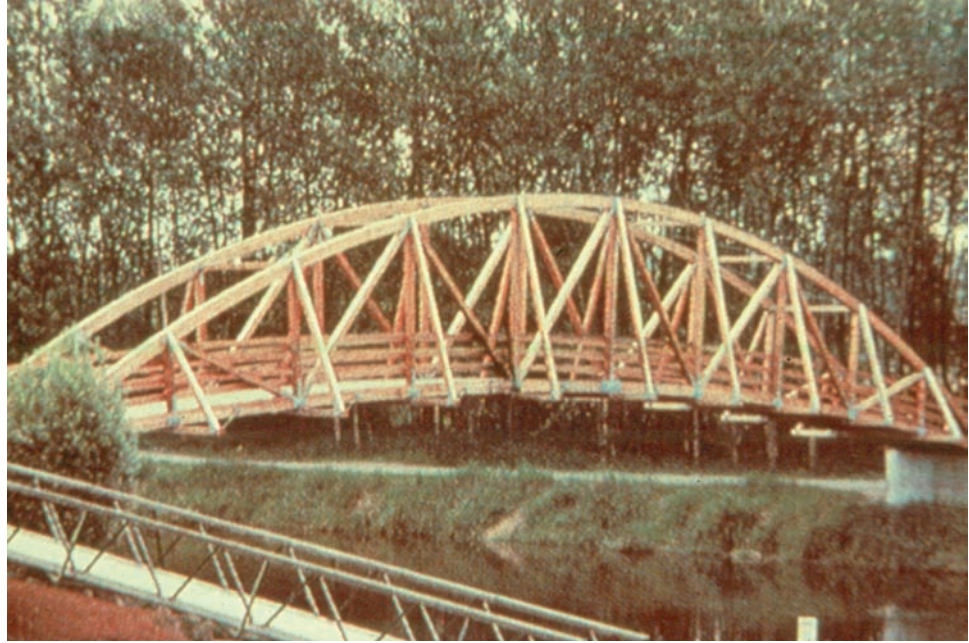
Trusses may be of the through-type or of the deck-type. Usually the floor system consists of a timber deck supported by timber stringers and floorbeams, all of which are supported by the trusses (see Figures 6.2.3 and 6.2.4). Timber trusses are generally used for spans that are not economically feasible for timber multi-beam bridges. Timber trusses are practical for spans that range from 46 to 76 m (150 to 250 feet) (see Figure 6.2.5).

Figure 6.2.4 Bowstring Truss Pedestrian Bridge

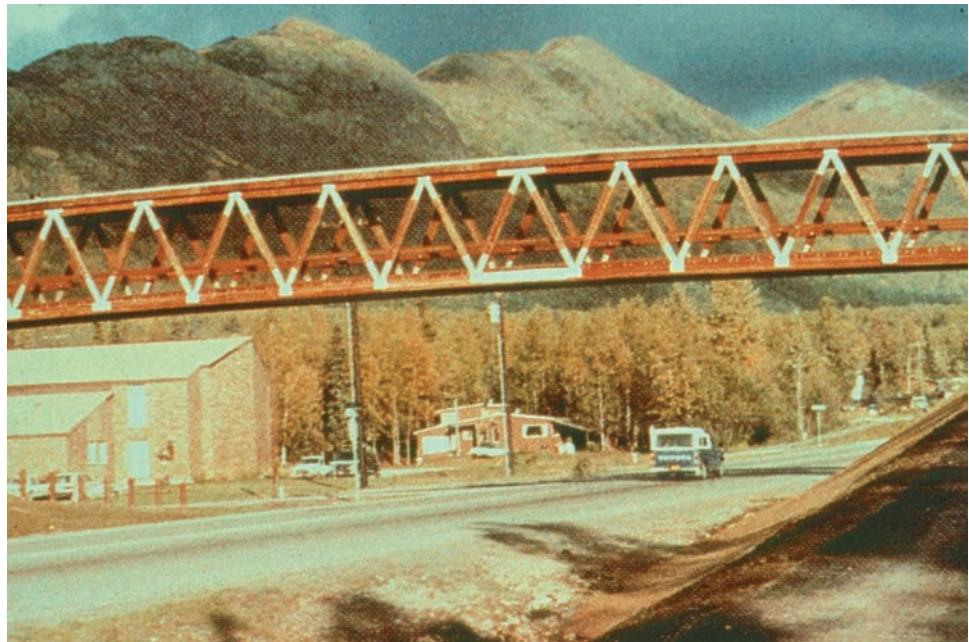
Figure 6.2.5 Parallel Chord Truss Pedestrian Bridge (Eagle River, Alaska)

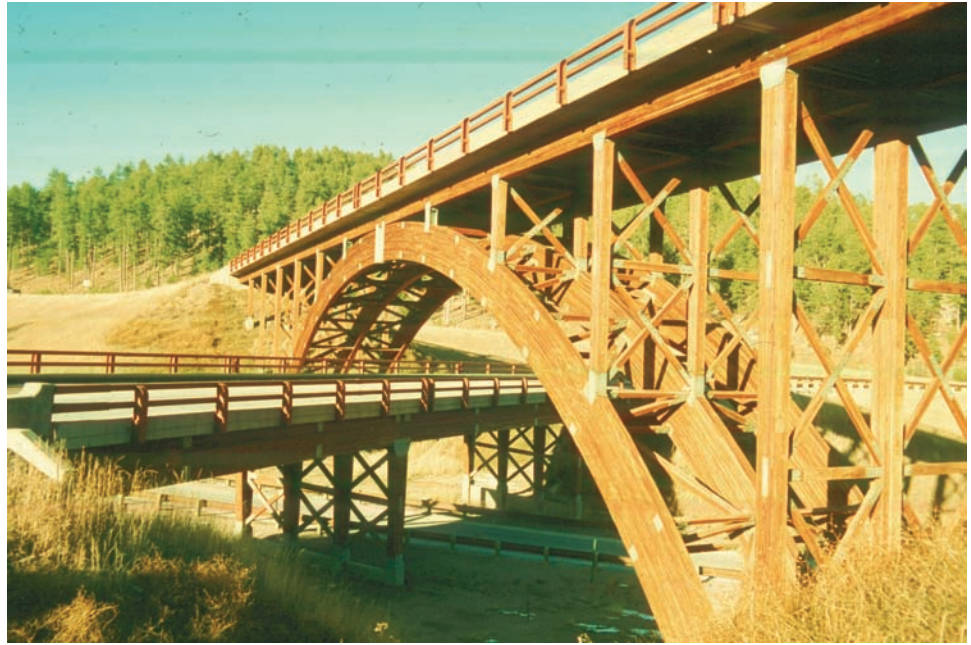
Glulam arch bridges usually consist of two- or three-hinged deck arches, which support a glulam deck and floor system (see Figures 6.2.6 and 6.2.7). Glulam arches are practical for spans of up to about 91 m (300 feet). Although they are not widely used for highway bridges, they are frequently used for pedestrian overpasses and in locations such as parks where aesthetics is important.

Figure 6.2.6 Glulam Arch Bridge over Glulam Multi-beam Bridge (Keystone Wye interchange, South Dakota)

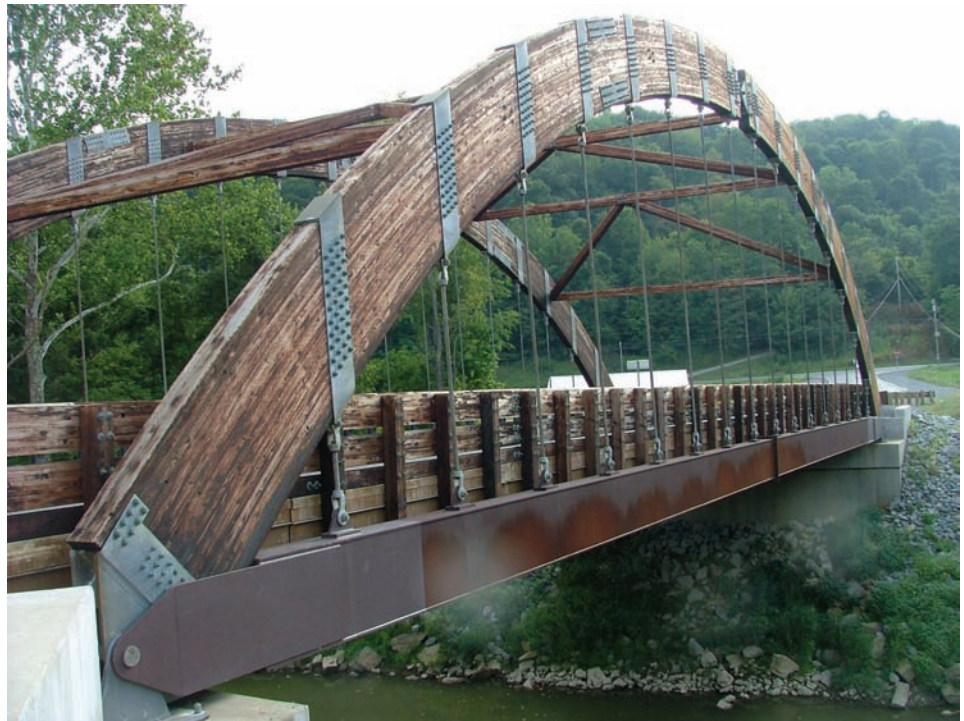
Figure 6.2.7 Glulam Arch Bridge (West Virginia)

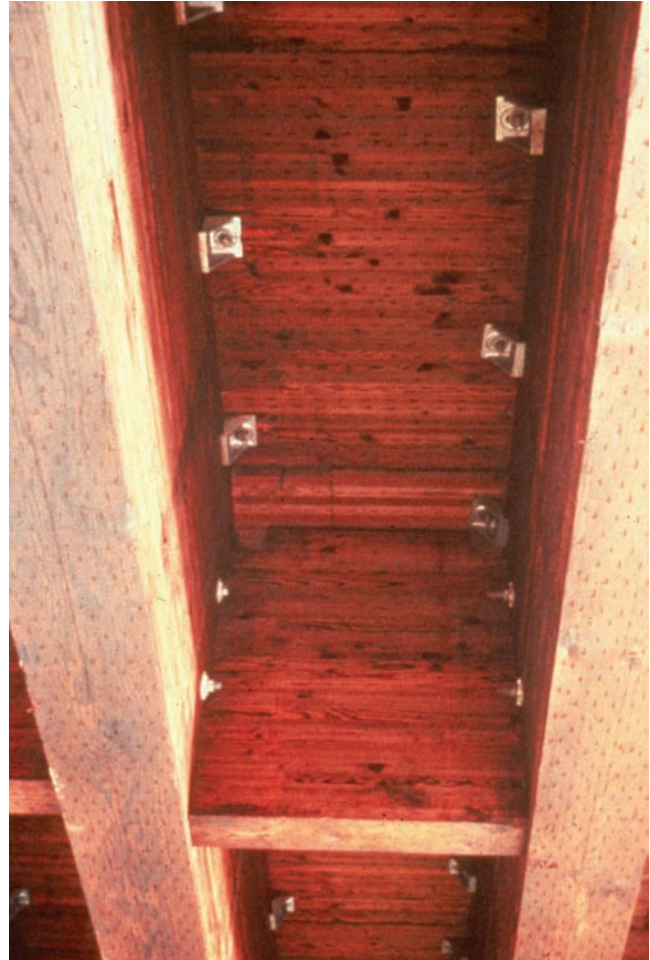
The primary members of glulam multi-beam bridges are the beams, and the secondary members are the diaphragms or cross bracing (see Figure 6.2.8). Due to the larger depth of the glulam beams, diaphragms or cross bracing should always be present. Diaphragms are usually constructed of short glulam members, and cross bracing is usually constructed of steel angles.

Figure 6.2.8 Typical Glulam Diaphragm

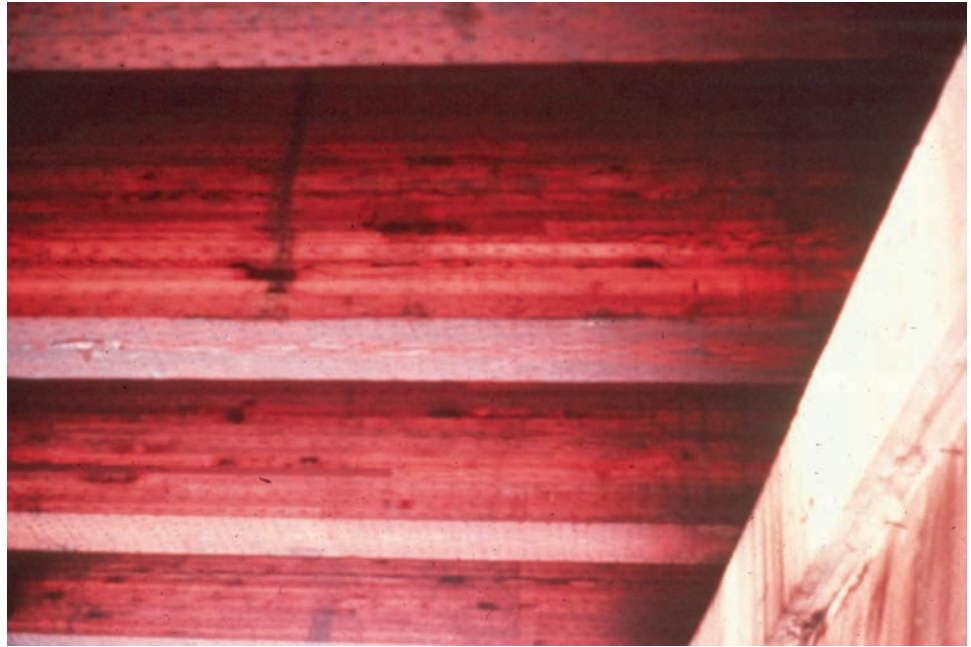
Examine for horizontal shear cracks and delaminations near the ends of the beam. Delaminations (i.e., separations in the laminations) can occur due to either failure of the glue or failure at the bond between the glue and the lamination (see Figure 6.2.10). Delaminations that extend completely through the cross section of the member are the most serious since this makes the member act as two smaller members. Delaminations that are located near the center of the cross section are more serious than those near the top or bottom of the beam. Delaminations directly through a connector are also undesirable.

Figure 6.2.10 Close-up View of Glulam Bridge Showing Laminations

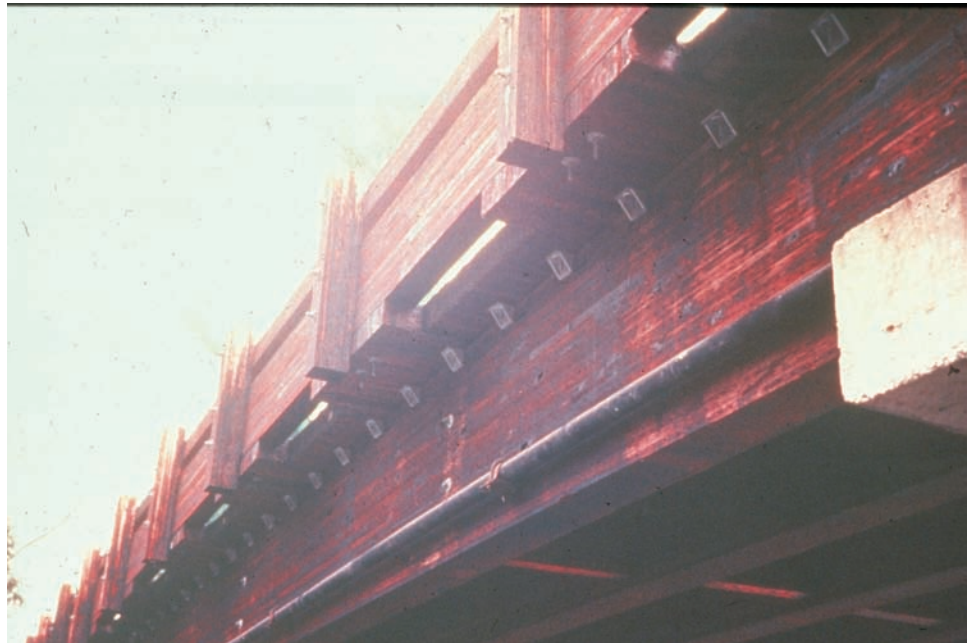
Examine the zone of maximum tension for signs of structural distress (see Figure 6.2.11). The maximum tension generally occurs at the bottom half of the middle third of the beam span. Investigate for section loss due to decay or fire, especially near mid-span. Inspect for excessive deflection or sagging in the beams.

Figure 6.2.11 Elevation View of Beam of Glulam Multi-beam Bridge

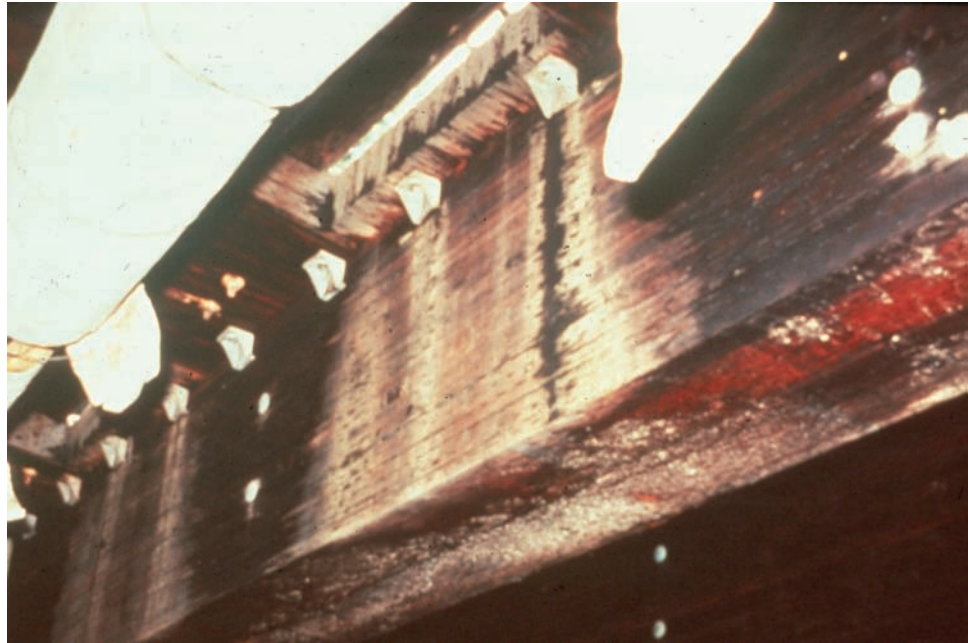
Investigate for signs of decay along the full length of the member but especially where the beam is subjected to continual wetness or prolonged exposure to moisture (see Figure 6.2.12). Decay and chemical attack may be evidenced by discolored wood, brown and white rot, the formation of fruiting bodies (the result of fungal attacks, which produce disc-shaped bodies that distribute reproductive spores), "sunken" faces in the wood, or the soft "punky" texture of the wood.

Figure 6.2.12 Decay on Glulam Beam

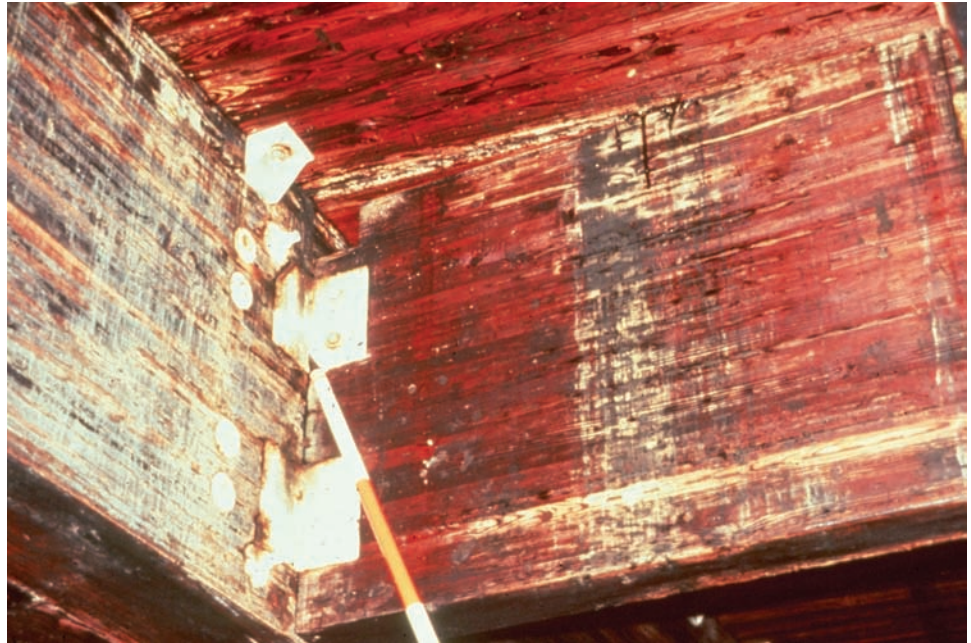
Examine diaphragms for decay, fire damage, and insect damage (see Figure 6.2.13). Check steel cross bracing for corrosion, bowing, or buckling (see Figure

Figure 6.2.13 Typical Diaphragm for a Glulam Multi-beam Bridge

Inspect all fasteners for corrosion, tightness, and missing parts (see Figure 6.2.13).

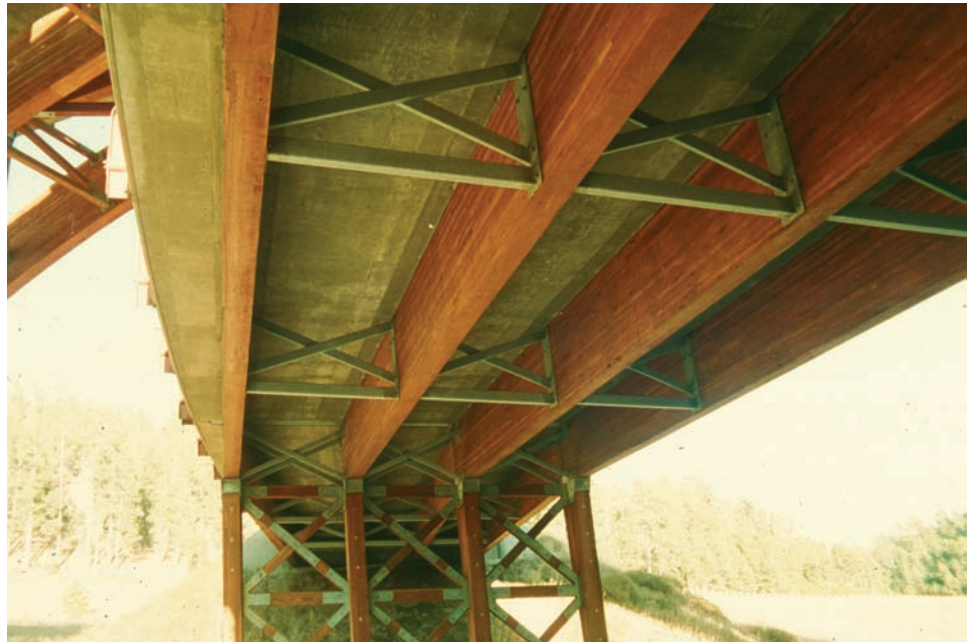
6.2.14). Examine connections for tightness, cracks and splits, and corroded, loose, or missing fasteners. Deteriorated secondary members may indicate problems in the primary members.

Figure 6.2.14 Glulam Beams with Numerous Fastener Locations

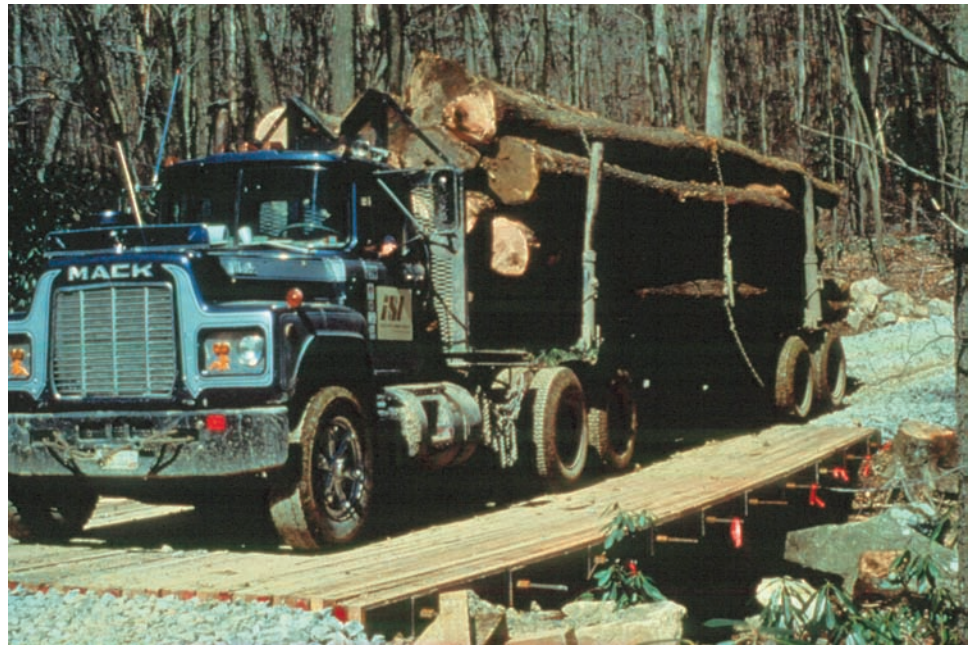
Stress-laminated timber bridges were first developed in Canada, in 1976, by the Ontario Ministry of Transportation and Communications. These bridges consist of multiple planks mechanically clamped together using metal rods to perform as one unit (see Figure 6.3.1). The compression induced frictional resistance within the timber laminations is the mechanism that makes this structural system effective.

Figure 6.3.1 Stress-Laminated Timber Slab Bridge Carrying a 90,000-Pound Logging Truck (Source: Barry Dickson, West Virginia University)

Stress-laminated timber slab bridges can be used for simple spans of up to 15 m (50 feet) and are capable of carrying modern highway loadings (see Figures 6.3.1 and 6.3.3). Stressed deck bridges have also been constructed using glulam members. Combining glulam technology with stress-lamination increases practical span lengths to 19 m (63 feet) (see Figure 6.3.4).

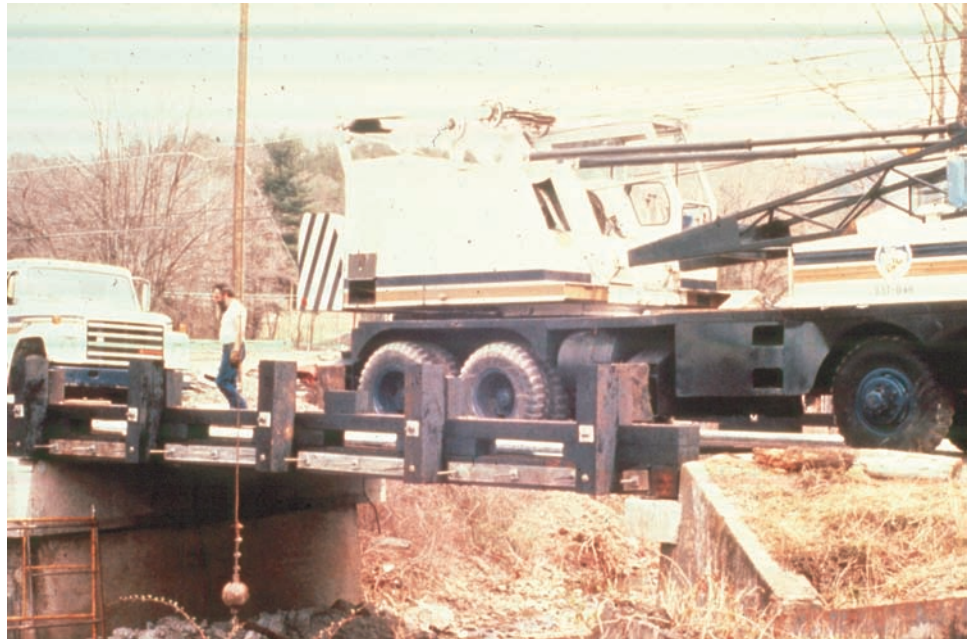
Figure 6.3.3 Stress-Laminated Timber Slab Bridge

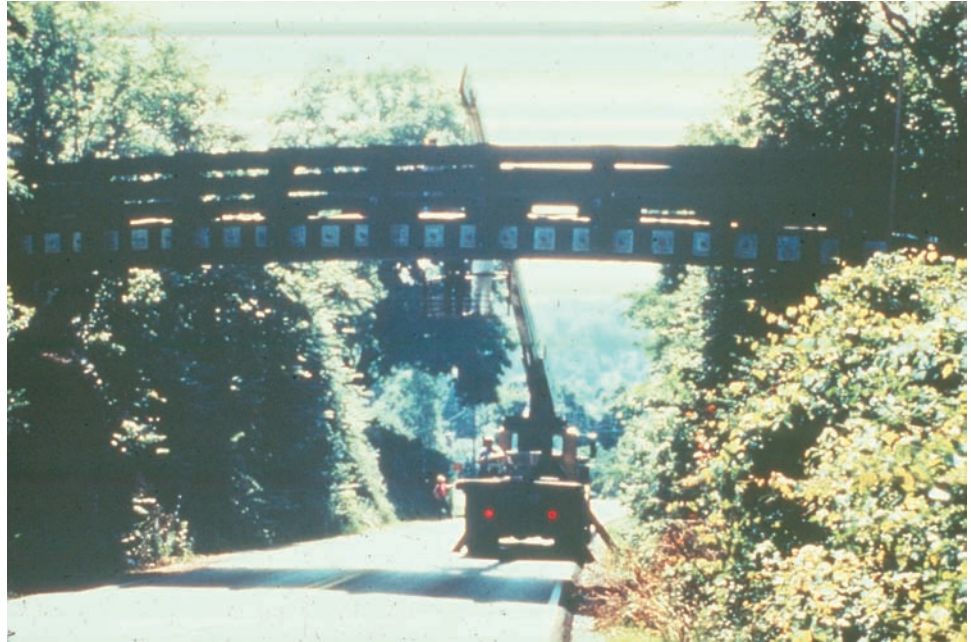
Figure 6.3.4 Glulam Stress-Laminated Timber Slab Bridge

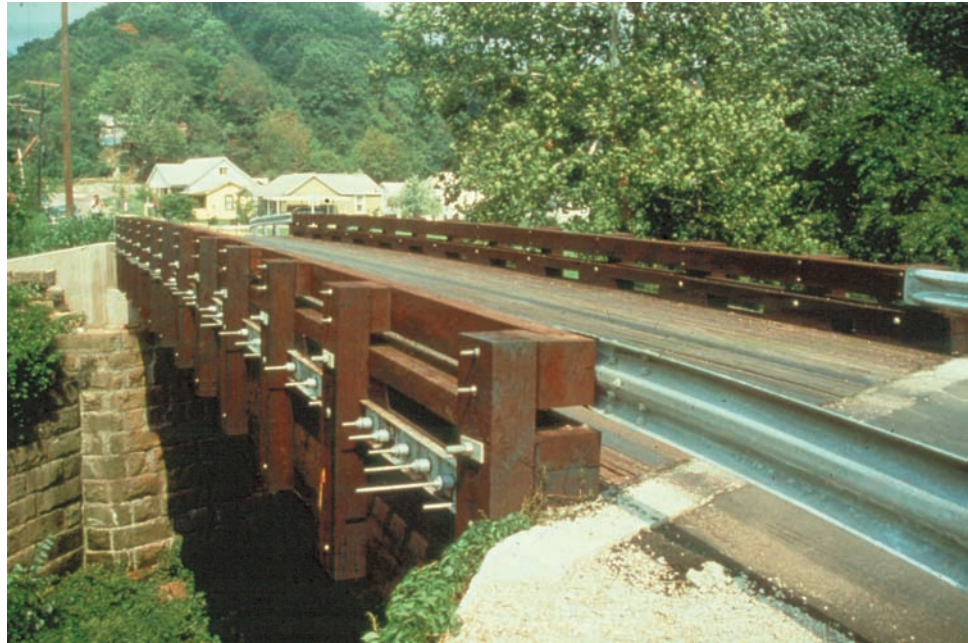
Figure 6.3.6 Elevation View of Stress-Laminated Timber Tee Beam Bridge (West Virginia)

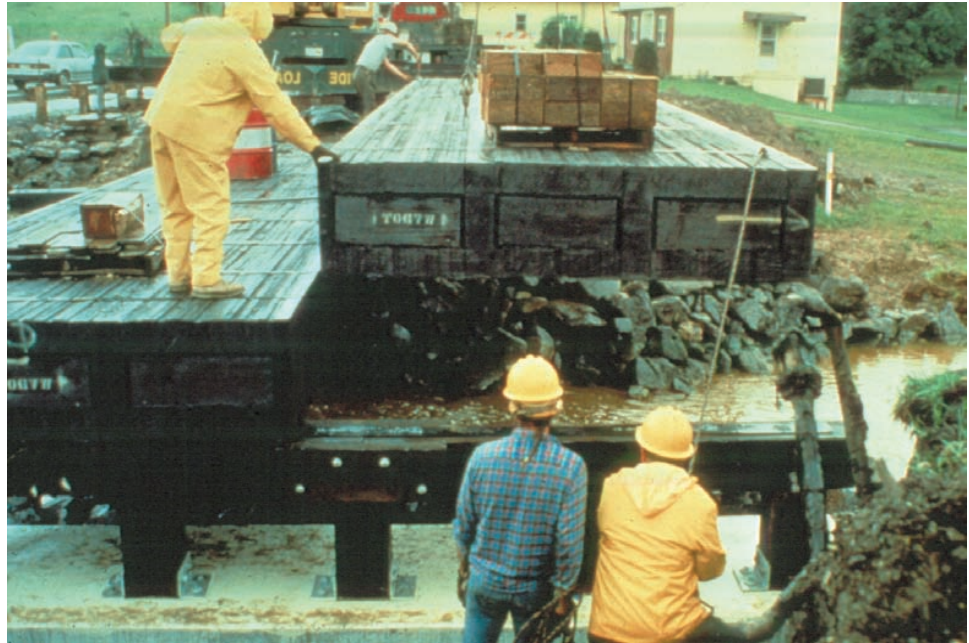
Figure 6.3.8 Stress-Laminated Timber Box Beam Bridge Being Erected

Stress-laminated timber box beam bridges represent further development of timber bridges by West Virginia University. These bridges consist of adjacent box beam panels individually comprised of stress-laminated flanges and glulam beam webs (see Figure 6.3.7). This bridge type is also known as a cellular stressed deck. Span lengths of up to 18 m (60 feet) have been designed, and there is a potential for longer spans (see Figure 6.3.8).

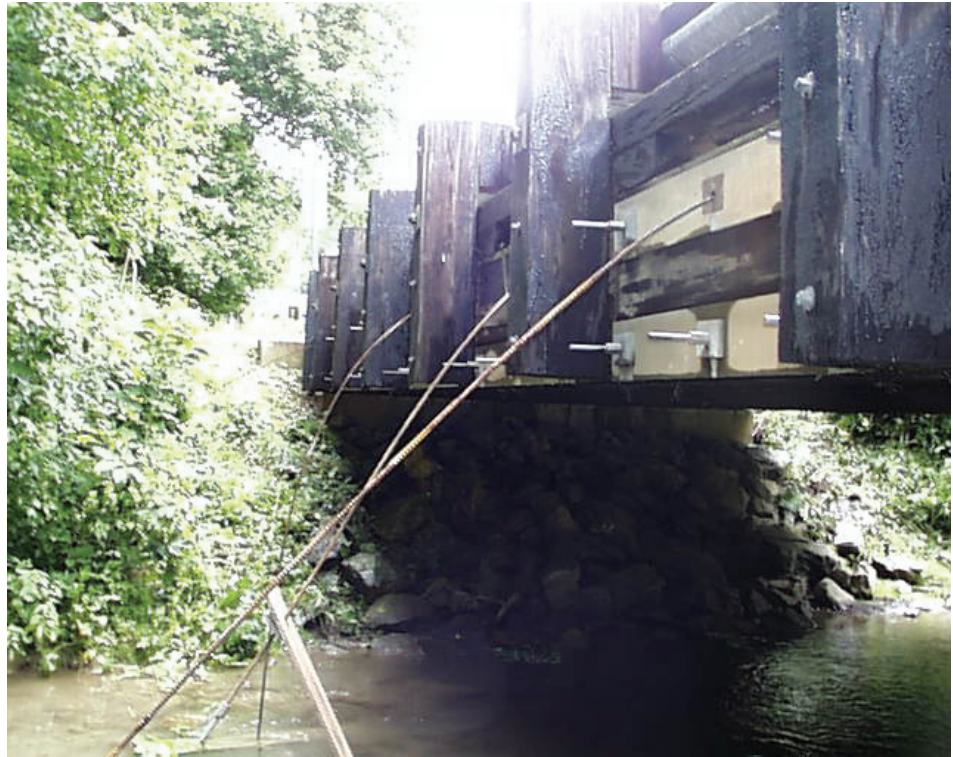
Examine the condition of the steel stressing rods, and inspect for crush and splits in the fascia members. Check for loss of prestress in the rods, which would be indicated by shifted planks in the stress-laminated timber element and excessive deflection or loose rods. This may be observed when the bridge is subject to a moving live load.

Figure 6.3.10 Broken Stressing Rods
