FHWA Bridge Inspections: Common Timber Superstructures

“Bridge Inspector's Reference Manual: Section 6,
Inspection and Evaluation of Common Timber Superstructures”

Section 6 Inspection and Evaluation of Common Timber Superstructures

Topic 6.1 Solid Sawn Timber Bridges

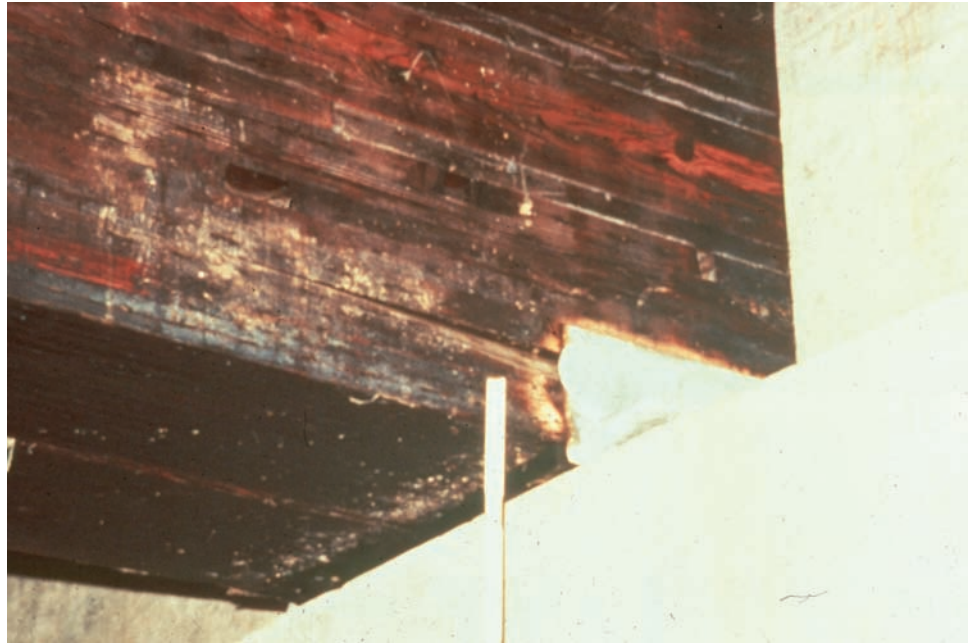
Figure 6.3.11 Close-up View of End of a Stress-Laminated Timber Bridge Showing Laminations

Examine for horizontal shear cracks and delaminations near the ends of the beam. Delaminations (i.e., separations in the laminations) can occur due to either failure of the glue or failure at the bond between the glue and the lamination (see Figure 6.3.11). Delaminations that extend completely through the cross section of the member are the most serious since this makes the member act as two smaller members.
