## Section 8 Inspection and Evaluation of Common Steel Superstructures

SECTION 8: Inspection and Evaluation of Common Steel Superstructures  
TOPIC 8.2: Rolled Steel Multi-beams and Fabricated Steel Multi-girders

# Topic 8.2 Rolled Steel Multi-beams and Fabricated Steel Multi-girders

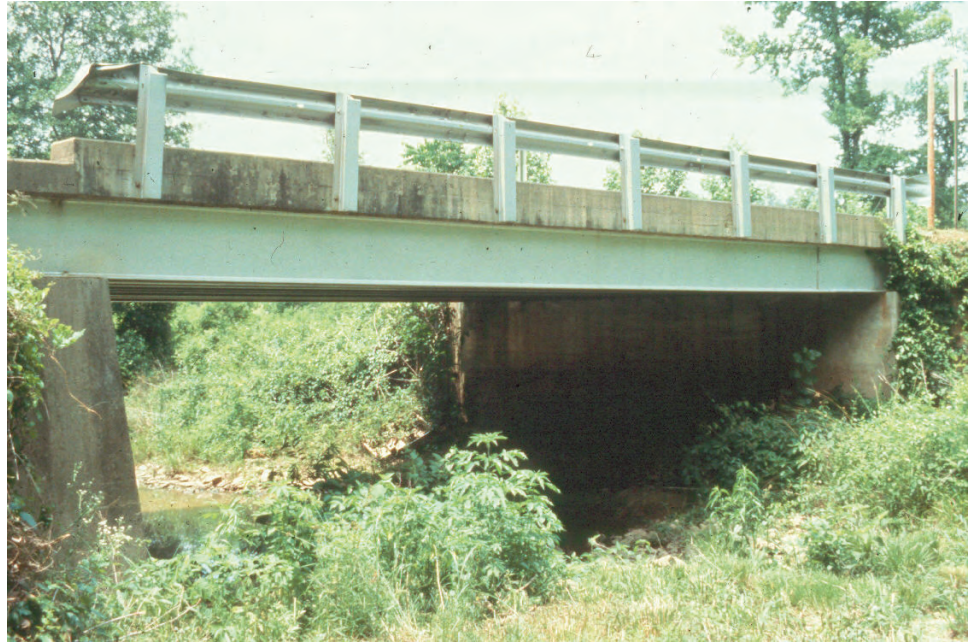
**Figure 8.2.1** Simple Span Rolled Multi-beam Bridge

The steel rolled multi-beam bridge is a configuration of three or more parallel rolled beams with a deck placed on top of the beams. The most common use of this superstructure type is for simple spans, with span lengths from 9 to 15 m (30 to 50 feet) (see Figure 8.2.1). Continuous span designs have also been used, some of which incorporate pin and hanger connections (see Figure 8.2.2). Rolled beams are manufactured in structural rolling mills from one piece of steel (i.e., the flanges and web are manufactured as an integral unit). Rolled beams in the past were generally available no deeper than 915 mm (36 inches) in depth but are now available from some mills as deep as 1200 mm (48 inches).

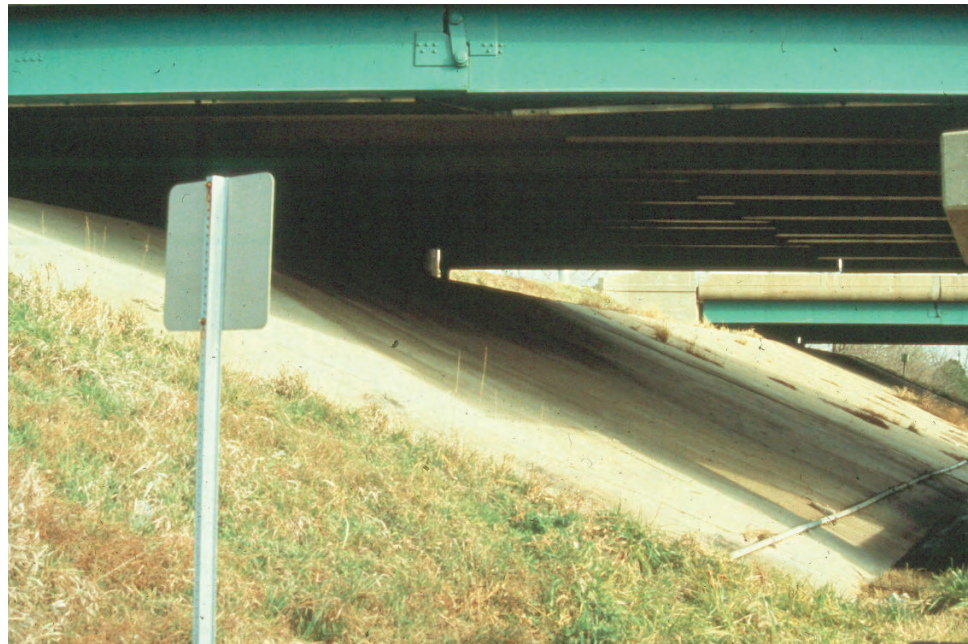
**Figure 8.2.2** Continuous Span Rolled Multi-beam Bridge with Pin & Hanger

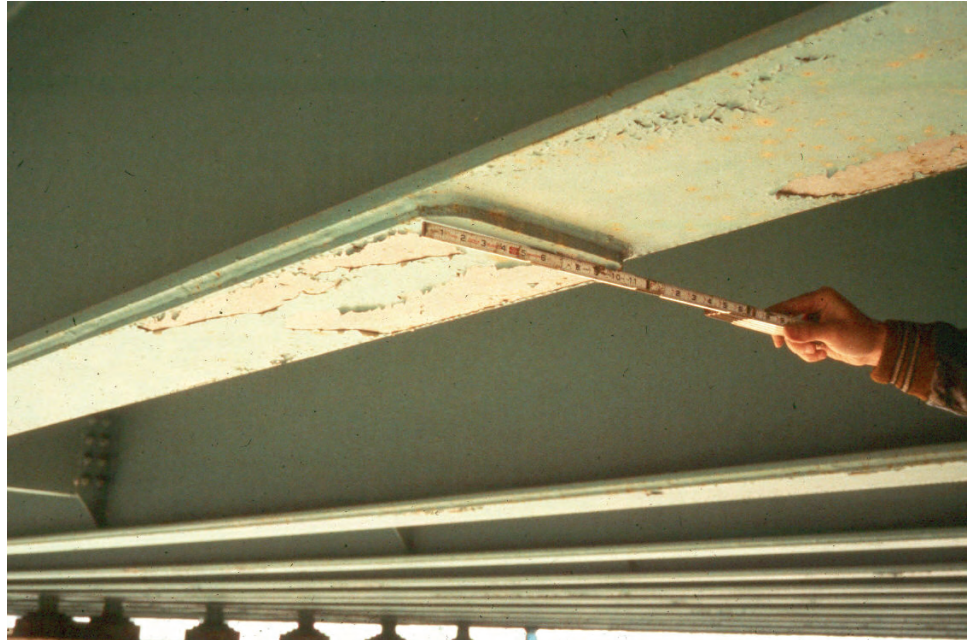
**Figure 8.2.3** Rolled Multi-beam Bridge with a Cover Plate

In the past, a common method of economically increasing the capacity of a rolled multi-beam bridge was to weld partial length cover plates to the flanges (see Figure 8.2.3). The cover plates increased a beam's bending strength. This practice also creates a fatigue prone detail in the tension flange, which may lead to cracking. The cover plates are attached by riveting or welding. Fatigue cracking occurs in the beam flanges at the ends of partial length cover plates.

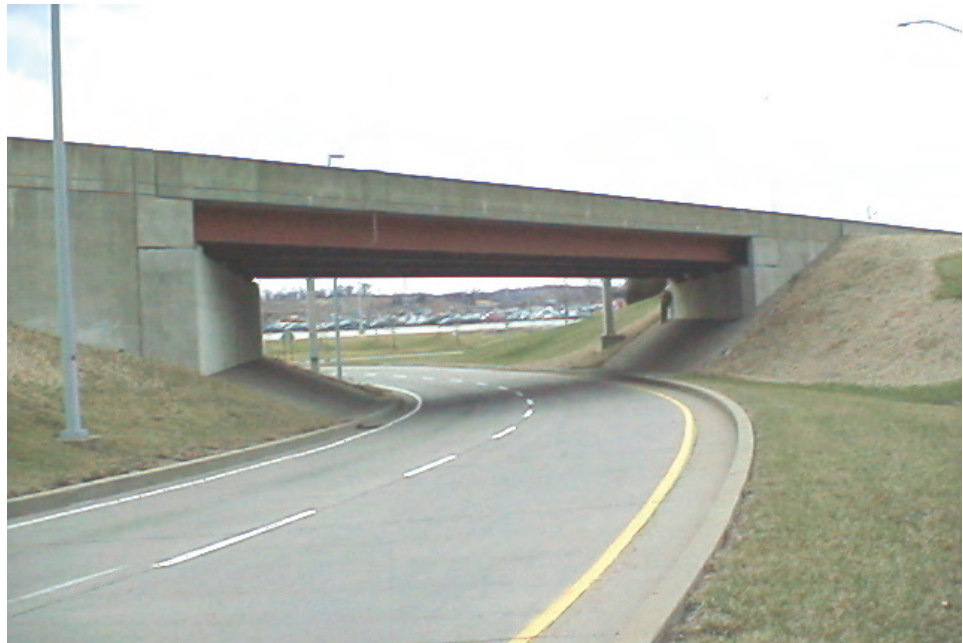
**Figure 8.2.6** Single Span Fabricated Multi-girder Bridge

This bridge type can be found in single span (see Figure 8.2.6), multiple span, and continuous span designs (see Figure 8.2.7), and it is widely used when curved bridges are required (see Figure 8.2.8). Continuous welded multi-girders have been built for spans of over 152 m (500 feet). Pin and hanger connections are also found in multi-girder construction (see Figure 8.2.9).

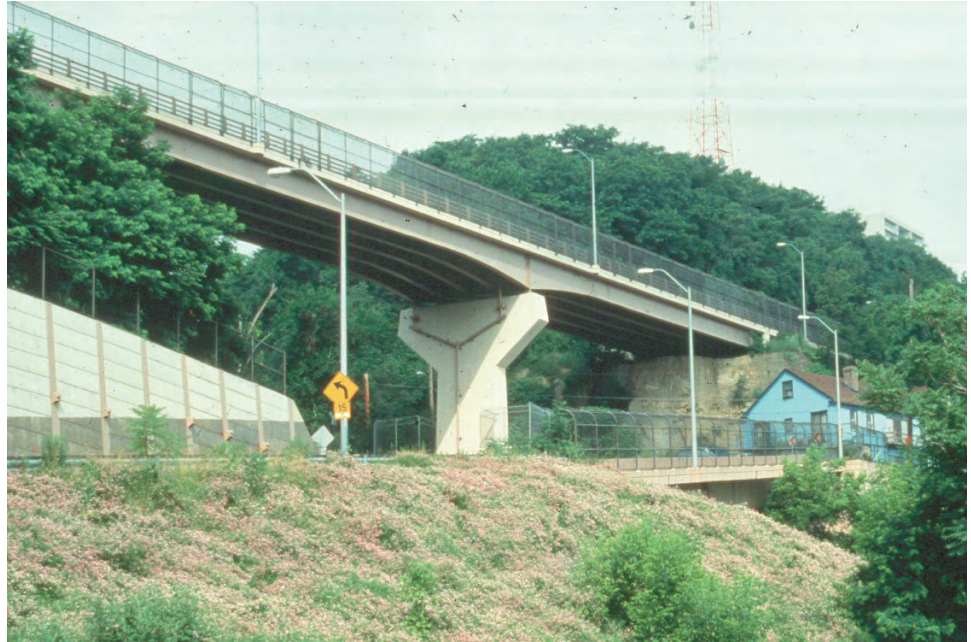
**Figure 8.2.7** Continuous Span Fabricated Multi-girder Bridge

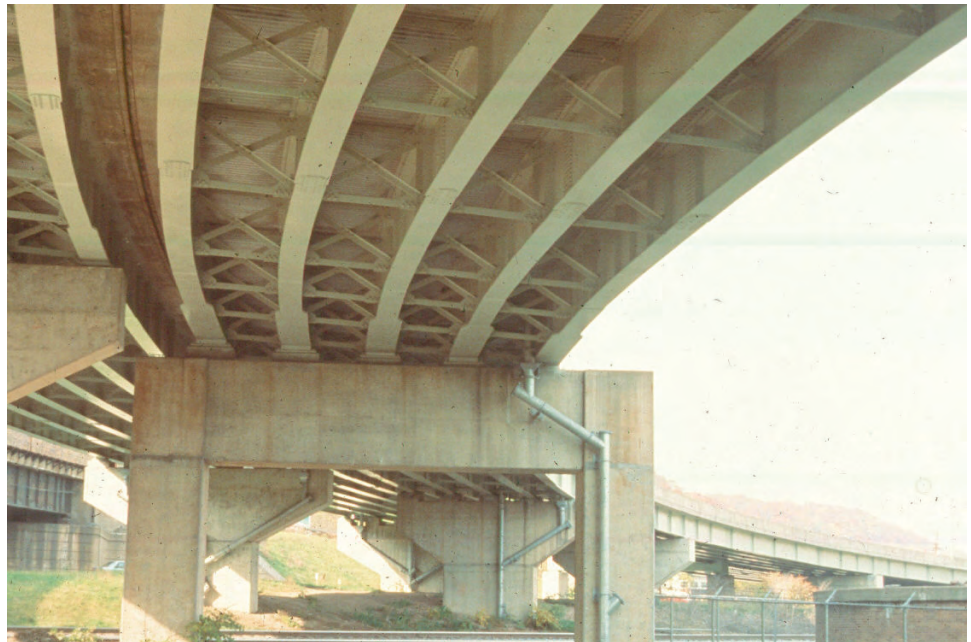
**Figure 8.2.8** Curved Fabricated Multi-girder Bridge

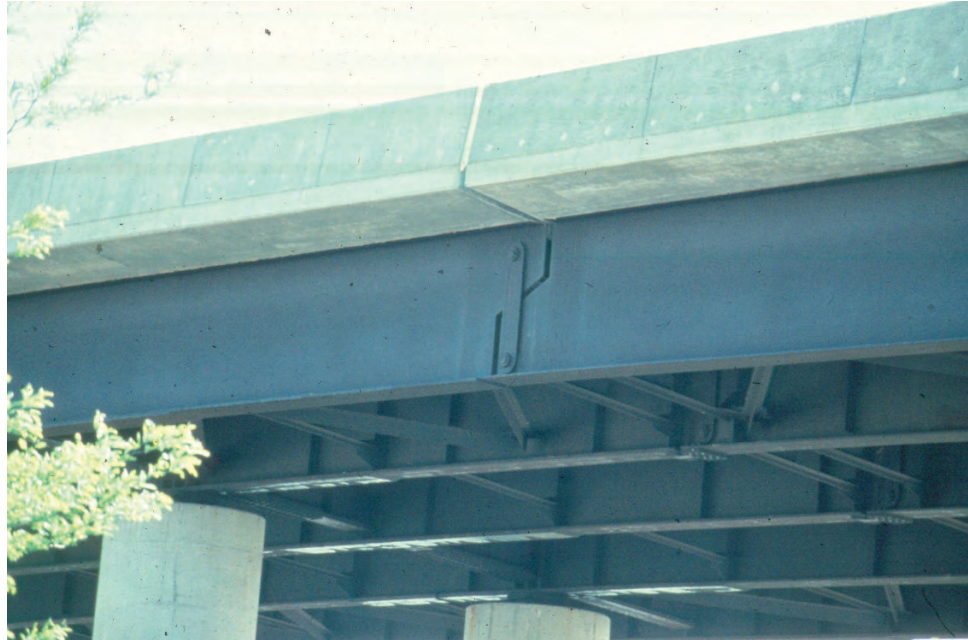
**Figure 8.2.9** Fabricated Multi-girder Bridge with Pin & Hanger Connection

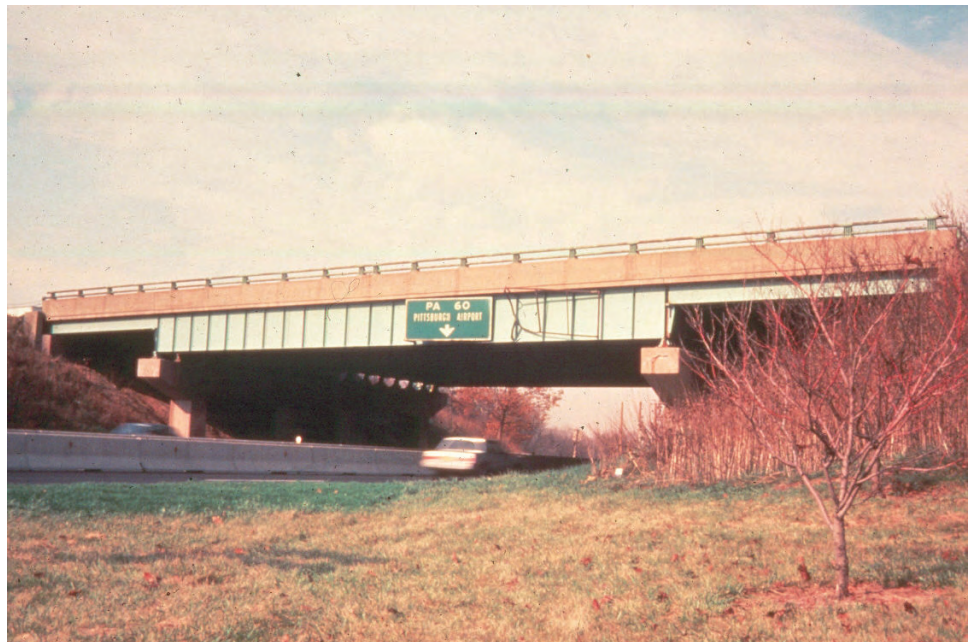
**Figure 8.2.10** Combination Rolled Beams and Fabricated Girders

Sometimes, both types of superstructure, rolled steel beams and fabricated steel girders can be used on the same bridge (see Figure 8.2.10). The shorter approach spans are rolled beams while the longer main span utilizes fabricated girders.

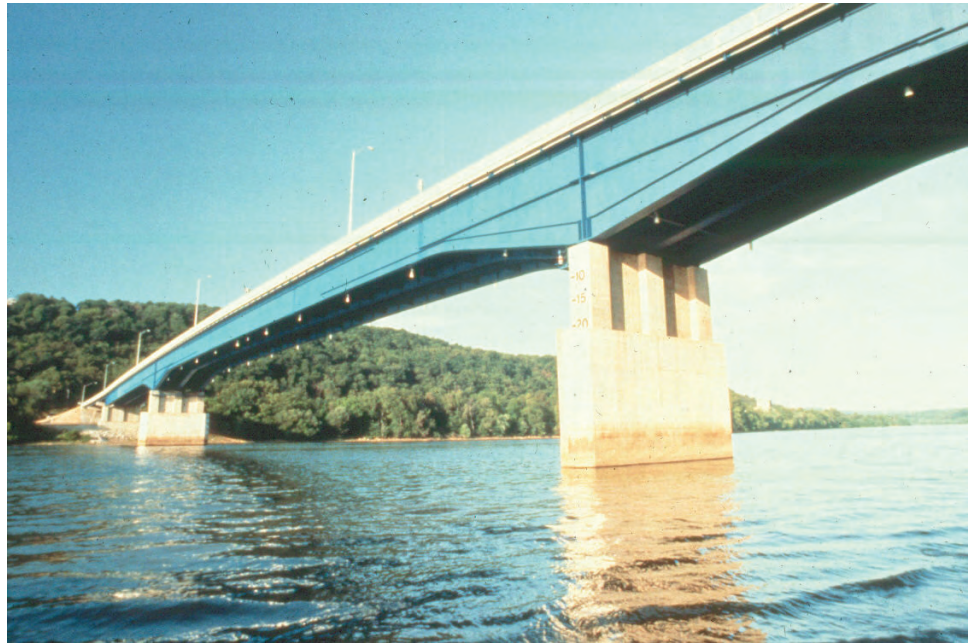
**Figure 8.2.12** Fabricated Variable Depth Girder Bridge

A fabricated variable depth girder is the method used today (see Figure 8.2.12). The web plate is simply fabricated to the required depth. The top and bottom flange plates are then welded to the web plate.

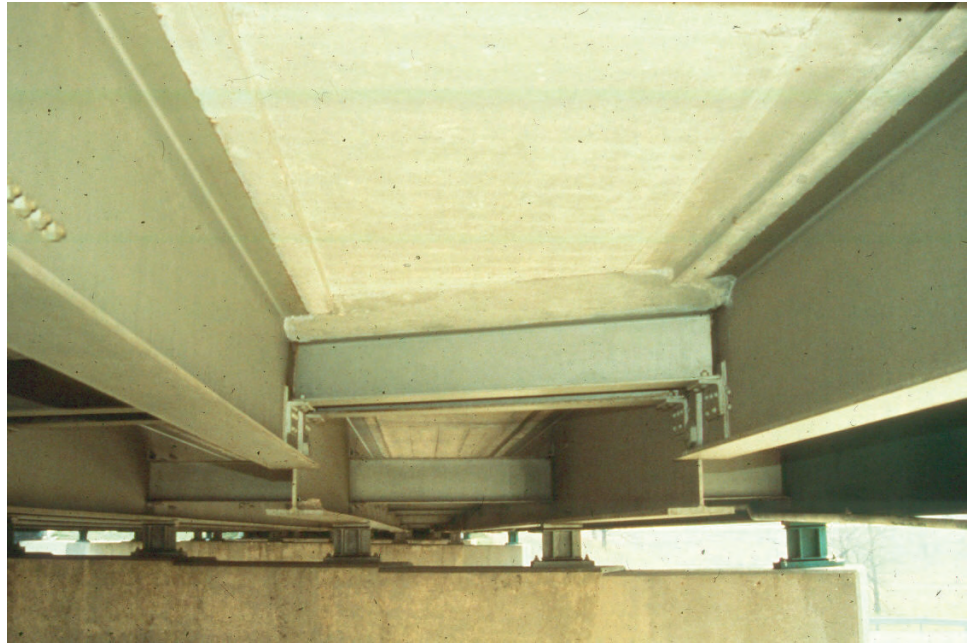
**Figure 8.2.13** Rolled Beam (Primary Member) with Diaphragm (Secondary Member)

The primary members of a rolled multi-beam bridge are the rolled beams, and the secondary members are the diaphragms (see Figure 8.2.13). Intermediate and end diaphragms are provided to stabilize the beams during construction and to help distribute the live load more evenly to the rolled beams. Diaphragms may or may not be present on the multi-beam bridge.

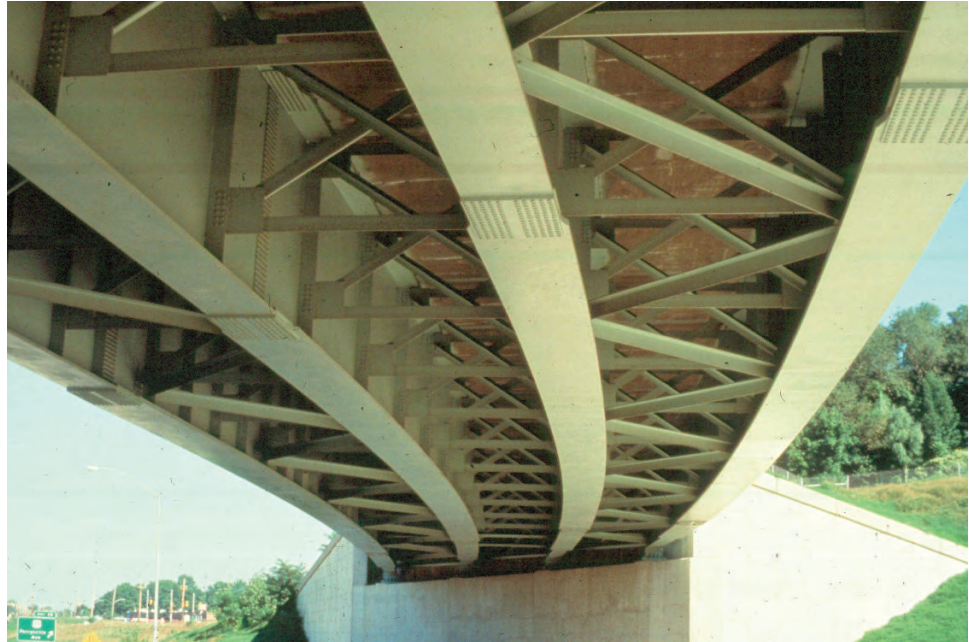
**Figure 8.2.14** Curved Multi-girder Bridge

The primary members of a fabricated multi-girder bridge are the fabricated girders, as well as the diaphragms on a curved bridge. In the case of a curved structure, the diaphragms are designed to withstand the torsional loading attributed to curved structures and therefore, are also considered primary members (see Figure 8.2.14).

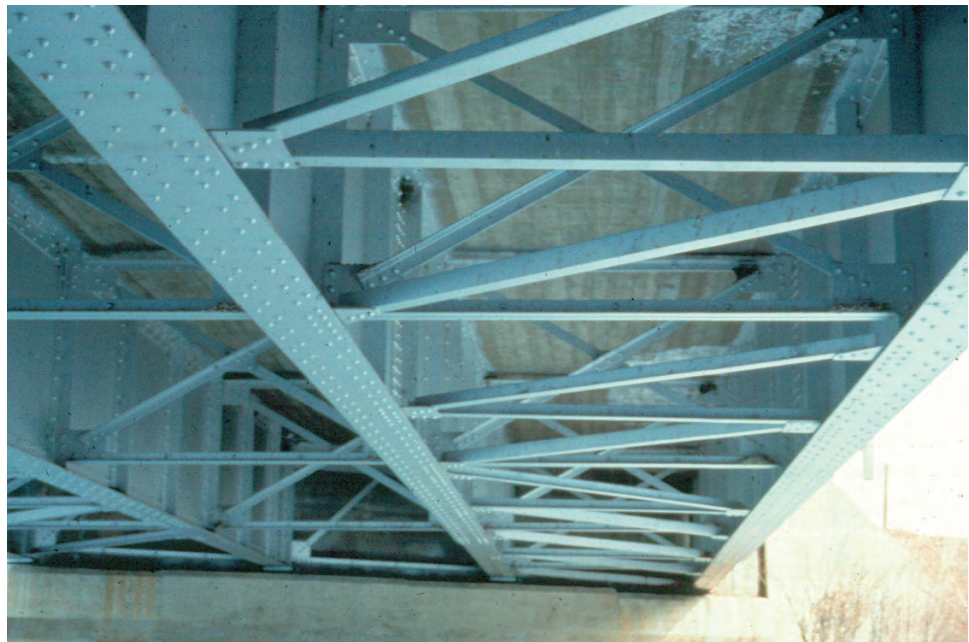
**Figure 8.2.15** Straight Multi-girder Bridge

On straight multi-girder bridges, diaphragms are considered secondary members. Similar to rolled beam bridges, diaphragms are provided to stabilize the girders during construction and to help distribute secondary live load (see Figure 8.2.15). Diaphragms can be rolled shapes (e.g., I-beams and channels) or they can be cross frames constructed from angles, tee shapes, and plates. They are usually attached to transverse web stiffeners which are normally referred to as connection plates. On older bridges, secondary members also include lateral bracing. Current design specifications discourage the use of lateral bracing. This is due to connections for lateral bracing being fatigue-prone.

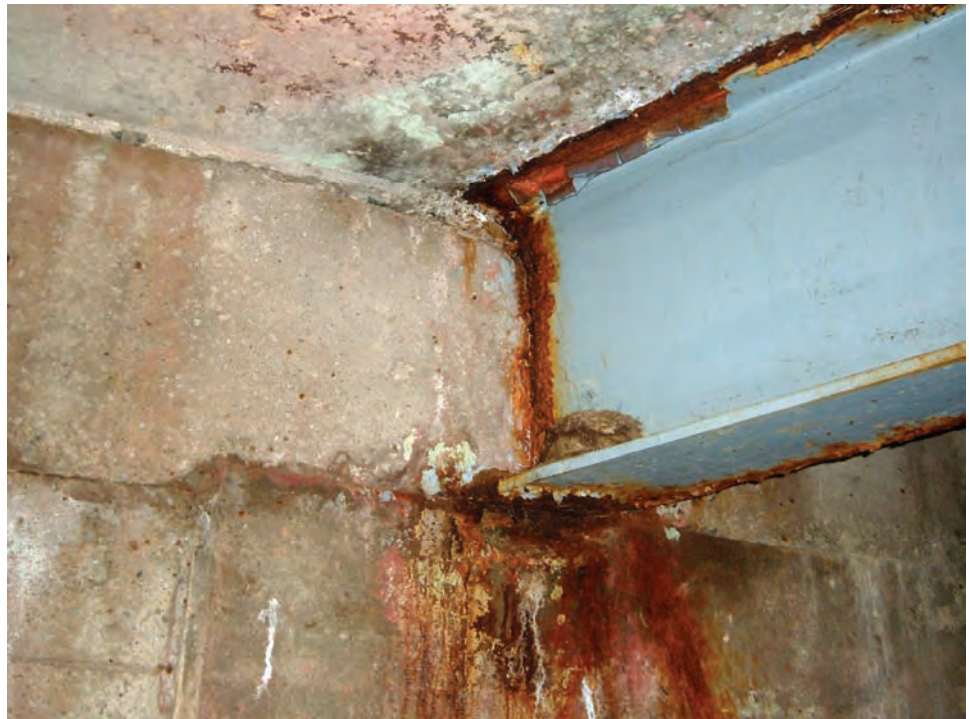
**Figure 8.2.16** Corroded Shear Zone on a Rolled Multi-beam Bridge

Examine the web areas near the supports for any section loss or buckling (see Figure 8.2.16). Shear stresses are greatest near the supports. Therefore, the condition of the web is more critical near the supports than at mid-span. Also investigate the web for buckling due to overloads. If girders have been haunched by the use of insert plates, check the weld between the web and the insert plate.

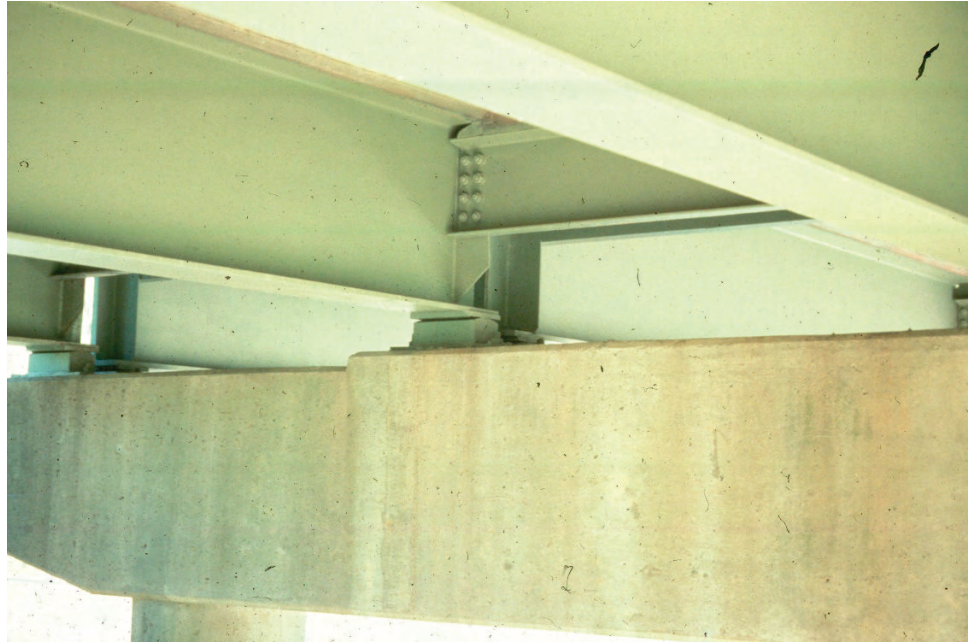
**Figure 8.2.21** End Diaphragm

Examine the diaphragm and bracing connections for loose fasteners or cracked welds (see Figures 8.2.21 and 8.2.22). This problem is most common on skewed bridges, and it has also been observed on bridges with a high frequency of combination truck loads. Check horizontal connection plates, which can trap debris and moisture and are susceptible to a high degree of corrosion and

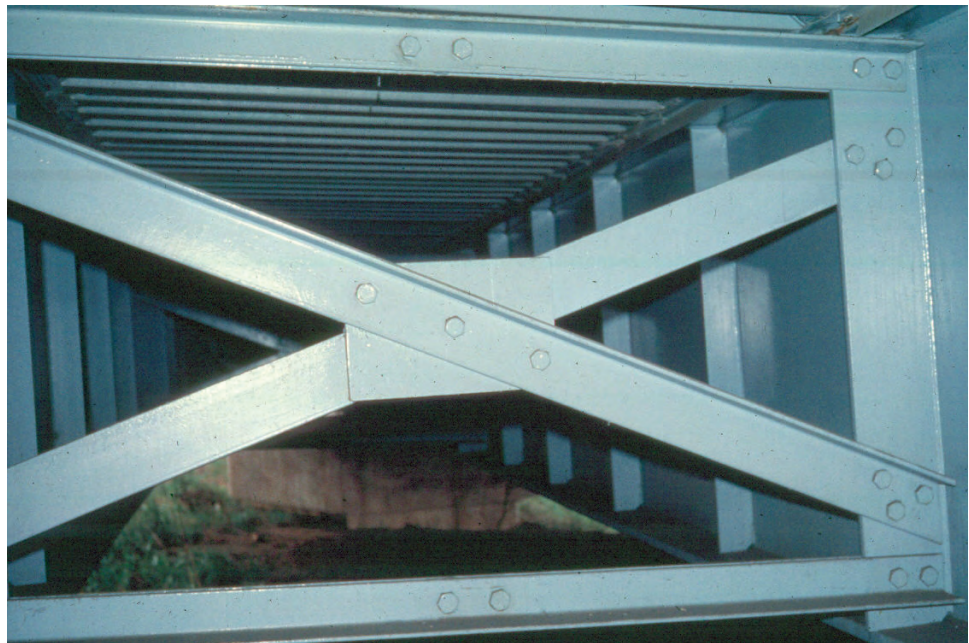
**Figure 8.2.22** Intermediate Diaphragm

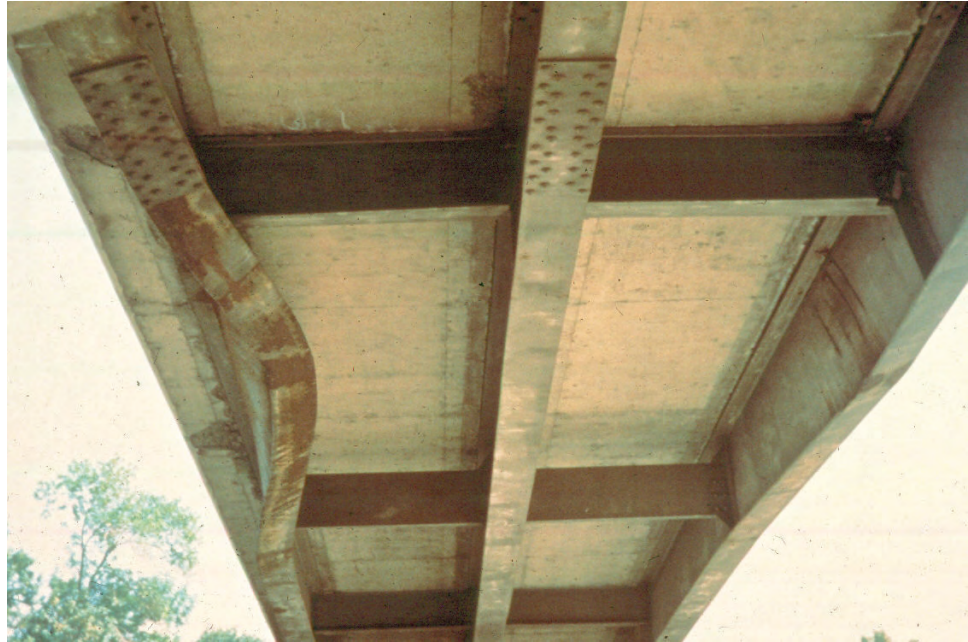
**Figure 8.2.24** Collision Damage on a Fabricated Multi-girder Bridge

Check underneath the bridge for collision damage to the main girders and bracing if the bridge crosses over a highway, railway, or navigable channel. Document any cracks, section loss, or distortion found (see Figures 8.2.23 and 8.2.24).

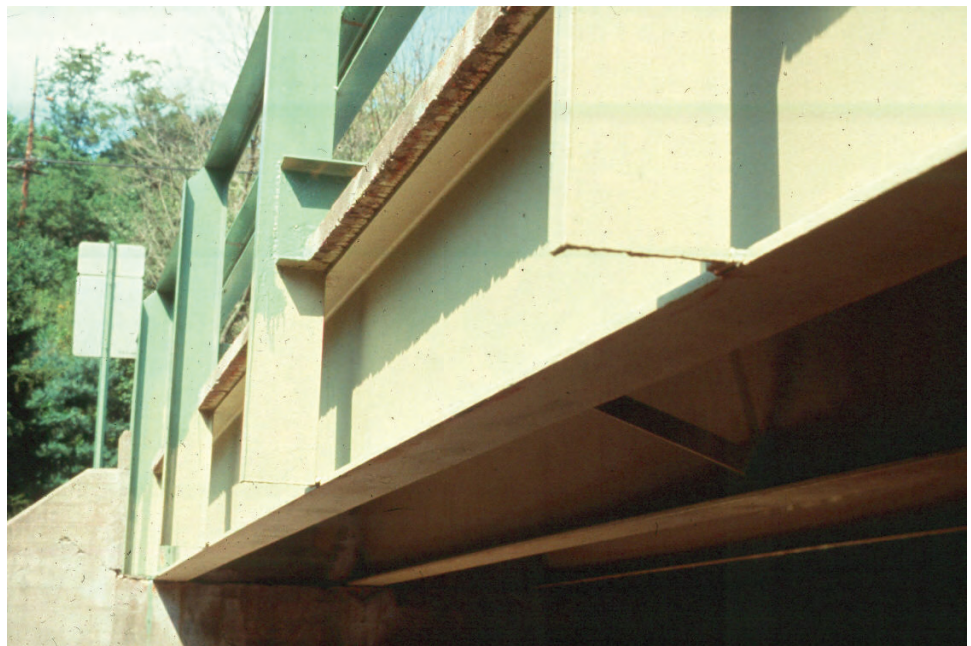
**Figure 8.2.26** Welded Attachment in Tension Zone of a Beam

If the structure has been painted, breaks in the paint accompanied by rust staining indicate the possible existence of a fatigue crack. Investigate the areas surrounding field splice plates on the tension flange (see Figure 8.2.25). The suspected crack area should be cleaned to determine the existence of a crack and its extent. If a crack with rust staining exists in the paint, the fatigue cracks in the steel can already be up to 6 mm (1/4 inch) deep in the beam flange. Check any attachment welds located in the superstructure tension zones, such as traffic safety features, lighting brackets, utility attachments, catwalks and signs (see Figure 8.2.26).

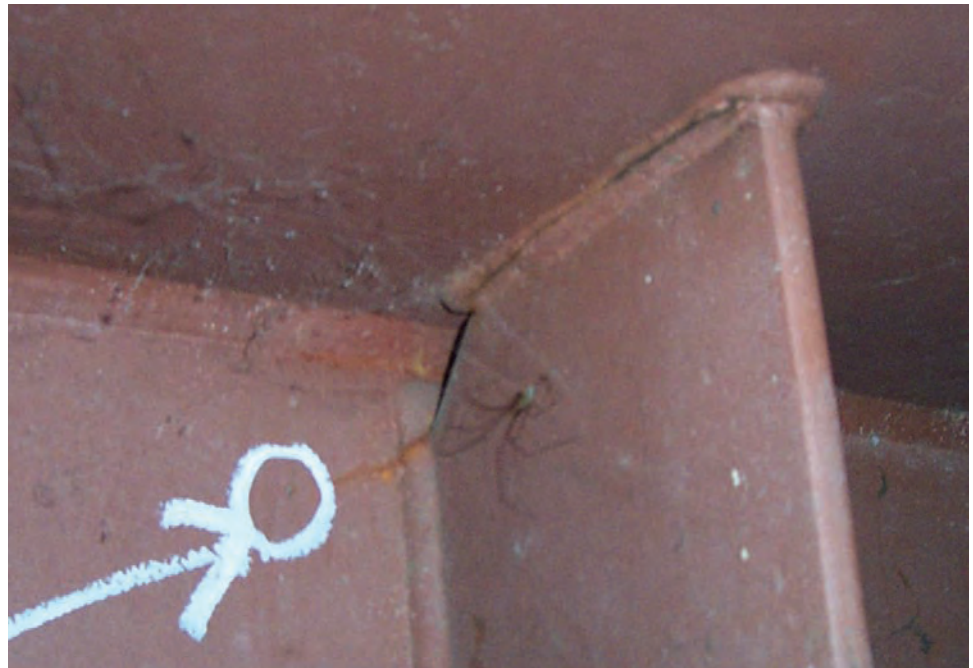
**Figure 8.2.28** Web Crack due to Out-of-plane Distortion at Top Flange

Connection plate at top flange - One type of connection detail which has incurred a large number of fatigue cracks is the end of diaphragm connection plates which are not attached to the top tension flange of continuous girder bridges. While the top flange is rigidly embedded in the bridge deck slab, and the connection plate itself is stiff enough to resist rotation and bending from the diaphragm, most of the out-of-plane distortions (perpendicular to the web) concentrate in the local region of the web above the upper end of the connection plate. Fatigue cracks develop in this region as a result of the web plate bending. The cracks are usually horizontal along the web-to-flange weld, and also propagate as an upside down U along the upper ends of the fillet welds of the connection plate. Detection of cracks of such length is not difficult. Knowing that unattached ends of diaphragm connection plates are likely locations of fatigue cracks increases the certainty of early detection of these cracks (see Figures 8.2.27 and 8.2.28).

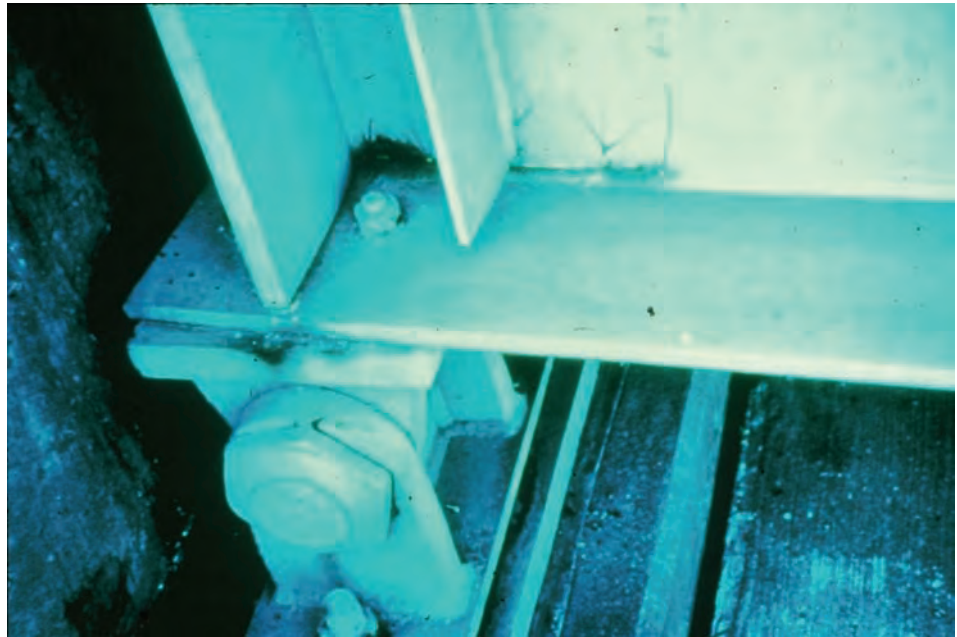
**Figure 8.2.29** Web Crack due to Out-of-plane Distortion at Bottom Flange

Connection plate at bottom flange - At the lower end of diaphragm connection plates which are not welded to the tension flange of girders, the condition of local out-of-plane distortion and bending of the web plate usually is less severe. This is because the tension flange is not restrained from lateral movement, which is sufficient to reduce the web plate bending. However, if the bottom flange is restrained from lateral deflection (e.g., at bearings), fatigue cracks will develop along the web to flange weld (see Figure 8.2.29).
