Section 8 Inspection and Evaluation of Common Steel Superstructures

SECTION 8: Inspection and Evaluation of Common Steel Superstructures
TOPIC 8.3: Steel Two-Girder Systems

Topic 8.3 Steel Two Girder Systems

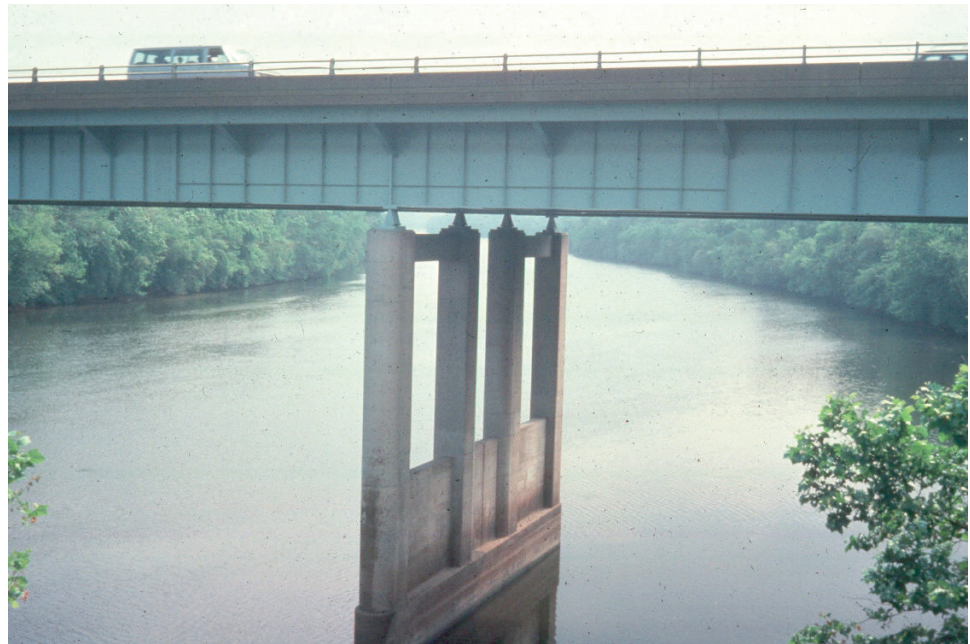
Figure 8.3.1 General View of a Dual Deck Girder Bridge

The steel two girder bridge, like the fabricated multi-girder bridge, can use either riveted or welded construction. The difference is that it has only two girders. Two girder bridges can also have features similar to those of fabricated multi-girder bridges, such as web insert plates, transverse web stiffeners, and longitudinal web stiffeners (see Figure 8.3.1).

In a deck girder system, the deck is supported by the floor system and top flanges of the two girders (see Figure 8.3.1). In a through girder system, the deck is supported by the floor system between the two girders (see Figure 8.3.2).

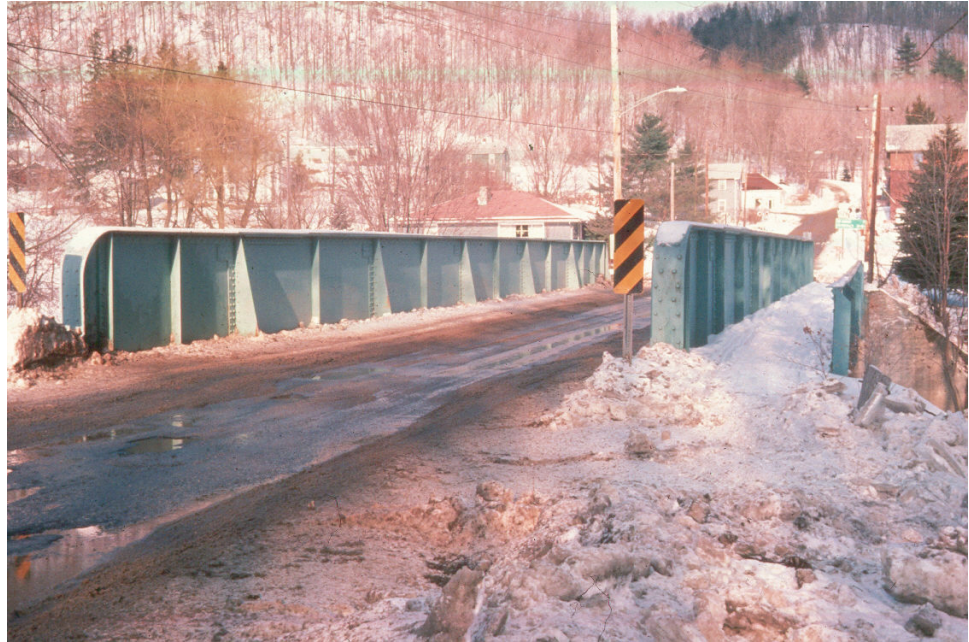
Figure 8.3.2 Through Girder Bridge

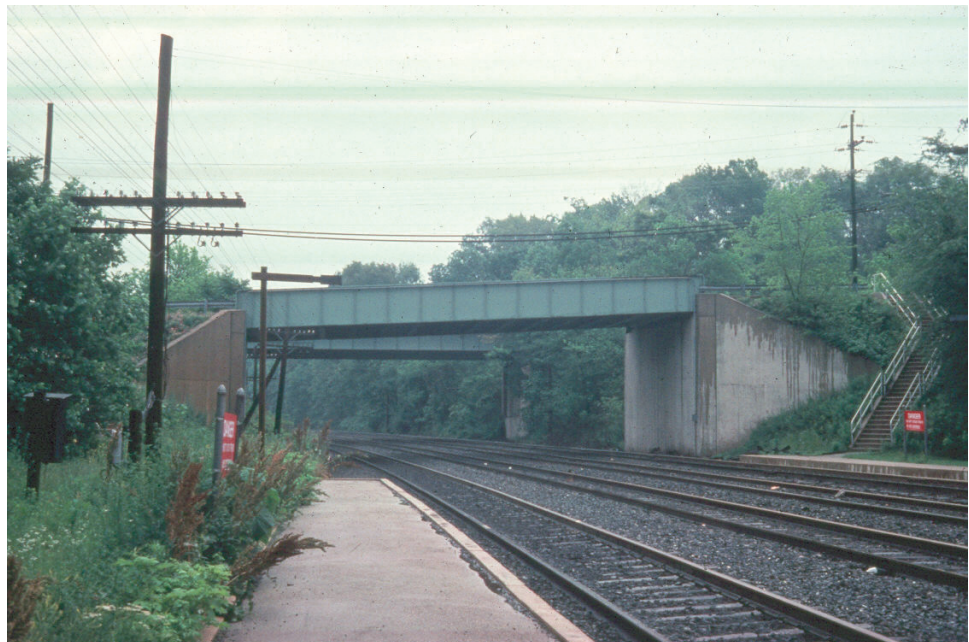
Figure 8.3.3 Through Girder Bridge with Limited Underclearance

While few through girders are constructed today, they were commonly used prior to the early 1950's. Since many through girder bridges were constructed in the 1940's and 1950's, they are commonly riveted. Their most common use was where vertical under-clearance was a concern, such as over railroads (see Figure 8.3.3).

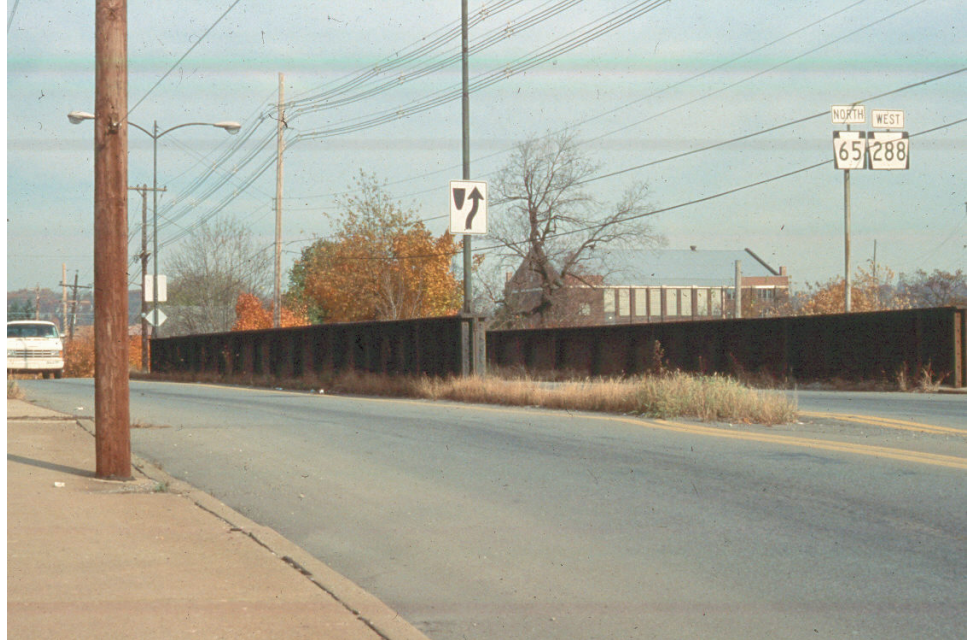
Figure 8.3.4 Through Girder Bridge with Three Girders

A rare type of through girder has three or more girders, with the main girders actually separating the traffic lanes (see Figure 8.3.4). These structures are most likely converted railroad or trolley bridges.

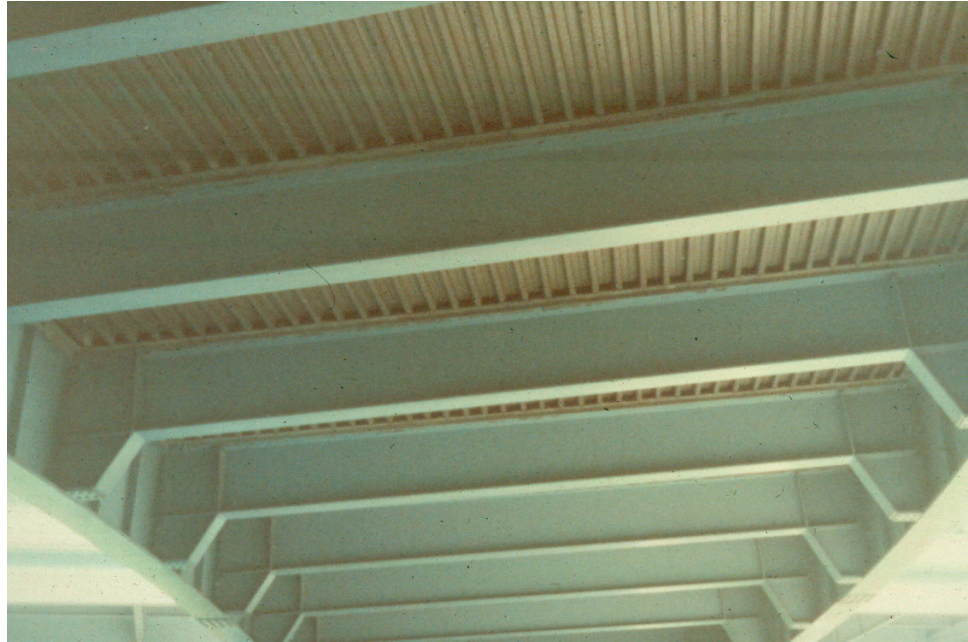
Figure 8.3.5 Two Girder Bridge with Girder-Floorbeam System

The girder-floorbeam (GF) system consists of floorbeams connected to the main girders. The floorbeams are considerably smaller than the girders and are perpendicular to traffic. The deck is supported by the floorbeams, which in turn transmit the loads to the main girders. The floorbeams can be either rolled beams, fabricated girders, or fabricated cross frames (see Figure 8.3.5).

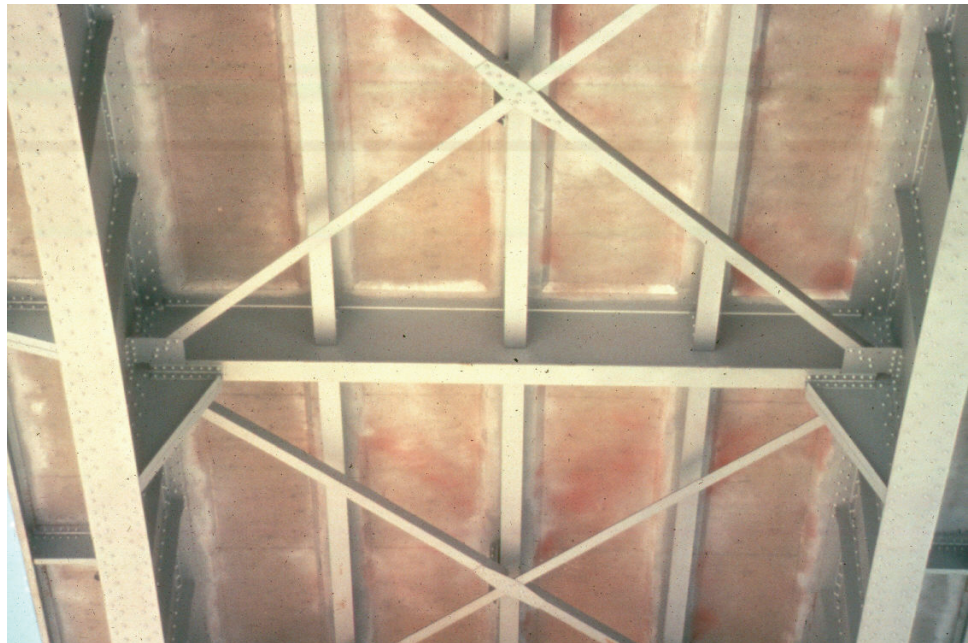
Figure 8.3.6 Two Girder Bridge with Girder-Floorbeam-Stringer System

The girder-floorbeam-stringer (GFS) system consists of floorbeams connected to the main girders, and longitudinal stringers, parallel to the main girders, connected to the floorbeams (see Figure 8.3.6). The stringers may either connect to the web of the floorbeams or be stacked on top of the floorbeams, in which case they may be continuous stringers. Stringers are usually rolled beams and are considerably smaller than the floorbeams. It is also possible to find floorbeams that are stacked on top of the main girders, and the floorbeams may extend or overhang from the girders (see Figure 8.3.7).

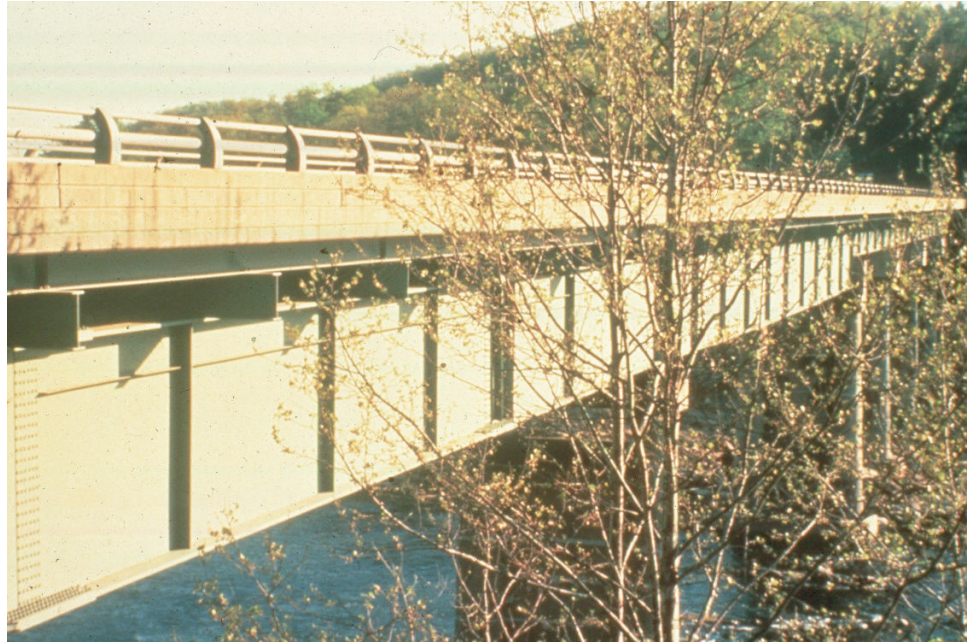
Figure 8.3.7 Two Girder Bridge with GFS System with Stacked Floorbeam and Stringers

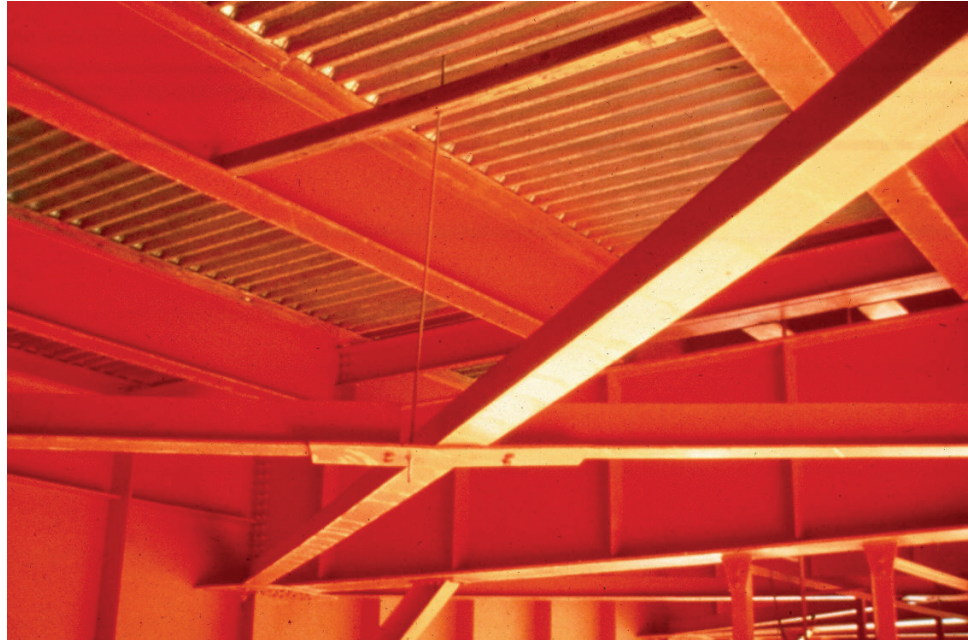
Figure 8.3.8 Underside View of Deck Girder Bridge with Lateral Bracing System

The primary members of a two girder bridge are the girders, floorbeams, and stringers, if present. The secondary members are diaphragms and the lateral bracing members, if present. These secondary members usually consist of angles or tee shapes placed diagonally in horizontal planes between the two main girders. The lateral bracing is generally in the plane of the bottom flange. Lateral bracing serves to minimize any differential longitudinal movement between the two girders (see Figure 8.3.8). Not all two girder bridges will have a lateral bracing system. Diaphragms, if present, are usually placed between stringers.

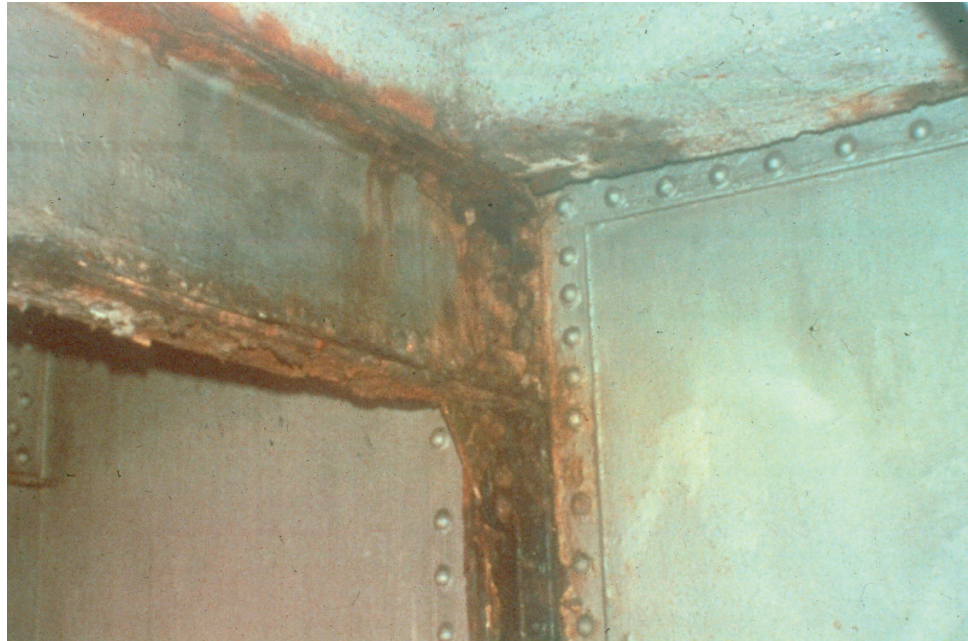
Figure 8.3.11 Shear Zone on a Deck Girder Bridge

Examine the web areas of the girders, floorbeams, and stringers near their supports for section loss or buckling (see Figures 8.3.11 and 8.3.12). This is a critical area, especially if the web is coped or the flange is blocked.

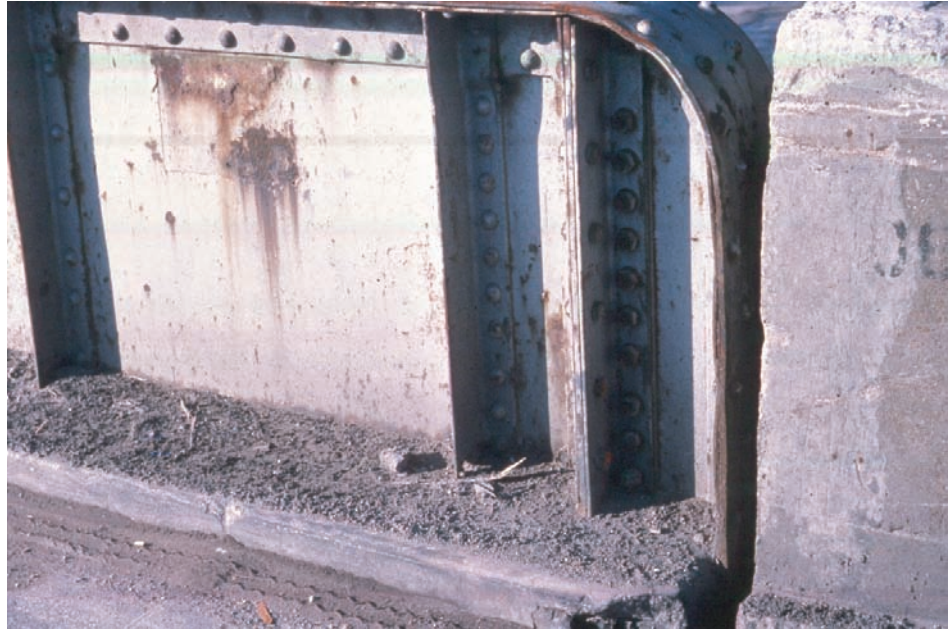
Figure 8.3.12 Web Area Near Support on a Through Girder Bridge

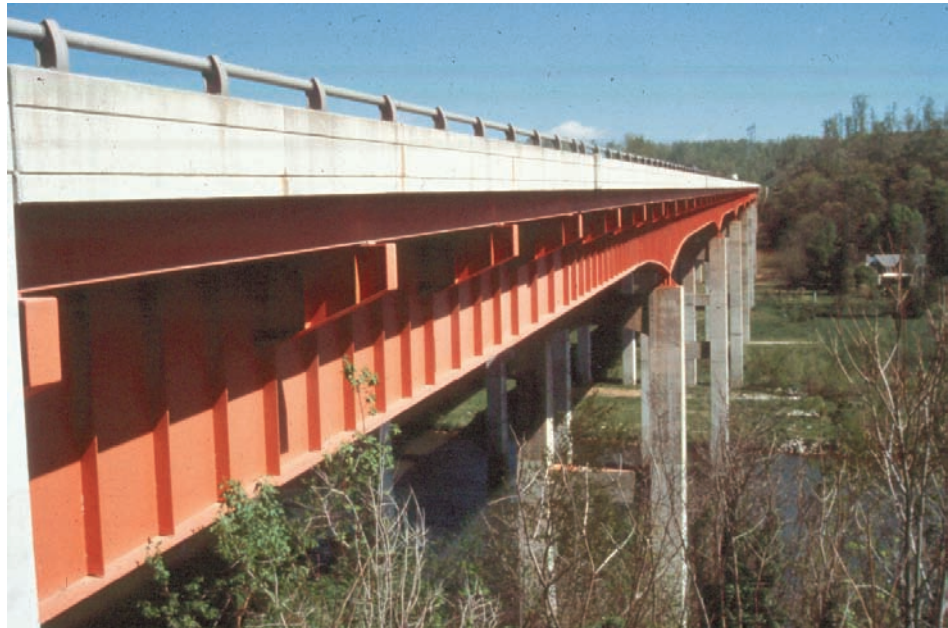
Figure 8.3.13 Flexural Zone on a Two Girder Bridge

The flexure zone of each girder includes the entire length between the supports (see Figures 8.3.13 and 8.3.15). Investigate the tension and compression flanges for corrosion, loss of section, cracks, dings, and gouges. Check the flanges in high stress areas for bending or flexure-related damage. Examine the compression flange for local buckling and, although it is uncommon, for elongation or fracture of the tension flange. On continuous spans, the beams over the intermediate supports have high flexural stresses due to negative moment. Check flange splice welds and longitudinal stiffener splice welds in tension areas (see Figure 8.3.14).

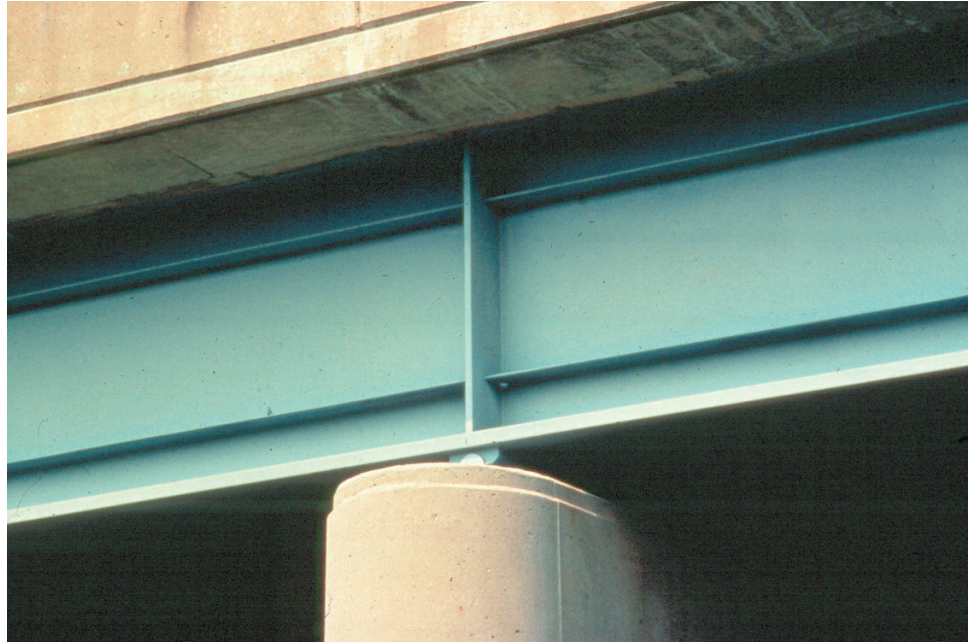
Figure 8.3.14 Longitudinal Stiffener in Tension Zone on a Two Girder Bridge

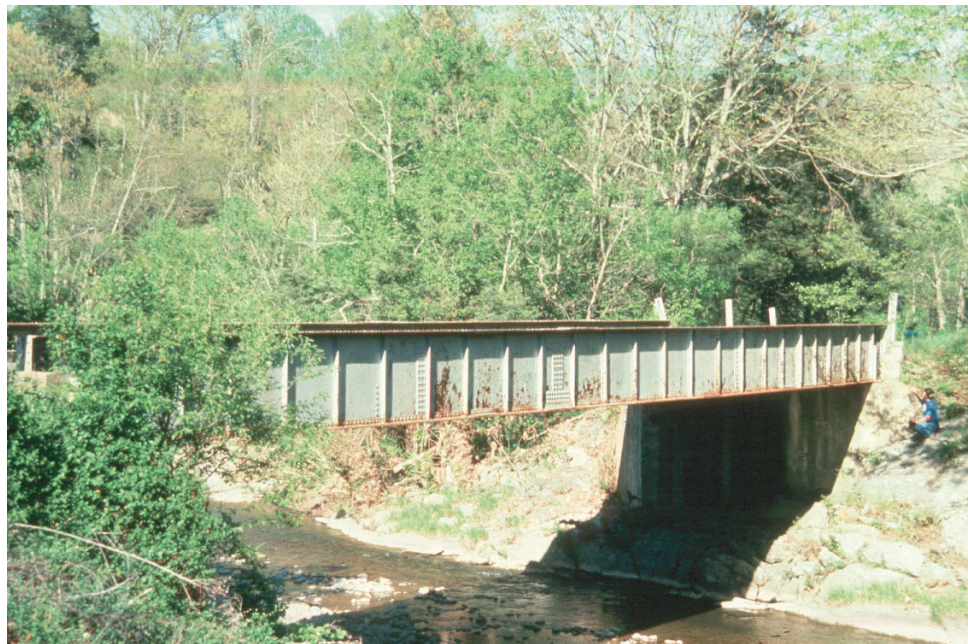
Figure 8.3.15 Flexural Zone on a Through Girder Bridge

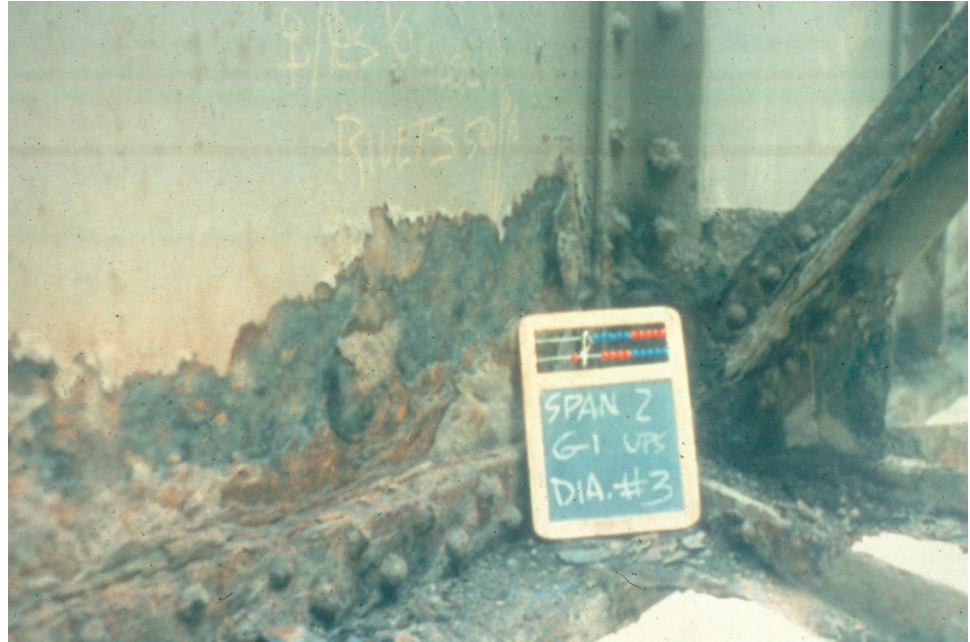
Figure 8.3.16 Lateral Bracing Connection on a Deck Girder Bridge

Investigate the diaphragms, if present, and the connection areas of the lateral bracing for cracked welds, fatigue cracks, and loose fasteners. Inspect the bracing members for any distortion or corrosion (see Figures 8.3.16 and 8.3.17). Distorted or cracked secondary members may be an indication the primary members may be overstressed or the substructure may be experiencing differential settlement.

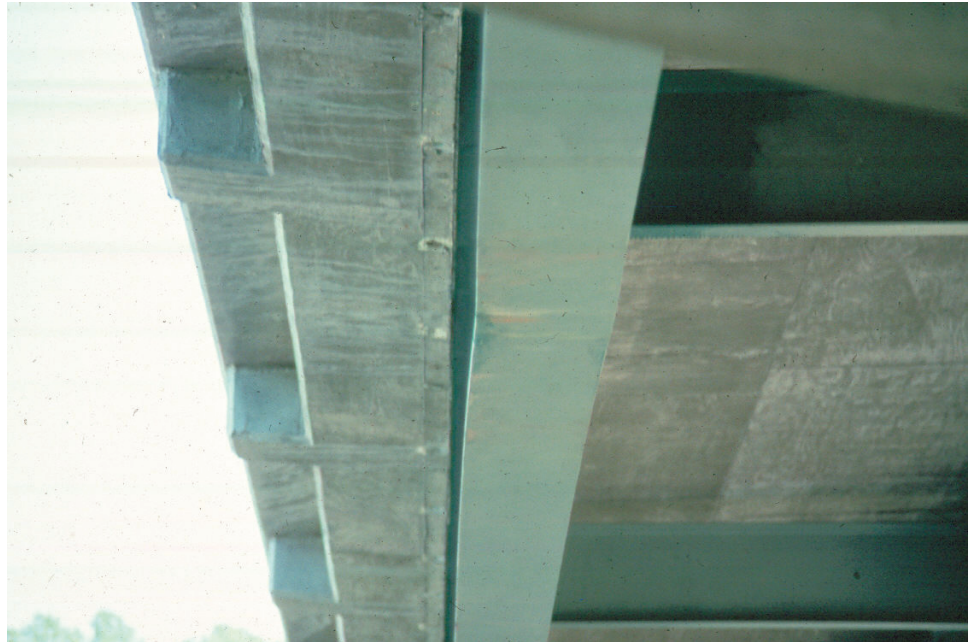
Figure 8.3.18 Collision Damage to a Two Girder Bridge

Check underneath the bridge for collision damage to the main girders and bracing if the bridge crosses over a highway, railway, or navigable channel. Document any cracks, section loss, or distortion found (see Figures 8.3.18 and 8.3.19). On a through girder bridge, investigate the main girders along the curb lines and at the ends for collision damage.

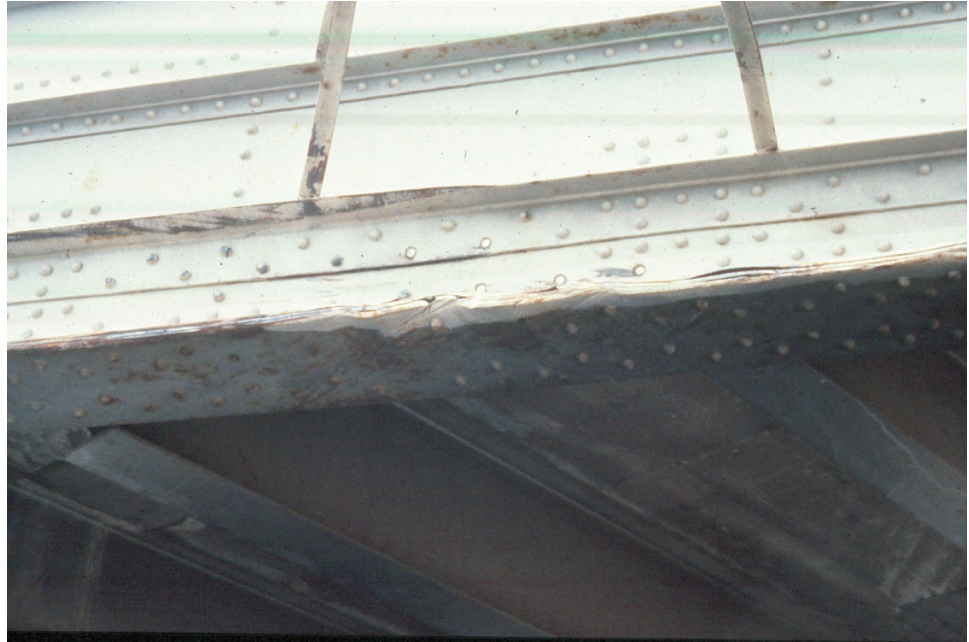
Figure 8.3.19 Collision Damage to a Through Girder Bridge

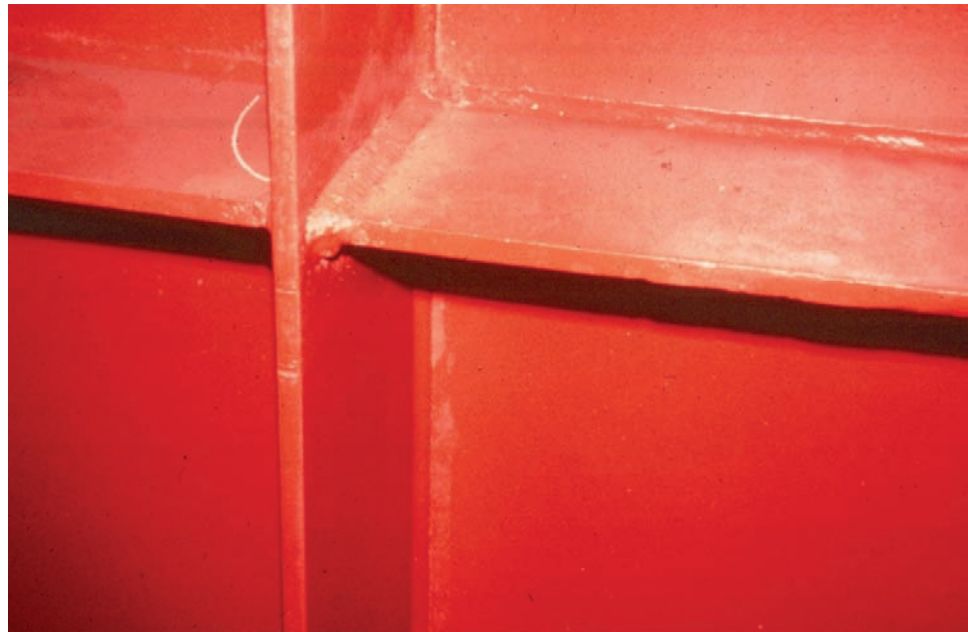
Figure 8.3.21 Intersecting Welds

Check web stiffener welds, welded web/flange splices, and intersecting welds (see Figures 8.3.20 and 8.3.21). Also inspect any attachment welds located in the tension zone of the girder and floorbeam bracket tie plate (see Figure 8.3.22), especially unplanned miscellaneous attachment welds, such as utility brackets.

If the structure has been painted, breaks in the paint accompanied by rust staining indicate the possible existence of a fatigue crack. Investigate the areas surrounding field splice cover plates on the tension flange. The suspected crack area should be cleaned to determine the existence of a crack and its extent. If a crack with rust staining exists in the paint, the fatigue cracks in the steel can already be up to 6 mm (1/4 inch) deep in the beam flange. Check any attachment welds located in the superstructure tension zones, such as traffic safety features, lighting brackets, utility attachments, catwalks and signs. Welds are considered to be intersecting if they are within 6 mm (1/4 inch) from each other (see Figure 8.3.21).

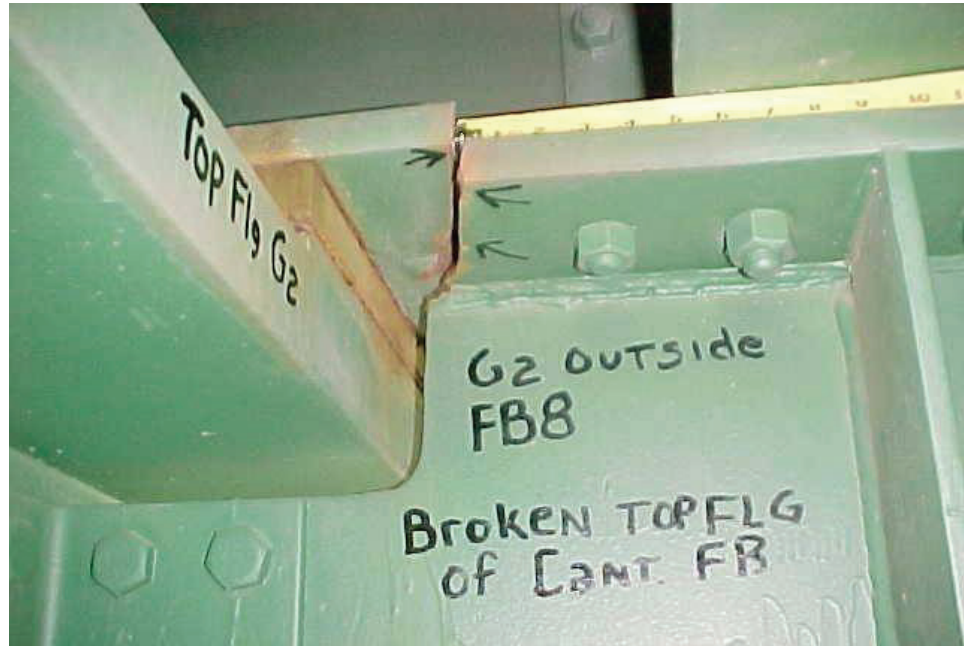
Figure 8.3.28 Cracked Cantilever Floorbeam

The floorbeam may be connected to the girder web (see Figure 8.3.28). Inspect for cracks in the floorbeam and girder. A tie plate may be utilized to reduce the fatigue stresses in the floorbeam/girder connection (see Figure 8.3.29). Carefully inspect the tie plate for fatigue cracking.

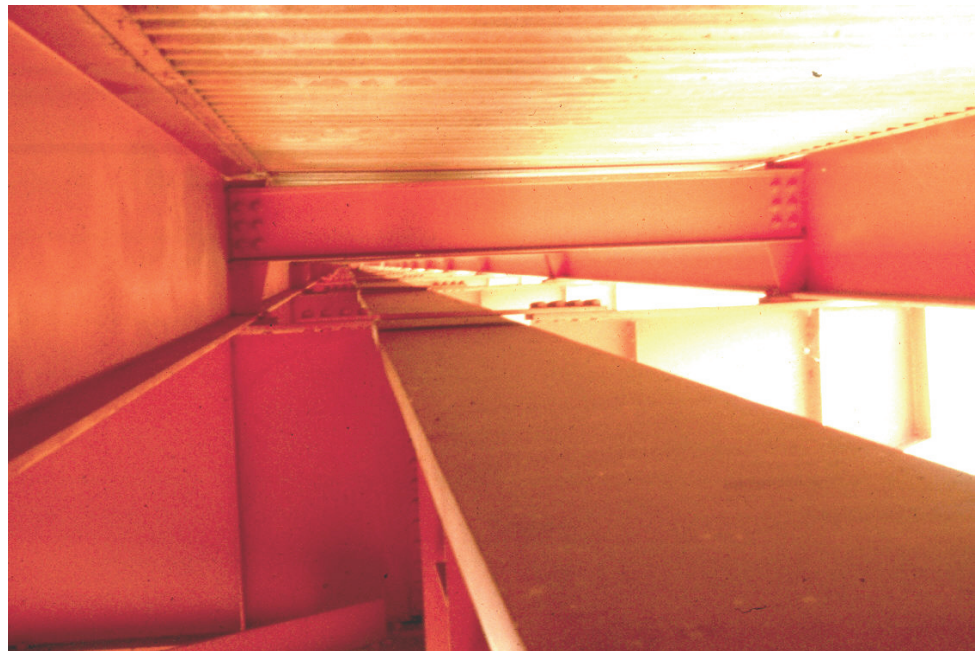
Figure 8.3.29 Tie Plate for Cantilever Floorbeam
