Impact of Vegetation on Earthen Dams

**"Technical Manual for Dam Owners: Impact of Plants on Earthen
Dams"**

Pub. # FEMA 534

Impacts of Plants on Earthen Dams

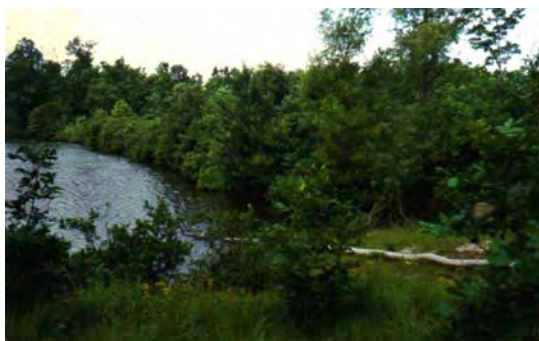
Figure 3. Example dam with inspection-hindering trees in Tennessee.

The problem most commonly noted by state officials is that trees, woody vegetation, briars, and vines interfere with effective safety inspections. Figure 3 illustrates this problem for a dam located in Tennessee.

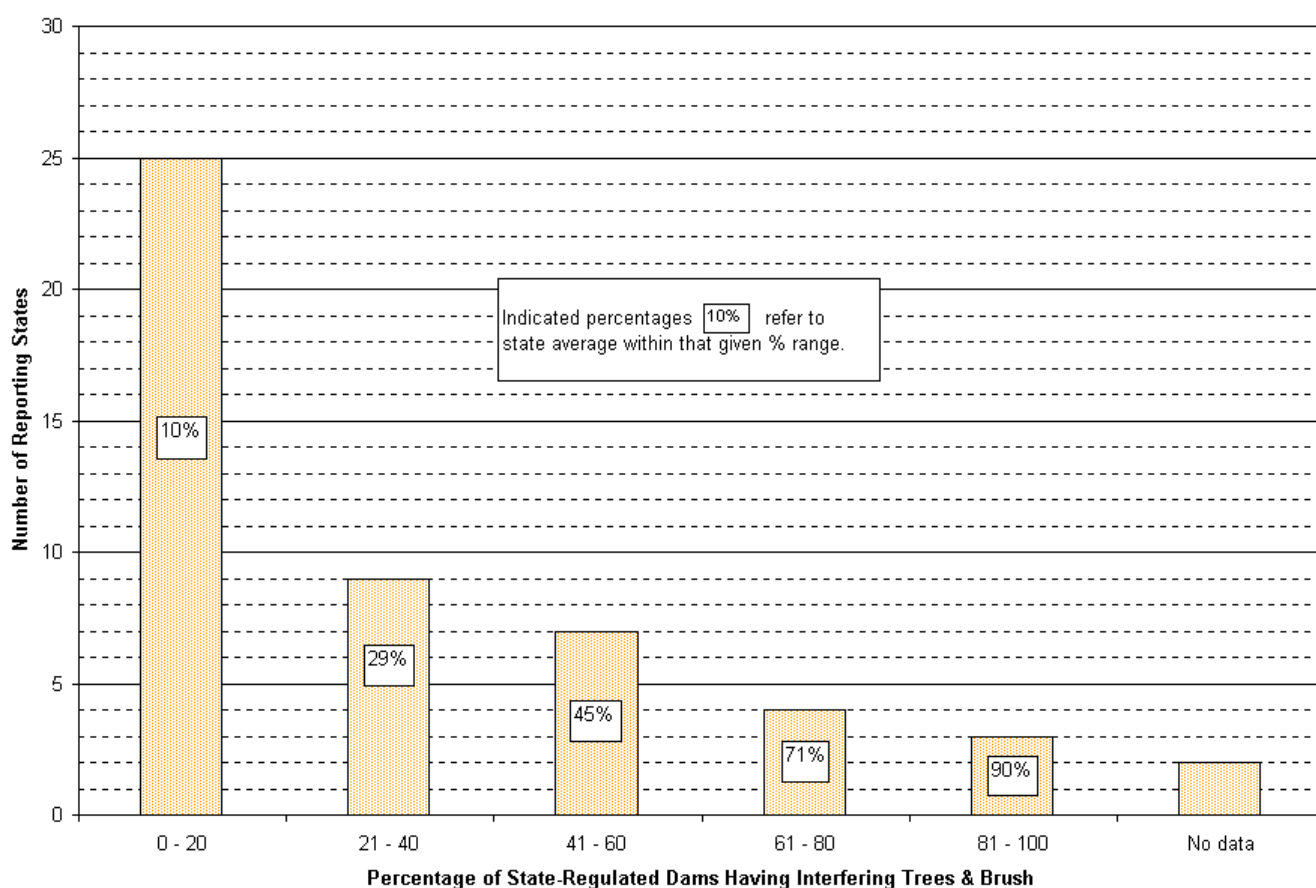
Figure 4. Estimated percentages of state-regulated dams where trees and brush are considered a deterrent to effective safety inspections.

Figure 4 gives a breakdown of the percentage ranges of regulated dams where the 48 reporting state dam safety officials shown in Figure 1 estimate that trees and brush hinder safety inspections in their respective states (ASDSO, 1999). While half the states report having only 20 percent or fewer dams with significant trees and woody vegetation that hinder inspections, vegetation on an estimated 30,000 or nearly a third of the collective state-regulated dams, is reported to obstruct effective dam safety inspections.

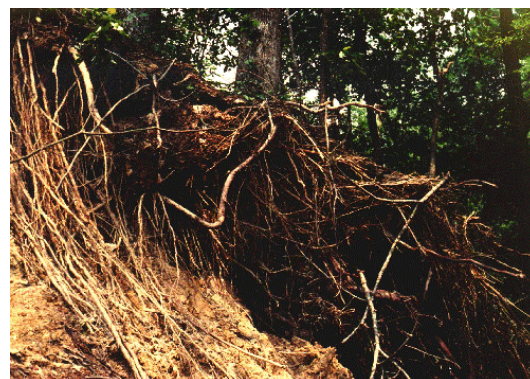
Figure 8. Exposed tree roots in overtopped dam.

Twenty-nine states indicated documented evidence where vegetation on dams has either caused dam failure or negatively affected their safe operation. Sixteen states had no documented evidence and five states had no response. Several states provided photos (Figure 8) and information on tree caused failures or dam

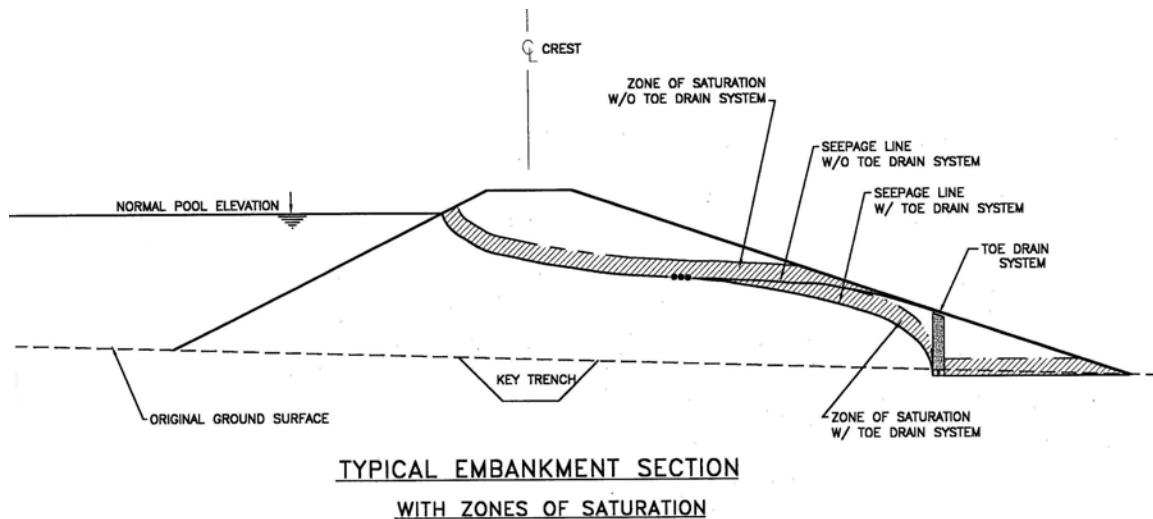
Important moisture regimes other than the steady-state seepage line (phreatic surface) are often not given proper consideration in the evaluation of the performance of earthen dams. The *zone of saturation* is located immediately above the phreatic surface or seepage line where embankment fill soils have become saturated as a result of capillary rise caused by capillary forces in the soil voids. Figure 3 illustrates the presence of zones of saturation associated with that of a theoretical seepage line location without an embankment subdrain system as well as that of a modified seepage line location with an embankment toe drain system. The height of capillary rise (thickness of the zone of saturation) is directly dependent upon the effective mean diameter of soil voids within the earthen dam embankment. The effective mean diameter of compacted soil is dependent upon the *effective particle size* (D_e) of the compacted embankment fill soil. Soil within

the zone of saturation is completely saturated; however, there is no flow or gravity induced movement of water unless some external force disturbs the soil. This phenomenon is often observable during the inspection of downstream slopes of earthen

dams. Seepage and free flowing water can be seen on the downstream slope of an older dam below the point of interception of the seepage line if no embankment subdrain is present. Above the point of interception of the seepage line with the downstream slope, the soil is saturated and the Zone of Saturation can be observed for a significant distance above the seepage line intercept in some cases. In the Zone of Saturation, pore water may be observed to fill tracks made in the water-softened embankment soil. However, once the tracks are filled by pore water released from the disturbed soil there will be no continued flow or seepage from the embankment. This condition is often confused with the presence of embankment seepage. Installation of a subdrain location in this situation may lower the phreatic surface relatively quickly; however, months or even years may be required to drain the zone of saturation because of tensile forces or negative pore pressures in the embankment fill soils.

The estimated maximum steady-state seepage rate for the example dam will be about 5.5 gallons per day per foot of dam. Before leaving Figure 5, imagine that the example dam contains an embankment subdrain system as indicated in Figures 2 and 3. The rate of progression of the line of wetting and the line of saturation will both be affected by the presence of the subdrain system.

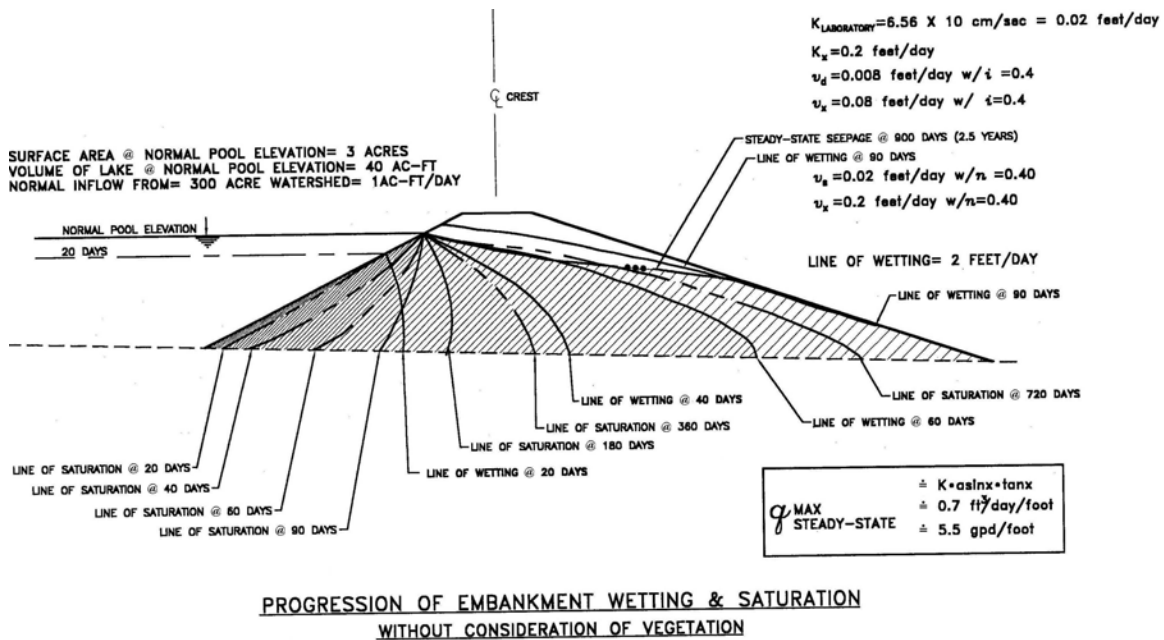
Based upon the estimated normal inflow from the contributing watershed, the lake retained by the example dam should reach about fifty percent volume in approximately twenty days and reach normal pool elevation in about forty days. Solid lines in Figure 5 illustrate the location of the line of wetting at various time intervals. The line of wetting should reach the downstream slope in about ninety days. *Note: The compacted embankment soils remain partially saturated after passage of the line of wetting.* Dashed lines in Figure 5 illustrate the line of saturation at various time intervals. The line of saturation moves at the seepage velocity that is about one-tenth the value of the wetting velocity. When the line of wetting has reached the downstream slope in about ninety days, the line of saturation is still at about the vertical from the intercept of the normal pool with the upstream slope. Based upon this rate of progression, the line of saturation will not reach the surface of the downstream slope and steady-state seepage will not be initiated for about 900 days (about 2.5 years), *provided that no external influences affect the rate of wetting and saturation.*

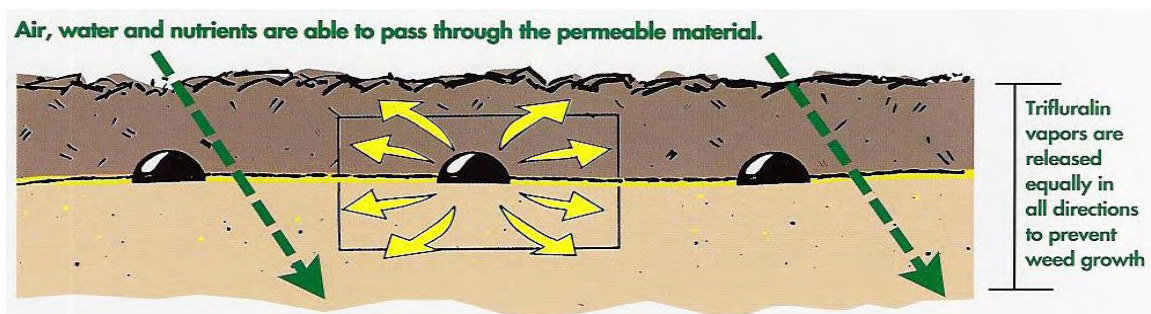
Figure 1. Chemical biocide barrier installation showing slow-releasing biocide nodules attached in a woven fabric matrix and installed under a cover of soil, mulch, gravel or stone (Biobarrier©).

One typical biocide product, called “Biobarrier©” is marketed and promoted, among other applications such as sidewalk and landfill cap protection, to prevent tree and plant roots from penetrating dams. The product consists of long-term, slow release nodules containing Trifluralin herbicide, that are bonded to a geotextile fabric as shown in Figure 1.

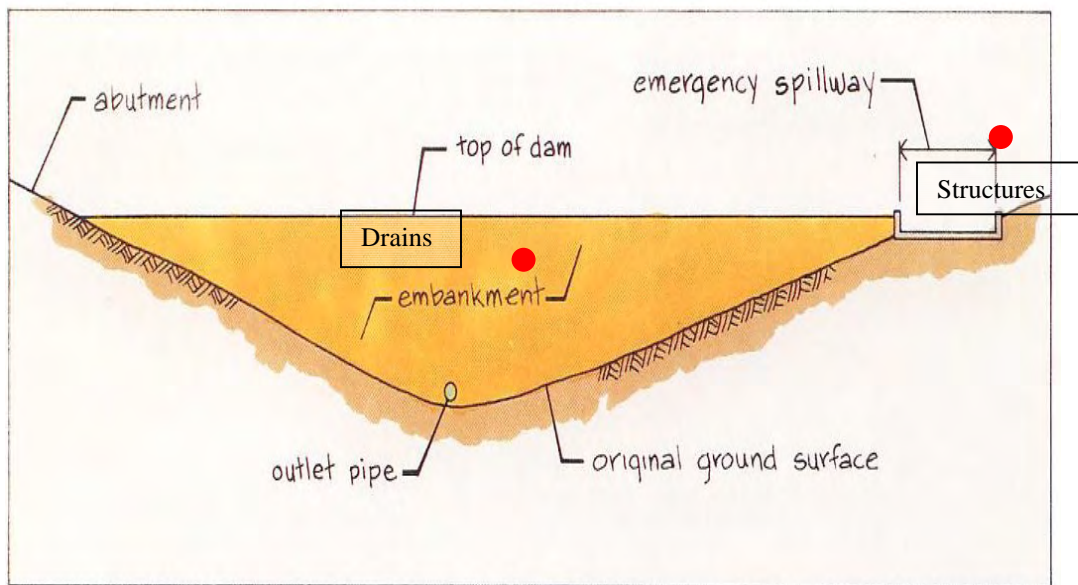
Figure 6. Tree clearance zones for embankment dams and dikes.

3. **Root exclusion zones** utilizing soil structure changes, soil compaction, water/aeration, stress, anaerobic conditions, soil injections and slurries, soil additives, and chemicals to prevent roots from colonizing the soil structure areas due to applied physical or chemical changes to the soil. Changing the soil structure, pore space volume or drainage/aeration matrices can generate a soil environment that roots cannot effectively grow and sustain. A variety of physical- or chemical-based soil altering materials (i.e., soil injected clay slurry or cement solutions) can be effective, at least over the short term if adequate soil volume is treated. Compacting soils appear to be a very good way to prevent root colonization. High density soils increase the resisting strength of these soils to root penetration and deprive the roots from needed oxygen and available water. Certain types of clay soils, freeze-thaw cycles, biological activity, and poor soil compaction can, over time, produce root-accessible pore space. Soil or infrastructure building material additives that neutralize or sterilize the available minerals and nutrients such as nitrogen gas, sulphur, sodium, zinc, borate, salts, or herbicides may produce serious environmental consequences, short-lived results, and non-targeted damage potential. Other methods or additives may be cost-prohibitive. See Figure 6 at end of chapter for root clearance zones.

8. **Creating avoidance zones** to separate tree growth from earthen dam embankments and dam appurtenances where root damage may be critical thus establishing biological-free zones that reduce potential problems. This method simply recognizes that there are places where trees are acceptable and other places, namely dams, where they are not (see Figure 6).

The reader is referred to the USDA guideline for detailed discussion on each of the six treatment methods listed in the above table. These methods can be applied to establish tree and woody plant clearance or avoidance zones on and around dams as illustrated in Figure 6.

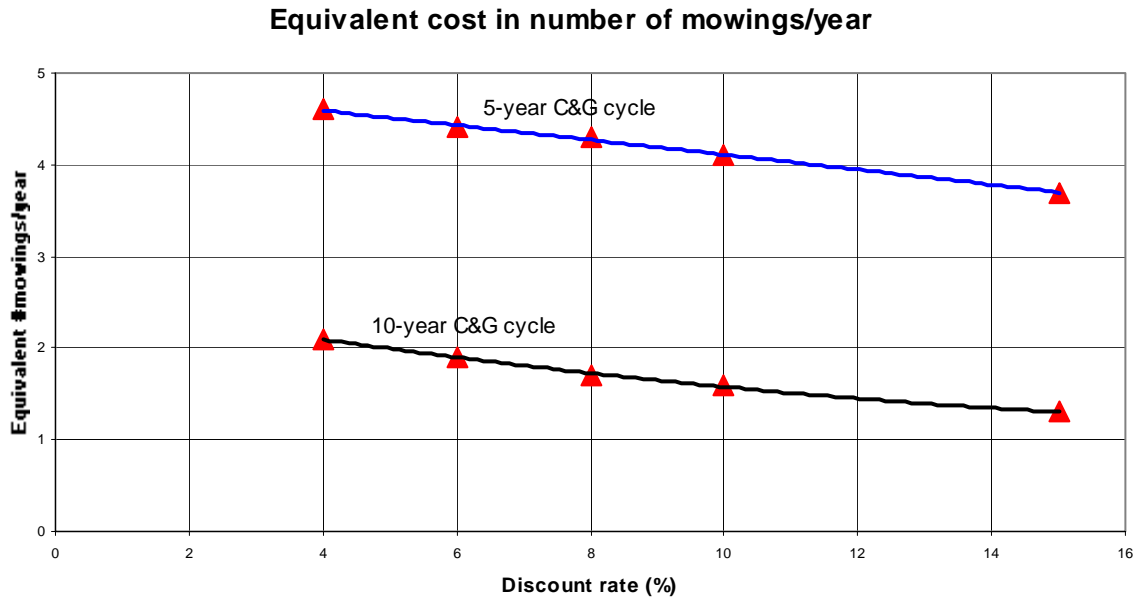
Figure 4. Comparison of Annual Tree Clearing and Grubbing Costs for 5 and 10-Year \$2500/acre payouts.

For a more conservative 5-year tree growth cycle and a \$2500 clearing and grubbing cost assumption, the annualized clearing and grubbing costs would be \$1523, \$1464, \$1406, \$1351, and \$1224 for the same discount rates, respectively. The corresponding justifiable mowings would be 4.6, 4.4, 4.3, 4.1, and 3.7 per year. Similarly, justifiable mowings for an assumed \$5000 clearing and grubbing cost would double the justifiable mowings to 9.2, 8.9, 8.6, 8.2, and 7.4 per year. Figure 4 compares 5 and 10-year annualized costs for \$2500/acre clearing and grubbing payouts.
