# Special Geotechnical Issues relating to Stream Stabilization

**“Soil Properties and Special Geotechnical Problems Related to Stream  
Stabilization Projects”**

*NRCS Stream Restoration Handbook  
National Engineering Handbook  
Technical Supplement 14H  
Part 654*

## Soil Properties and Special Geotechnical Problems Related to Stream Stabilization Projects

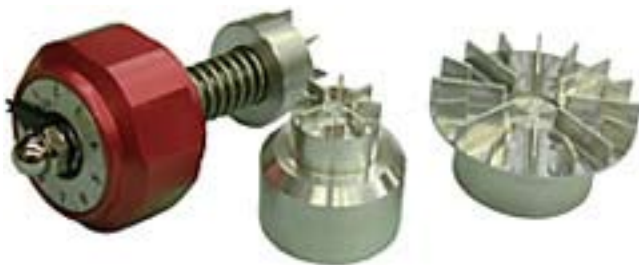
**Figure TS14A-1** Hand held torvane device (*Photo courtesy Geotest Instruments, Inc.*)

The saturated consistency of fine-grained soils with significant plasticity (plasticity index greater than about 7) correlates well with the soils' undrained shear strength. Saturated undrained strength of plastic fine-grained soils may be estimated with a field torvane device such as the one shown in figure TS14A-1 or from the descriptions provided in table TS14A-2.

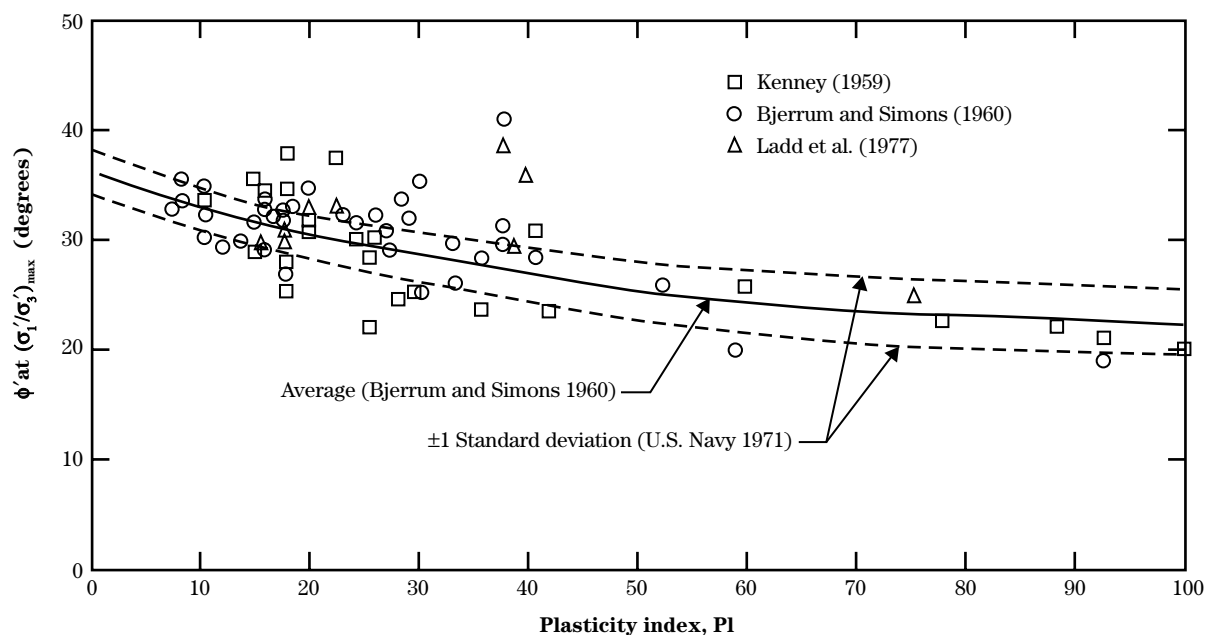
**Figure TS14A-2** Empirical correlation between effective phi angle ( $\phi$ ) and plasticity index (PI) from triaxial tests on normally consolidated clays

Analyses of fine-grain soils should consider both undrained and drained conditions, with the most critical condition governing the design. Typical soil properties for fine-grain materials are shown in table TS14A-3 (U.S. Army Corps of Engineers (USACE) 1994c, EM 1110-2-2504, Design of Sheet Pile Walls; Pile Buck Steel Sheet Piling Design Manual; and U.S. Navy, Naval Facilities Engineering Command (NAVFAC) DM-7.2, Foundations and Earth Structures). Peak effective  $\phi$  ( $\phi$ ) angles for slowly permeable soils may be estimated with empirical charts such as shown in figure TS14A-2 (Hopkins, Allen, and Dean 1974; Kenny 1959; Bjerrum and Simons 1960).

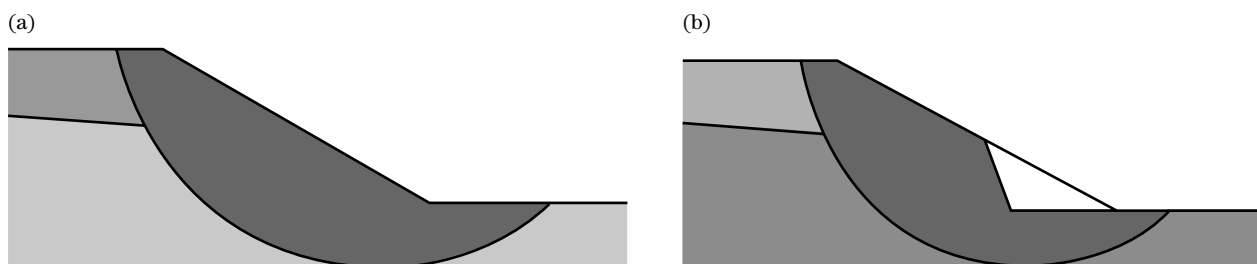
**Figure TS14A-3** Factor of safety computed before and after erosion of toe of slope: (a) before, FS=1.107; (b) after, FS=0.99

An example of a change in slope geometry is removal of the toe of the slope by streamflow. This removal of soil at the toe of the slope reduces the gravity forces resisting failure and may cause the factor of safety of the slope to be reduced to less than 1.0. Slope failures normally occur when the factor of safety is less than 1.0. This type of change in the geometry of the slope is probably responsible for more slope stability failures in streambanks than any other single cause. Figure TS14A-3 shows a factor of safety computation for a simple example slope before and after toe erosion. The eroded toe of the slope reduces the forces resisting failure so that the computed factor of safety changes from 1.1 to less than 1.0, and a failure is predicted. Repeated occurrences are common in this scenario. After a slope failure occurs from erosion of the toe, the failed material at the bottom of the slope can be subsequently eroded and the process repeats itself, with the top width of the channel increasing at each occurrence. This process is common in curves

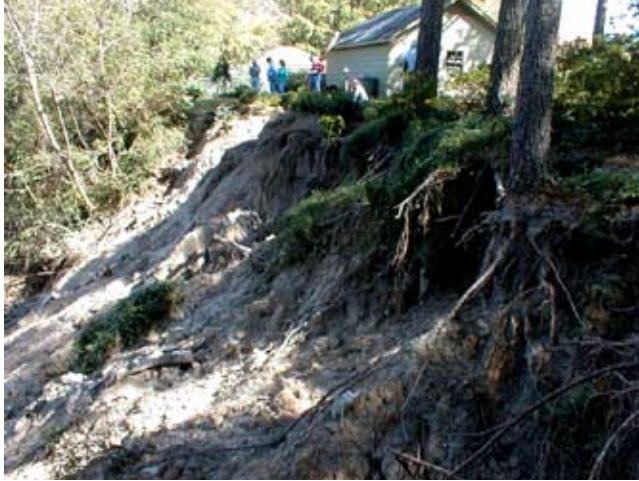
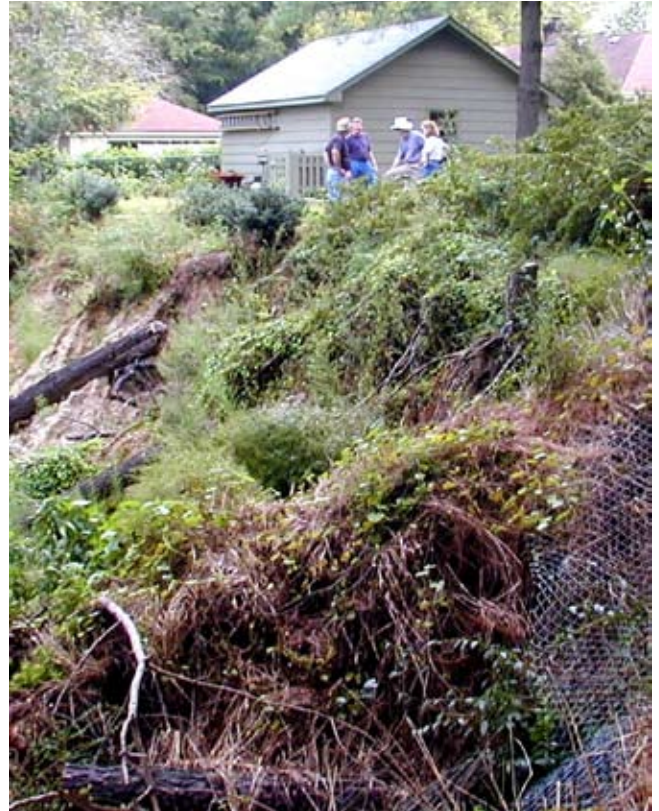
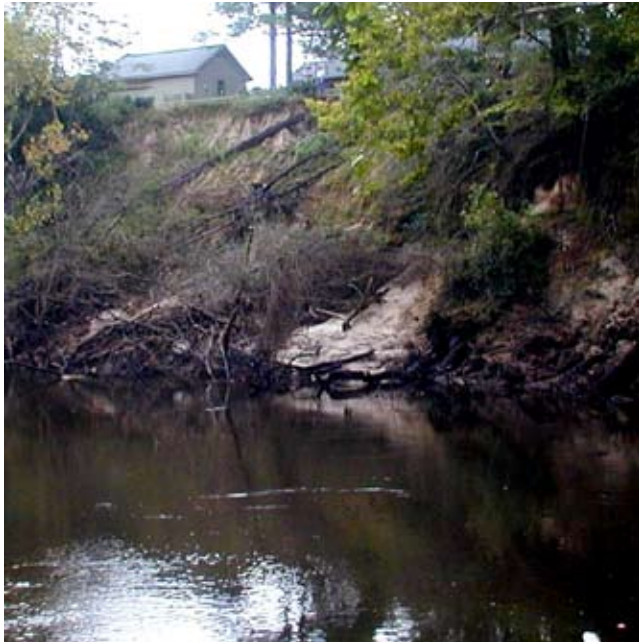
**Figure TS14A-4** Failed streambank in Tarboro, NC, following high channel flows following Hurricane Floyd. Erosion of the toe caused bank instability in the slope. Measures to protect the toe of the slope are essential, in addition to assuring stability of the system.

Figure TS14A-4 shows a slope where erosion of the toe has caused slope instability. In figure TS14A-4(a), the overall slope is seen with erosion that occurred at the toe of the slope following a large runoff event. Figure TS14A-4(b) shows the effect of the slope failure at the top of the slope, and figure TS14A-4(c) shows the middle of the failed slope area. Other ways that slope geometry or conditions may change, resulting in instability, include:

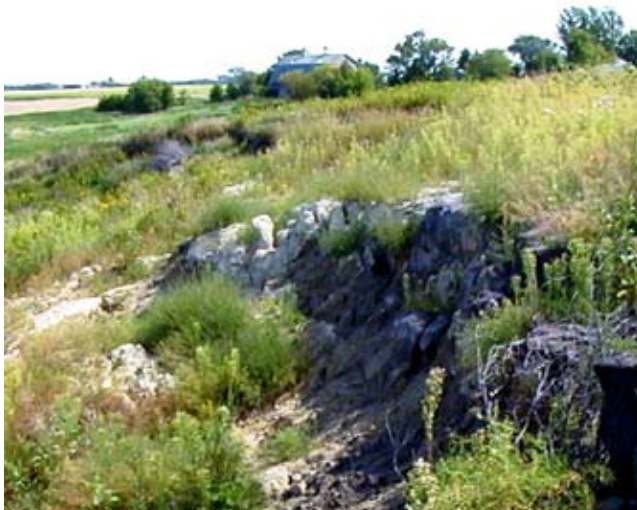
**Figure TS14A-5** Shallow sloughing failure in zone of saturated sand

Figure TS14A-5 shows a shallow slide occurring from a zone of saturated sand sloughing from seepage forces. Figure TS14A-6 shows the results of a deep-seated rotational failure in clayey soils. A later section in the document describes this type of failure in detail.

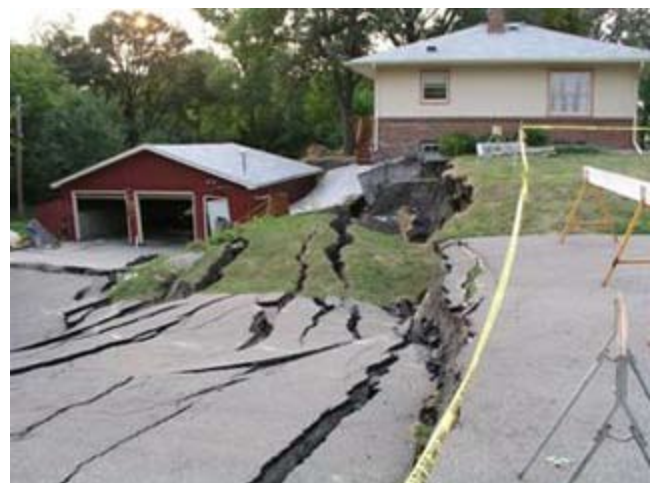
**Figure TS14A-6** Typical slope stability failure in clay soil type. Failure is a low-radius, deep rotational failure. (Photo credit City of Fargo, ND)

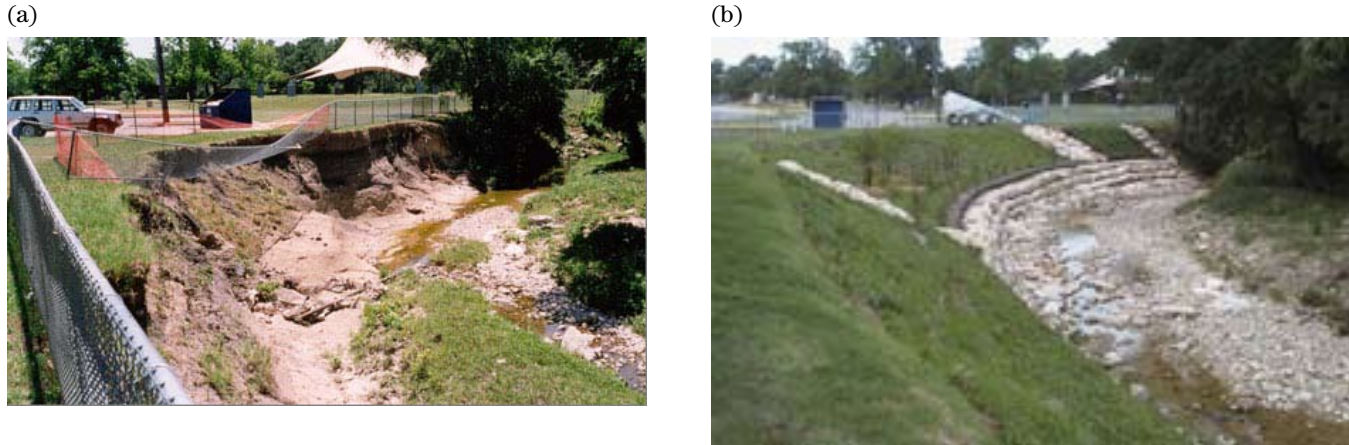
**Figure TS14A-7** Before and after pictures of project, Tannehill Branch Givens Park in Austin, TX. Note method for protecting toe of slope from erosion. (Photo courtesy of City of Austin, TX)

Figures TS14A-7, TS14A-8, and TS14A-9 show examples of methods used to protect the toe of slopes in a project in the city of Austin, Texas. Figure TS14A-10 shows the use of stream barbs to prevent erosion of the toe of a slope. Protecting the toe of a repaired slope from subsequent erosion is essential to the success of most streambank stabilization projects.

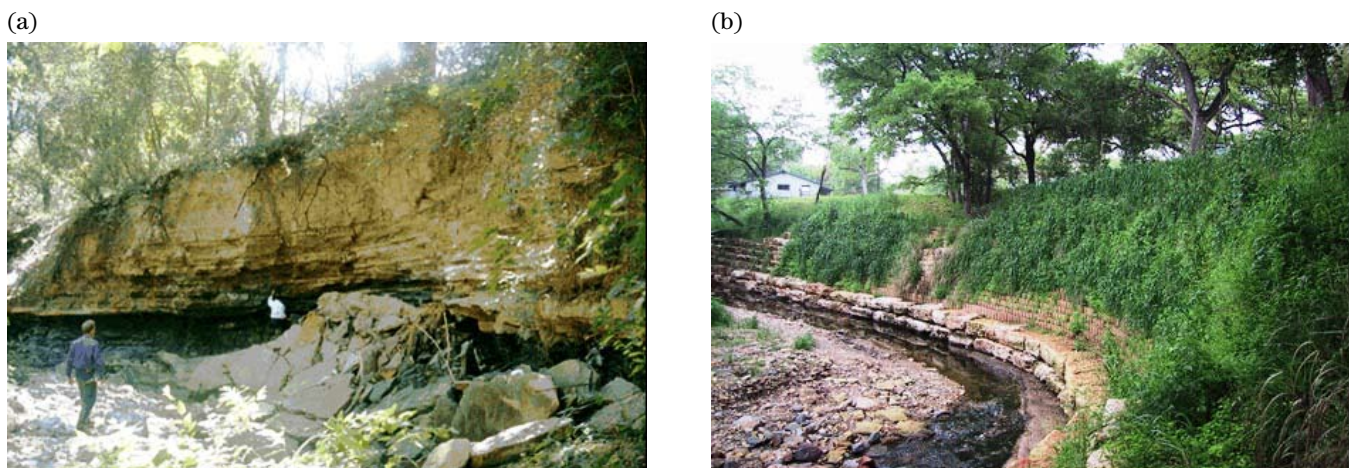
**Figure TS14A-8** Before and after pictures of project, West Bouldin Creek at South 6th Street in Austin, TX. Slope undercut and oversteepened by erosion of toe, which led to sloughing and bank failures. Note method for protecting toe of slope from erosion. (Photo courtesy of City of Austin, TX)

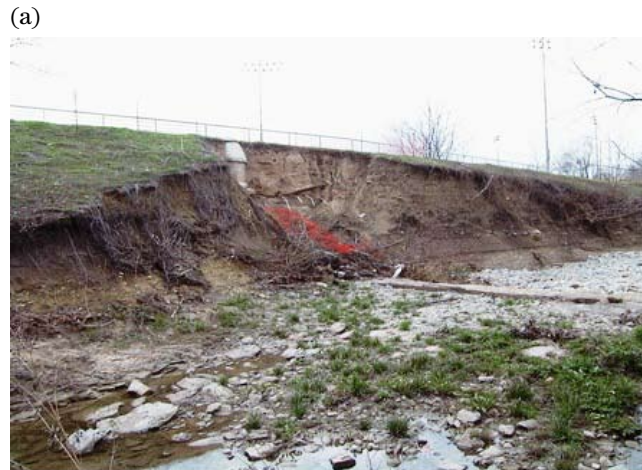
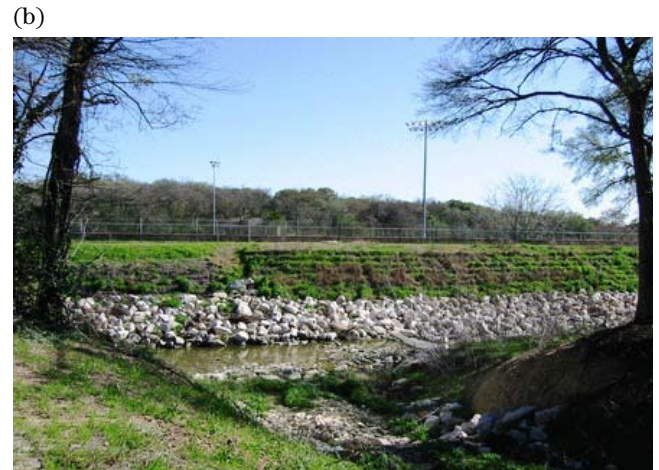
**Figure TS14A-9** Before and after pictures of project, Shoal Creek in Austin, TX. The toe of the slope was protected with riprap and the bank shaped above the protected toe. *(Photo courtesy of City of Austin, TX)*

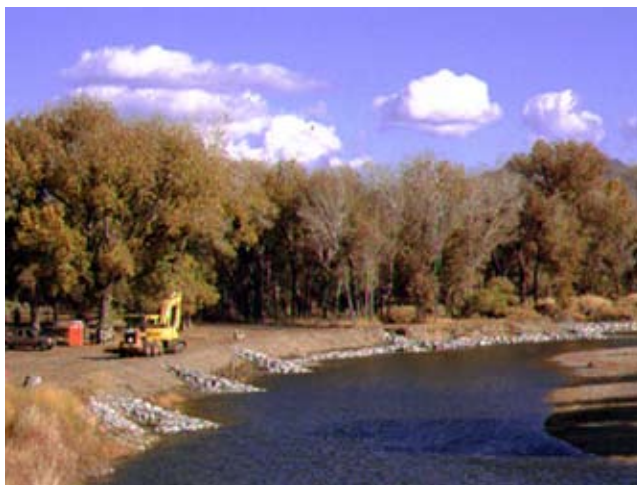
**Figure TS14A-10** Barb structures installed to protect toe of slope from erosion

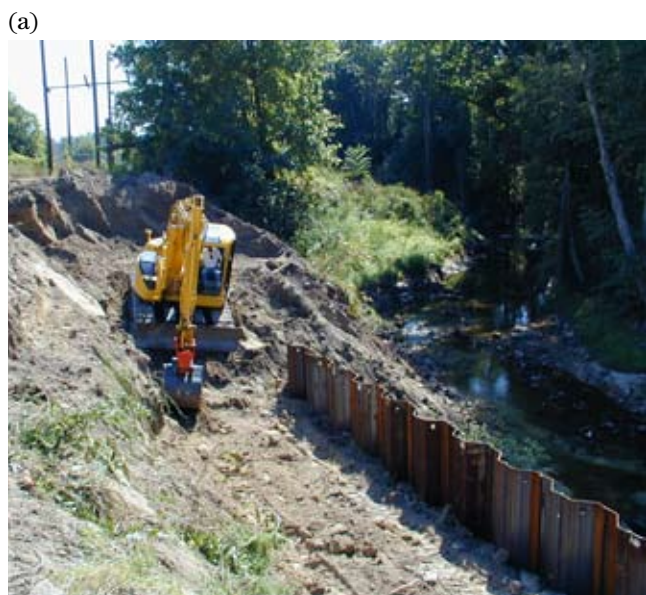
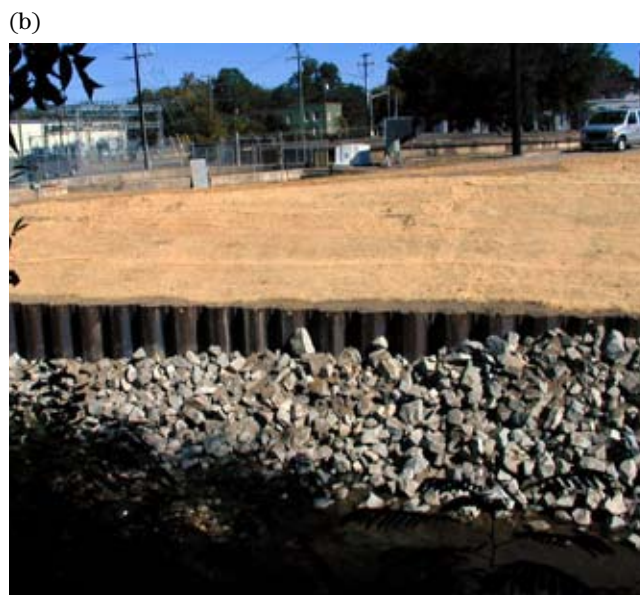
**Figure TS14A-11** Sheet pile wall at toe of slope in Tarboro, NC. Vegetation will be established above wall. Note erosion control fabric.

Figure TS14A-11 shows a project where the toe of the slope was protected using both riprap and a sheet pile wall. In many circumstances, rigid boundary constraints, improvements, or other obstacles at the top of the slope do not allow the slope to be flattened. Consequently, constructing a vertical feature at the toe of the slope may be needed.

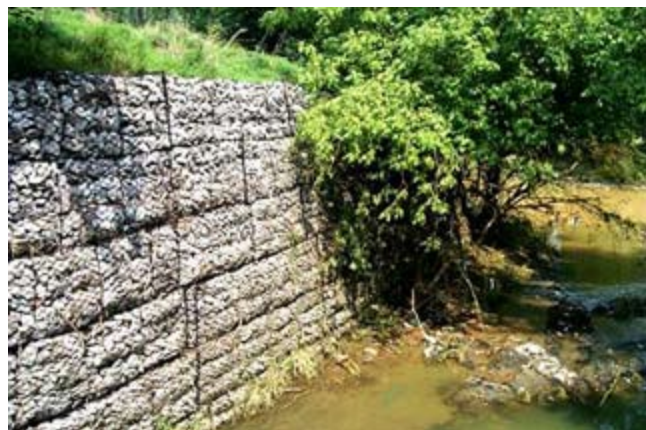
**Figure TS14A-12** Gabion wall constructed at toe of slope enabled reconstruction of failed slope where right-of-way limitations prevented flattening of the upper slope and use of other conventional toe protection measures at the toe

Another way of reconstructing a slope where limited right of way occurs is the use of gabion baskets to protect the toe of the slope (fig. TS14A-12).

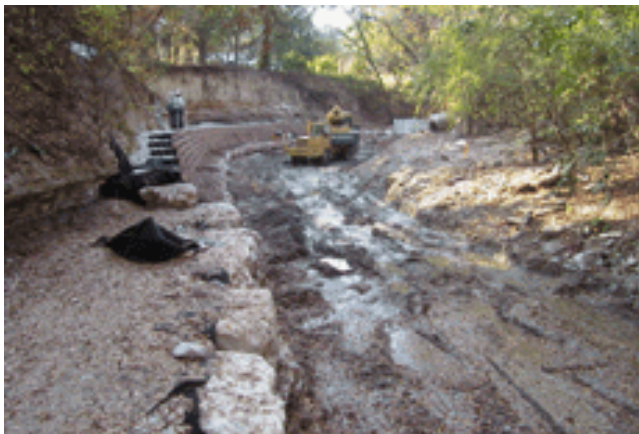
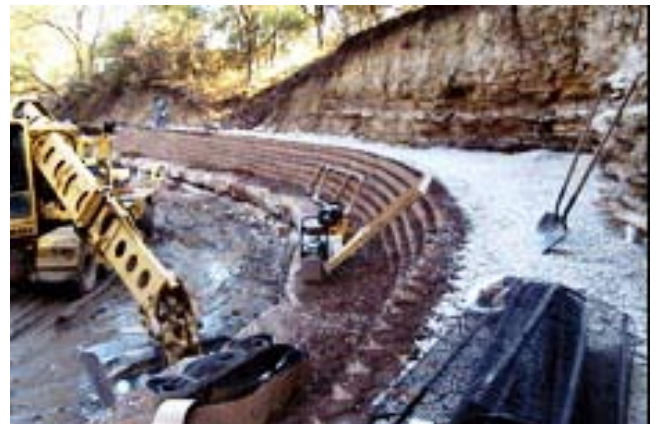
**Figure TS14A–13** Reinforced fill at toe of slope in Austin, TX. Note large stones used to protect reinforced fill from erosive forces in stream.

angle than would otherwise be possible. Examples of geosynthetic reinforcement include the use of geogrids and geocell products. These products are described in NEH654 TS14D. Figure TS14A–13 illustrates a project where the toe of the slope was protected by armoring, and the slope was reconstructed with reinforced soil lifts.

Figure TS14A–13 shows the reconstruction of the slope at the West Bouldin Creek at South 6th Street project. Figure TS14A–13(a) shows the site in the initial stages of construction. The toe of the slope has been excavated in preparation for installing limestone boulder armor

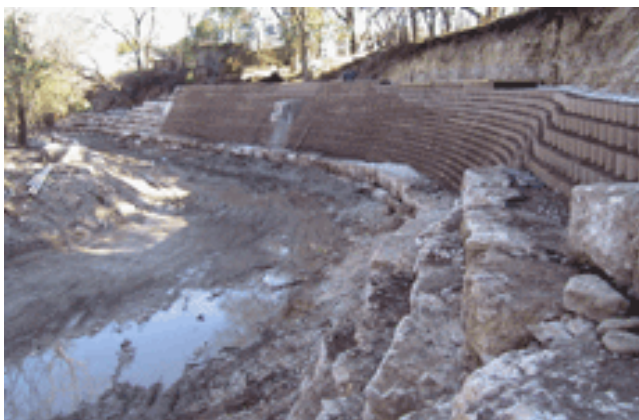
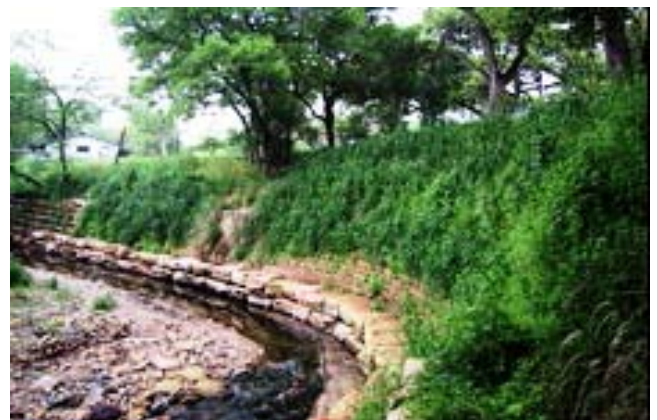
**Figure TS14A–14** West Bouldin Creek at South 6th Street, Austin, TX, project during last stages of construction

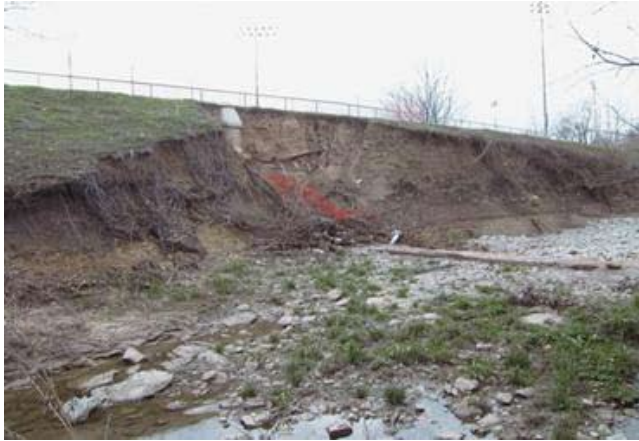
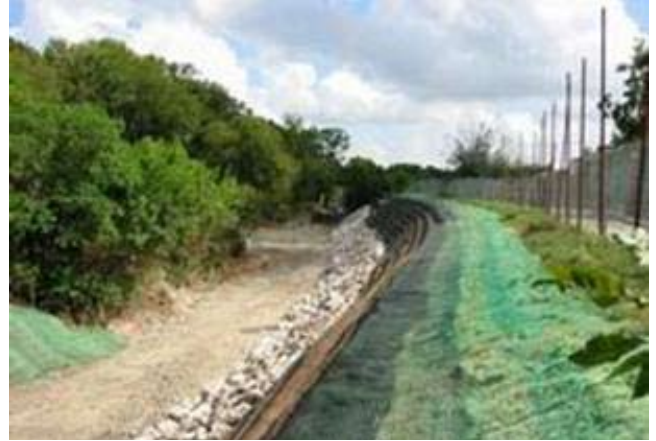
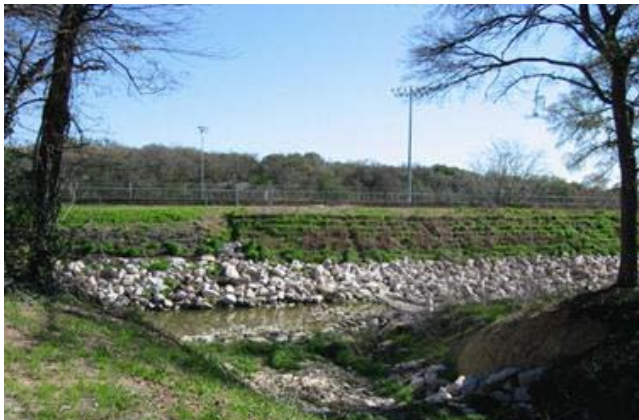
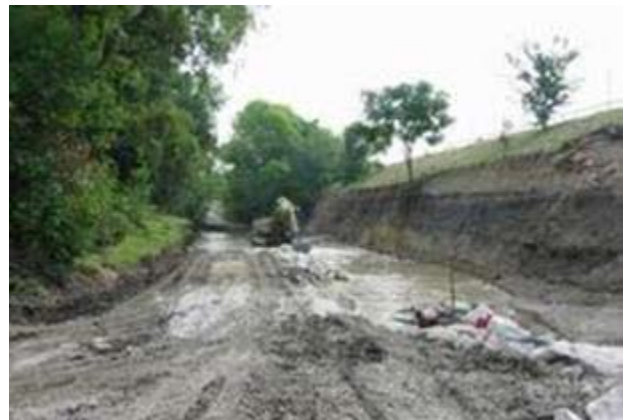
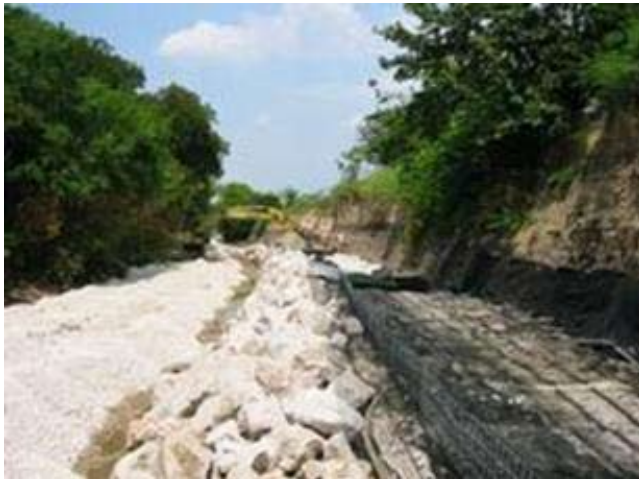
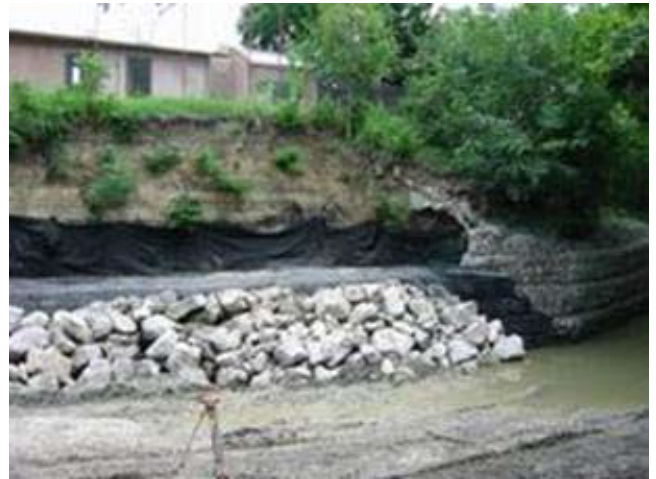
**Figure TS14A-15** Other slope stabilization projects

Figure TS14A–15 shows other slope stabilization projects where reinforced fill protected by rock armor riprap placed at the toe of the slope were employed. Figure TS14A–15(e) shows geogrids, a heavy lattice of very strong plastic placed in layers in the granular fill used to reconstruct the slope. Figure TS14A–15(f) shows the completed project.

allows vegetation to grow and mask the construction. Geocells allow very steep slopes to be used in the reconstruction. These six photographs show a project to stabilize unstable streambanks at the Shoal Creek Project, City of Austin, Texas (fig. TS14A–15).

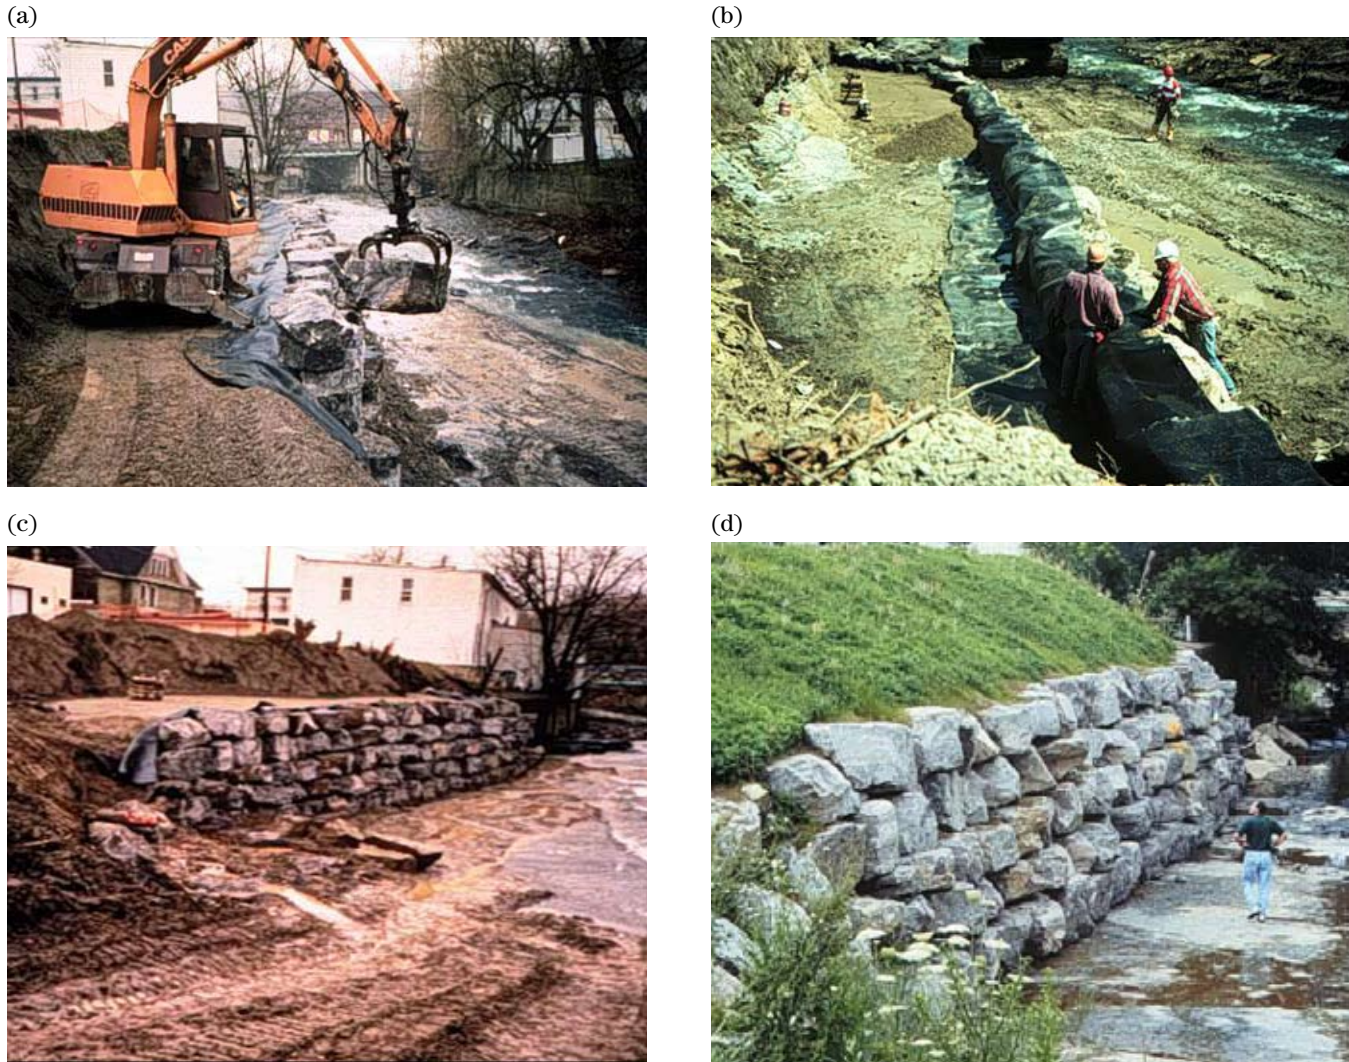
**Figure TS14A-16** Construction of a geotextile reinforced slope with large derrick stone armoring at toe of slope

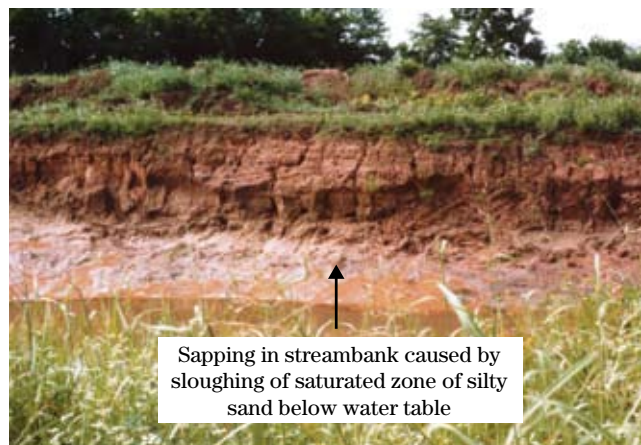
**Figure TS14A-17** Sloughing of saturated low plasticity zone in lower streambanks caused by seepage forces

be able to form a roof. In a related mode of failure, the saturated bank in this zone of low plasticity soils slumps or sloughs under the seepage forces. Sloughing of the lower banks can undermine overlying zones that are stable on a steeper slope. Figure TS14A-17 shows sloughing in the lower saturated banks of an excavated stream.

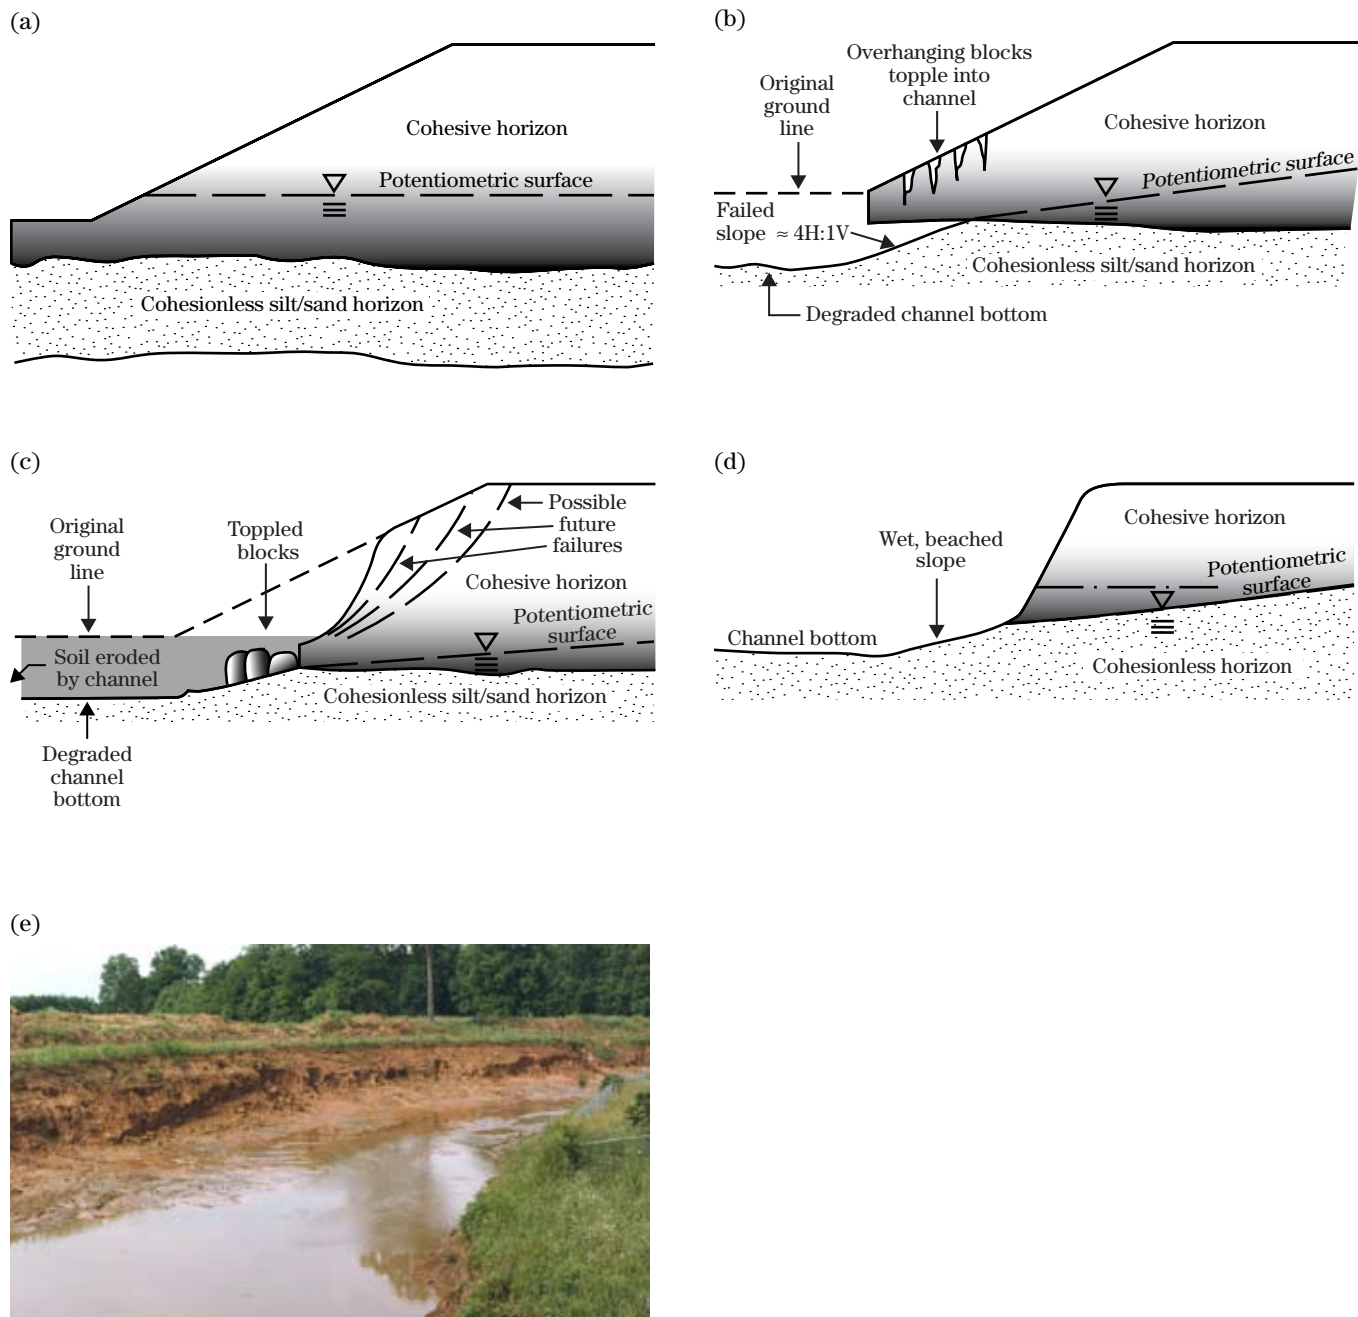
**Figure TS14A-18** Progression of sloughing type of failure mechanism in a streambank

These overlying soils then fail by toppling into the stream, as shown in figure TS14A-18(c). If erosion of the lower slopes is occurring or if the streambed is degrading, the process repeats. This results in substantial

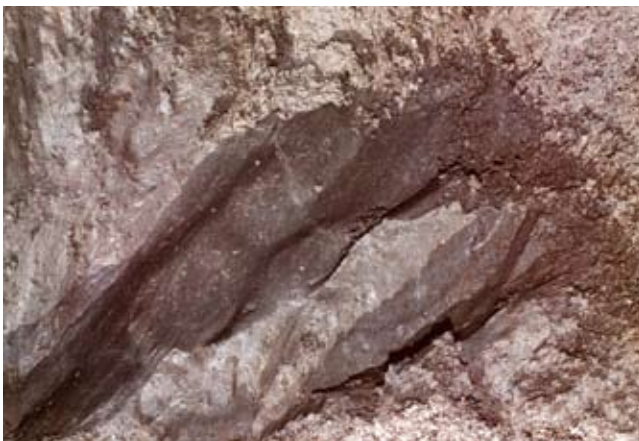
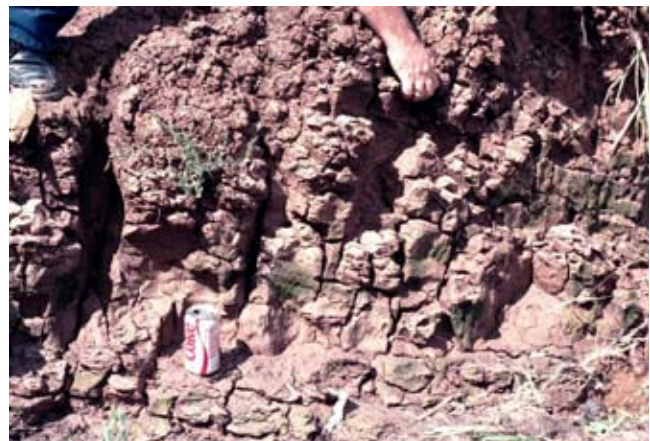
**Figure TS14A–19** Slickensides in exposure of clay soil

Figure TS14A–19 shows photographs of highly plastic clays with slickensides and blocky structure. Shallow surface slides commonly occur in these soils where streams have been modified or the stream system is not in equilibrium and bed degradation is occurring.

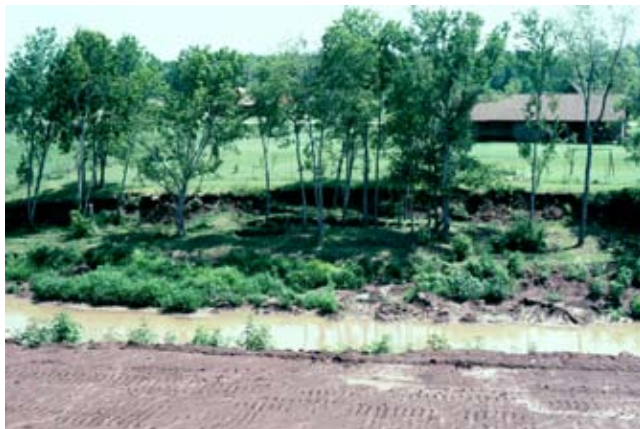
**Figure TS14A-20** Stream slope that failed when the stream was deepened by about 4 feet to increase the flow capacity

Figure TS14A-20 shows a slope failure on a stream-bank that occurred when the stream was deepened about 4 feet to increase the flow capacity and blocky structured clays occurred in the streambanks. Root reinforcement of large trees was inadequate to resist the large forces active in this type of failure. Note that large trees were displaced by the failure.

These types of failures have a shallow circular shape; are about 3 to 4 feet deep, measured normal to the slope surface; and frequently occur progressively. Larger failures follow small initial slides, if no corrective measures are taken. The scarp face (near-vertical surface at the top of the slide) may extend past the crest of the stream slope, but usually only after a series of failures has occurred at the same location.

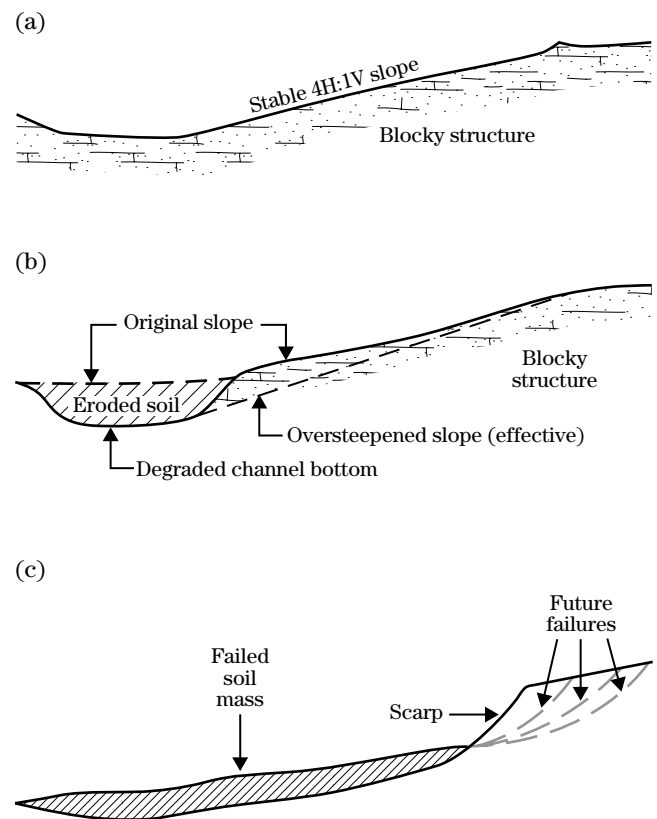
**Figure TS14A-21** Progression of events that can result in bank instability

The series of sketches in figure TS14A-21 show the progression of events that can result in bank instability. Figure TS14A-21(a) shows an initially stable condition prior to stream degrading into a horizon of soils that are susceptible to slope failures because of the blocky soil structure. Figure TS14A-21(b) shows streambed loss or degradation causes an effective steepening of the streamside slopes. The blocky structured clays are subject to slope failures when the stable condition is disturbed.

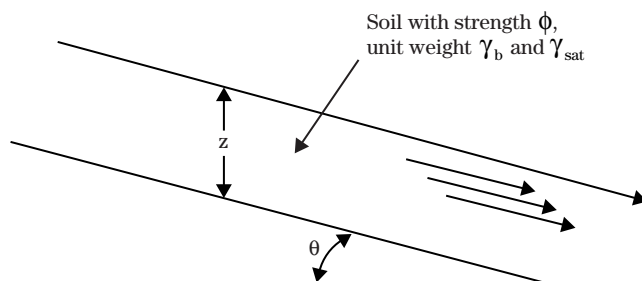
**Figure TS14A-22** Infinite slope equation for slope with small cohesion value

$$FS = \frac{\bar{c} \times \gamma_b \times z \times \cos^2 \theta \times \tan \bar{\phi}}{\gamma_{sat} \times H \times \sin \theta \cos \theta} \quad (\text{eq. TS14A-1})$$

These types of computer analyses are not appropriate for zero-cohesion soils because the critical failure surfaces are very shallow on the slope face with factors of safety approaching those obtained using the infinite slope equations.

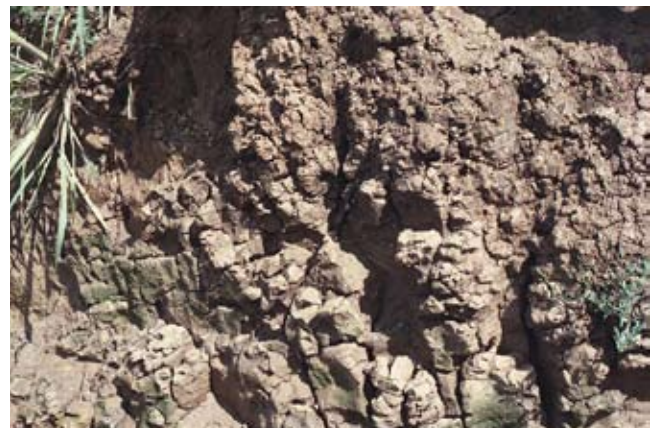
**Figure TS14A-23** Blocky structured clay in streambank exposure

The soils have an observable strongly blocky structure in an exposed face. The blocks of clay may be from one quarter to three-quarter inch in dimension. Figure TS14A-23 shows an exposure in a blocky clay soil. Other photographs show slickensides that are present in many such deposits. Slickensides develop from repeated wetting and drying cycles in clays.

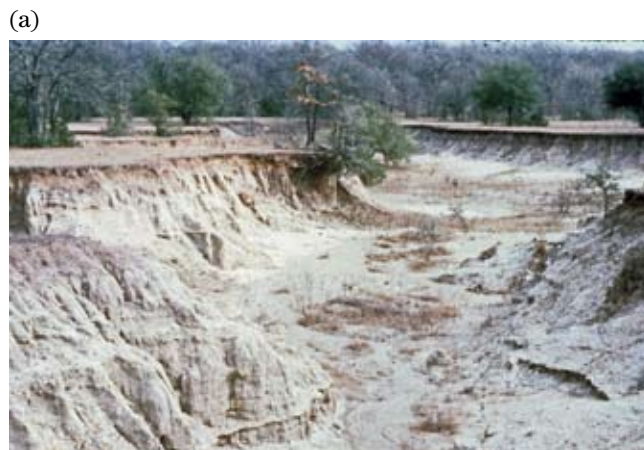
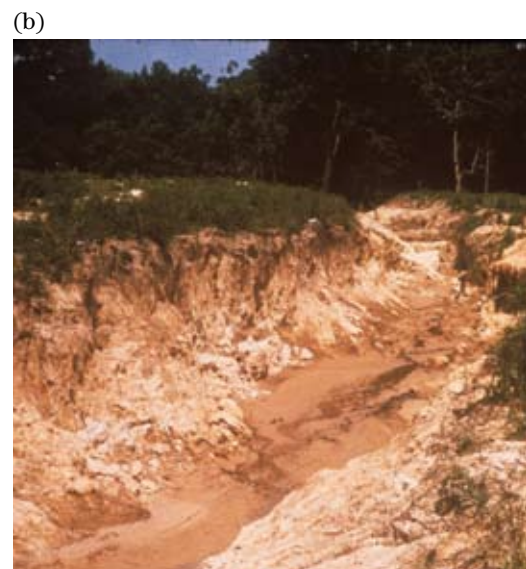
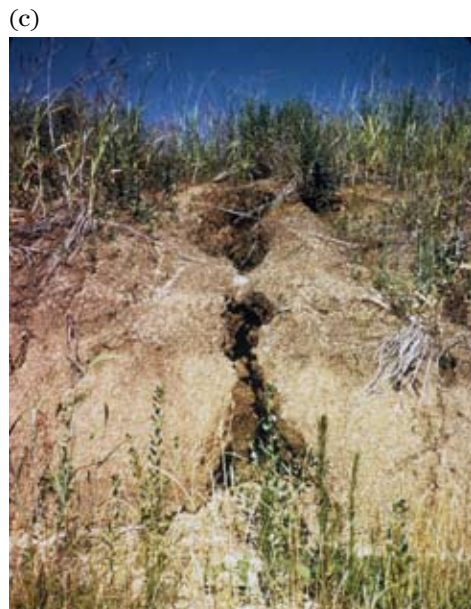
**Figure TS14A–24** Photographs of exposure of dispersive clays in streamside slopes in TX and OK

Dispersive clay slopes often are severely rilled. These rills often develop in a short time. Jugholes are an ideal diagnostic tool for dispersive clays. These features develop when a drying crack in the exposed soil provides an entrance for precipitation that can then erode the sides of the wall. This internal erosion of the crack results in subterranean cavities often termed jugholes. Figure TS14A–24 illustrates the special appearance of dispersive clays.

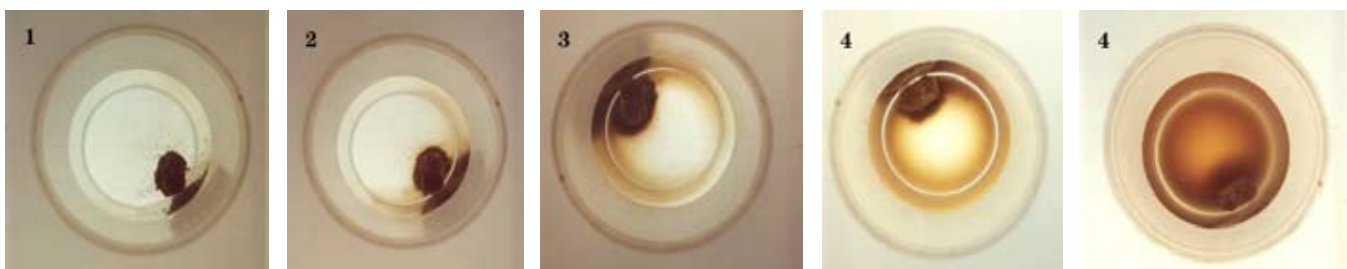
**Figure TS14A–25** Typical reactions in crumb test, a test for dispersive soils

A common field test for dispersive clays is the crumb test, a test for dispersive soils (fig TS14A–25). A small clump of the soil (about a half-inch cube) is placed in a cocktail glass that has about an inch of distilled water, and observed for at least an hour. A rapid formation of a cloud around the soil indicates that it is dispersive. The observed reaction is typically given a rating from the criteria listed.

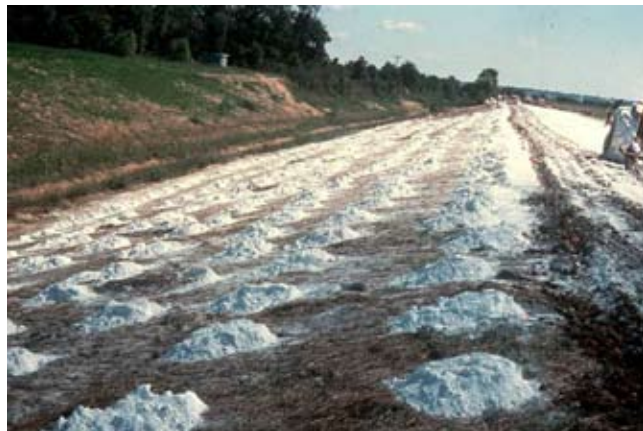
**Figure TS14A-26** A streambank where highly dispersive clays were treated by applying and mixing in hydrated lime to the slope soils

Another method for treating dispersive clays is to chemically alter the soils. Dispersive clays are predominated by sodium, and replacing the sodium ions with calcium, magnesium, or aluminum ions improves the interparticle attraction of the clays. Chemicals that have been successfully used include hydrated lime (fig. TS14A-26), quick lime, fly ash, alum, and gypsum. Refer to Soil Mechanics Note 13 for more detailed information.
