Coastal Construction: The Building Envelope

“Designing the Building Envelope”

Coastal Construction Manual

11 Designing the Building Envelope

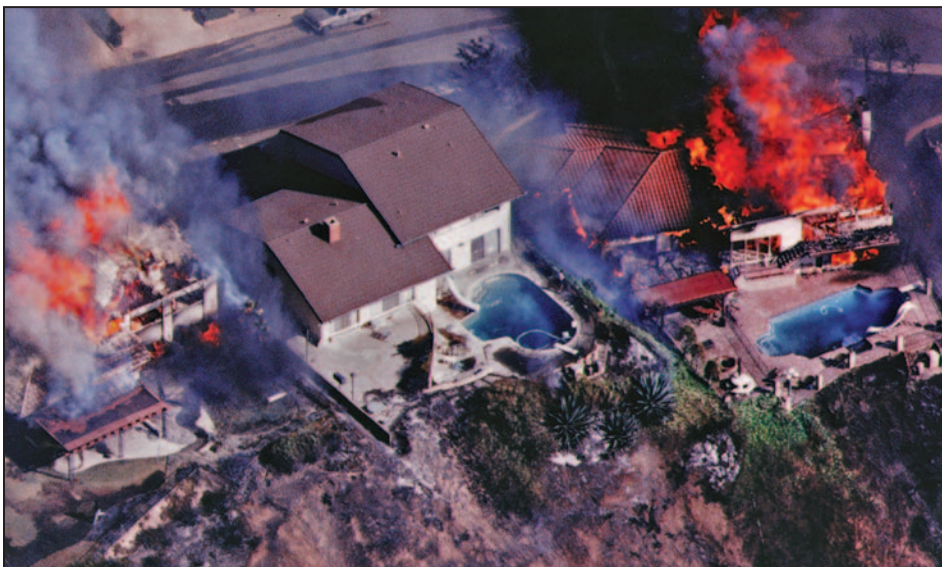
Figure 11-3. House that survived a wildfire due in part to fire-resistant walls and roof while surrounding houses were destroyed
SOURCE: DECRA ROOFING SYSTEMS, USED WITH PERMISSION

A building's susceptibility to wildfire depends largely on the presence of nearby vegetation and the characteristics of the building envelope, as illustrated in Figure 11-3. See FEMA P-737, *Home Builder's Guide to Construction in Wildfire Zones* (FEMA 2008), for guidance on materials and construction techniques to reduce risks associated with wildfire.

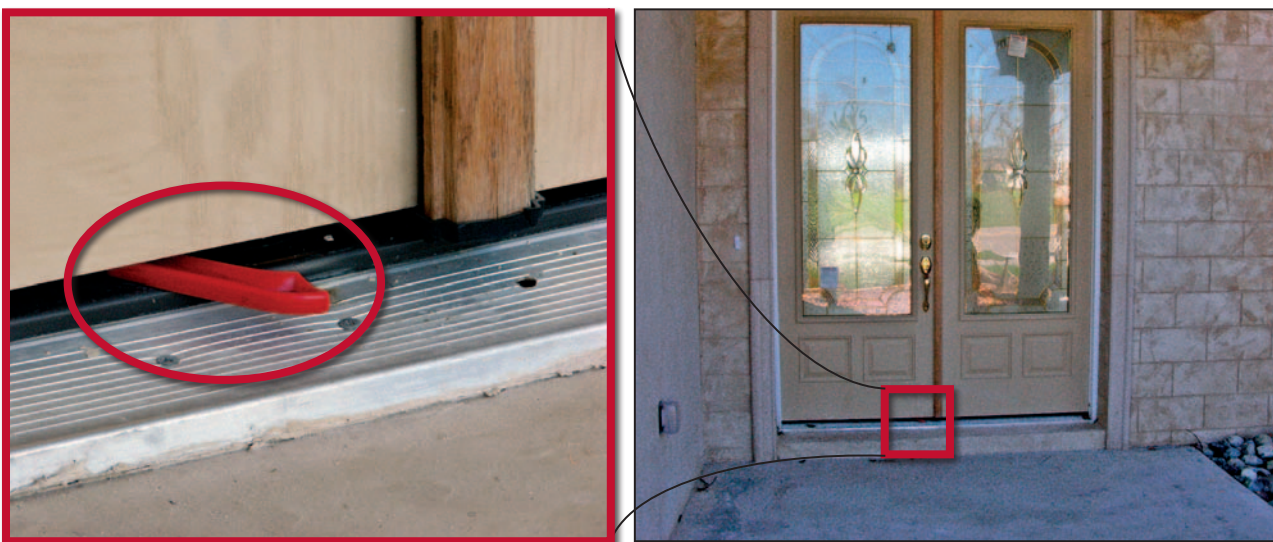
Figure 11-7.

A 3/8-inch gap between the threshold and door (illustrated by the spatula handle), which allowed wind-driven rain to enter the house. Estimated wind speed: 140 to 160 mph. Hurricane Charley (Florida, 2004)

Figure 11-7 shows a pair of doors that successfully resisted winds that were estimated at between 140 and 160 mph. However, as shown in the inset, a gap of about 3/8 inch between the threshold and the bottom of the door allowed a significant amount of water to be blown into the house. The weatherstripping and thresholds shown in Fact Sheet 6.1 in FEMA P-499 can minimize water entry.

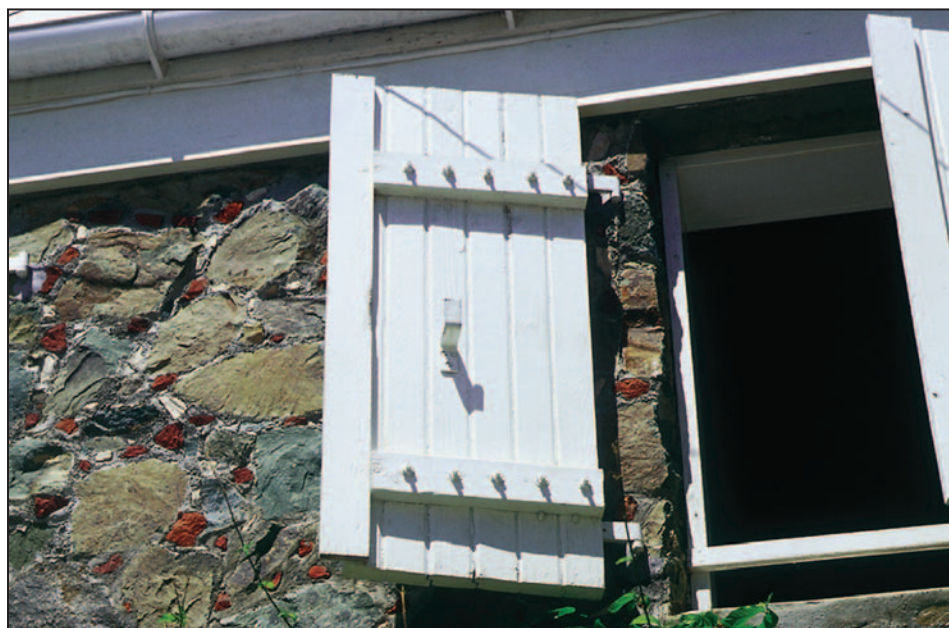
Figure 11-9.
Very old building
with robust shutters
constructed of
2x4 lumber, bolted
connections, and heavy
metal hinges. Hurricane
Marilyn (U.S. Virgin
Islands, 1995)

In windstorms other than hurricanes and tornadoes, the probability of a window or skylight being struck by debris is extremely low, but in hurricane-prone regions, the probability is higher. Although the debris issue was recognized decades ago, as illustrated by Figure 11-9, wind-borne debris protection was not incorporated into U.S. codes and standards until the 1990s. In order to minimize interior damage, the IBC and IRC, through ASCE 7, prescribe that exterior glazing in wind-borne debris regions be impact-resistant (i.e., laminated glass or polycarbonate) or protected with an impact-resistant covering (shutters). ASCE 7 refers to ASTM E1996 for missile (debris) loads and to ASTM E1886 for the test method to be used to demonstrate compliance with the ASTM E1996 load criteria. Regardless of whether the glazing is laminated glass, polycarbonate, or protected by shutters, glazing is required to meet the positive and negative design air pressures.

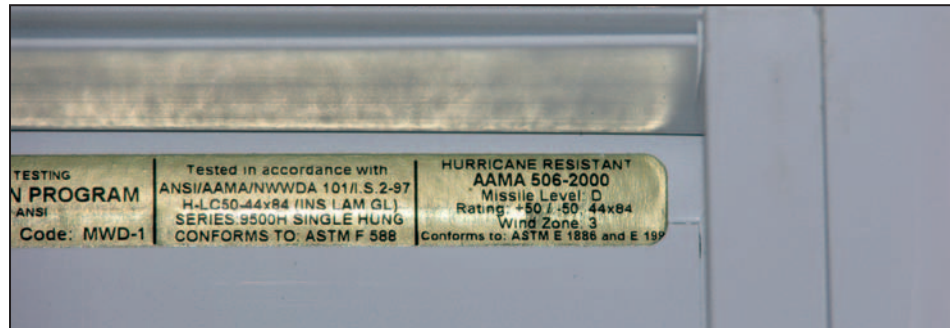
Figure 11-11.
Design pressure and impact-resistance information in a permanent window label. Hurricane Ike (Texas, 2008)

and test standards that were used to evaluate the pressure and impact resistance. Without a label, ascertaining whether a window or shutter has sufficient strength to meet pressure and wind-borne debris loads is difficult (see Figure 11-12). It is therefore recommended that design professionals specify that windows and shutters have permanently mounted labels that contain the type of information shown in Figure 11-11.

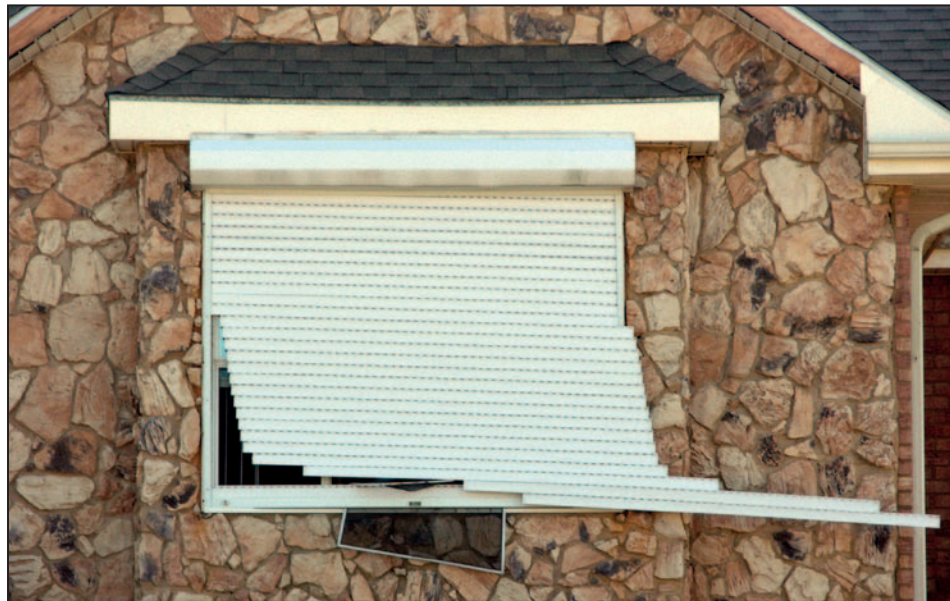
Figure 11-12.
Roll-up shutter slats that detached from the tracks. The lack of a label makes it unclear whether the shutter was tested in accordance with a recognized method. Estimated wind speed: 110 mph. Hurricane Katrina (Louisiana, 2005)

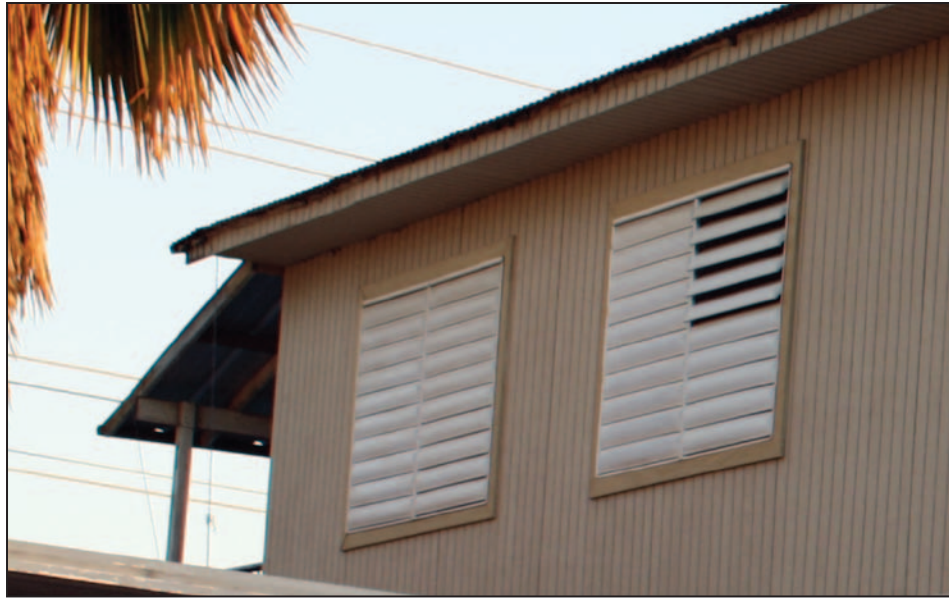
Figure 11-14.
House in Puerto Rico with
metal jalousie louvers

In tropical climates such as Puerto Rico, some houses have metal jalousie louvers in lieu of glazed window openings (see Figure 11-14). Metal jalousies have the appearance of a debris-resistant shutter, but they typically offer little debris resistance. Neither the UBC nor IRC require openings equipped with metal jalousie louvers to be debris resistant because glazing does not occur. However, the louvers are required to meet the design wind pressure.

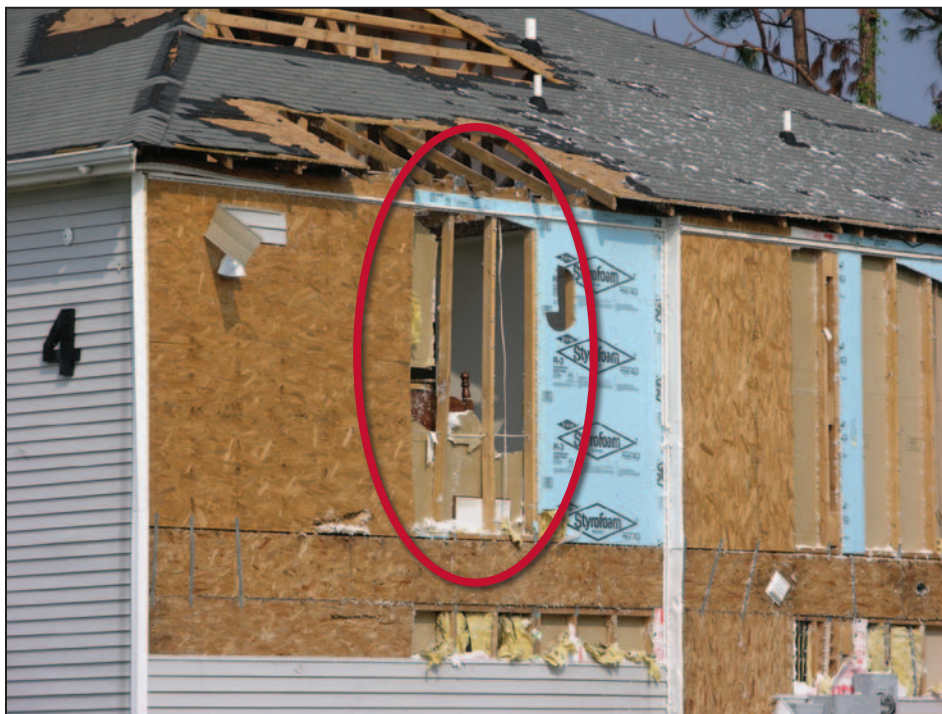
Figure 11-15. Blown-off vinyl siding and foam sheathing; some blow-off of interior gypsum board (circle). Estimated wind speed: 130 mph. Hurricane Katrina (Mississippi, 2006)

other siding or panel materials (see Figure 11-15). Problems with aluminum and fiber cement siding have also occurred (see Figure 11-16).

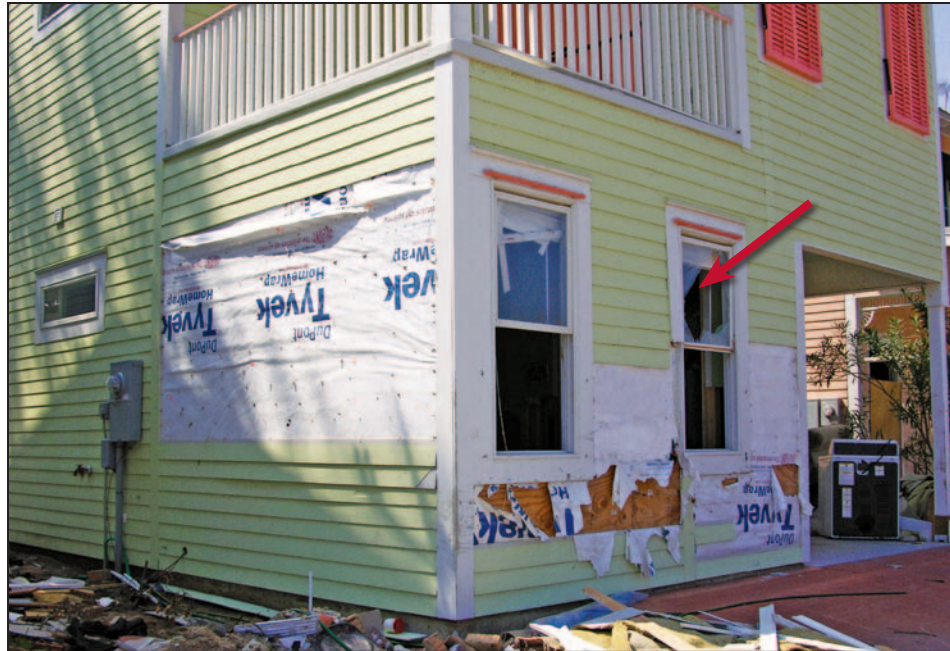
Figure 11-16.
Blown-off fiber cement siding; broken window (arrow). Estimated wind speed: 125 mph. Hurricane Katrina (Mississippi, 2006)

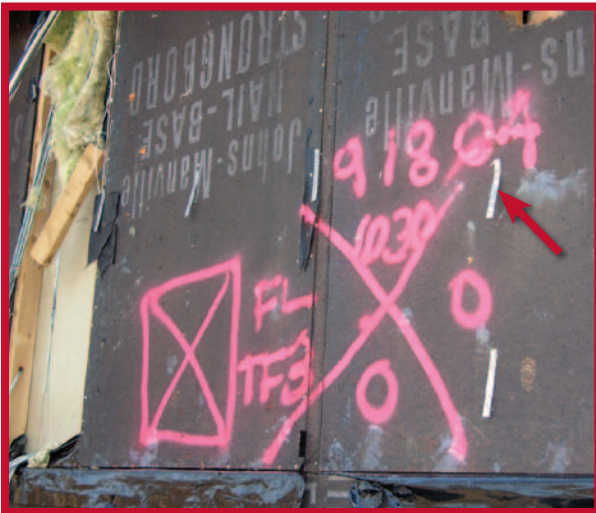
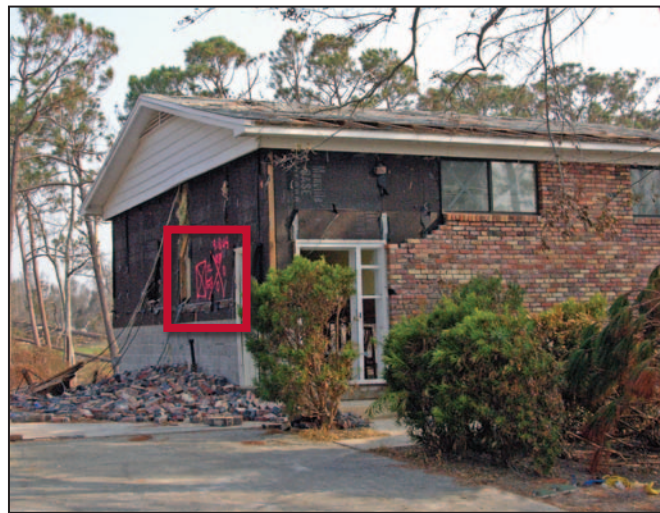
Figure 11-17.
Four brick veneer failure modes; five corrugated ties that were not embedded in the mortar joints (inset). Hurricane Ivan (Florida, 2004)

Blow-off of brick veneer has occurred often during high winds. Common failure modes include tie (anchor corrosion), tie fastener pull-out, failure of masons to embed ties into the mortar, and poor bonding between ties and mortar, and poor-quality mortar. Four of these failure modes occurred at the house shown in Figure 11-17. The lower bricks were attached to CMU and the upper bricks were attached to wood studs. In addition to the wall covering damage, roof sheathing was blown off along the eave.

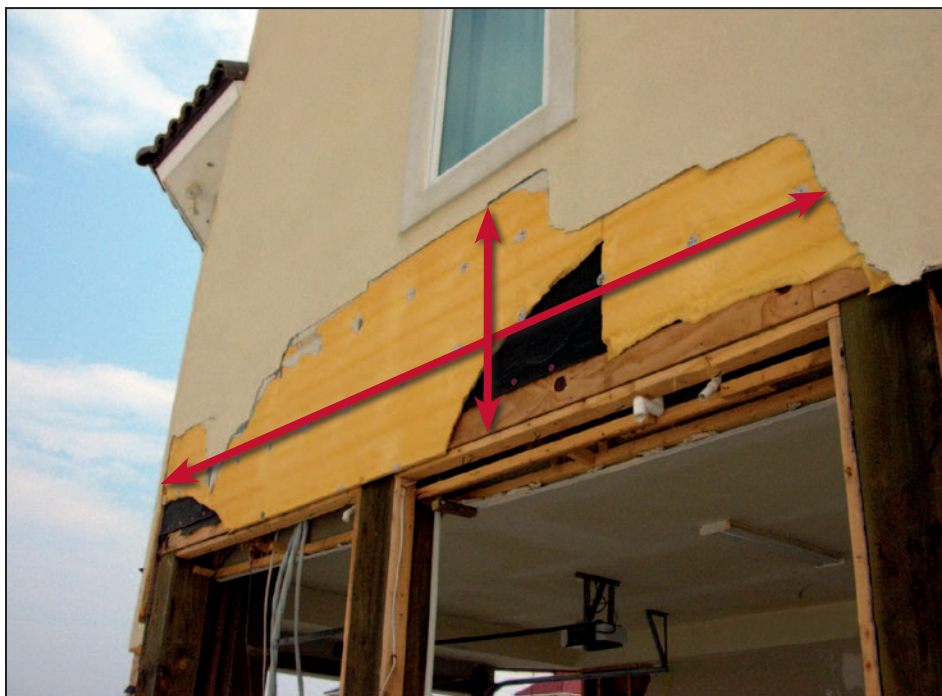
Figure 11-20. Collapse of the breakaway wall, resulting in EIFS peeling. A suitable transition detail at the top of breakaway walls avoids the type of peeling damage shown by the arrows. Estimated wind speed: 105 to 115 mph. Hurricane Ivan (Alabama, 2004)

At the house shown in Figure 11-20, floodwater collapsed the breakaway wall and initiated progressive peeling of the EIFS wall covering. A suitable flashing at the top of the breakaway wall would have avoided the progressive failure. When a wall covering progressively fails above the top of a breakaway wall, wave spray and/or wind-driven water may cause interior damage.

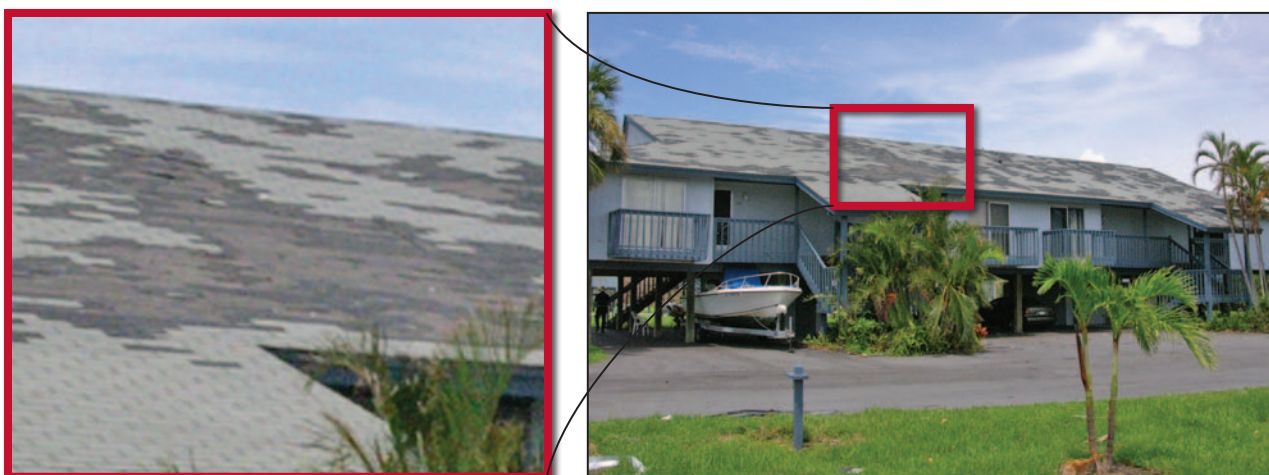
Figure 11-23.

Blow-off of several newer shingles on a roof that had been re-covered by installing new asphalt shingles on top of old shingles (newer shingles are lighter and older shingles are darker). Hurricane Charley (Florida, 2004)

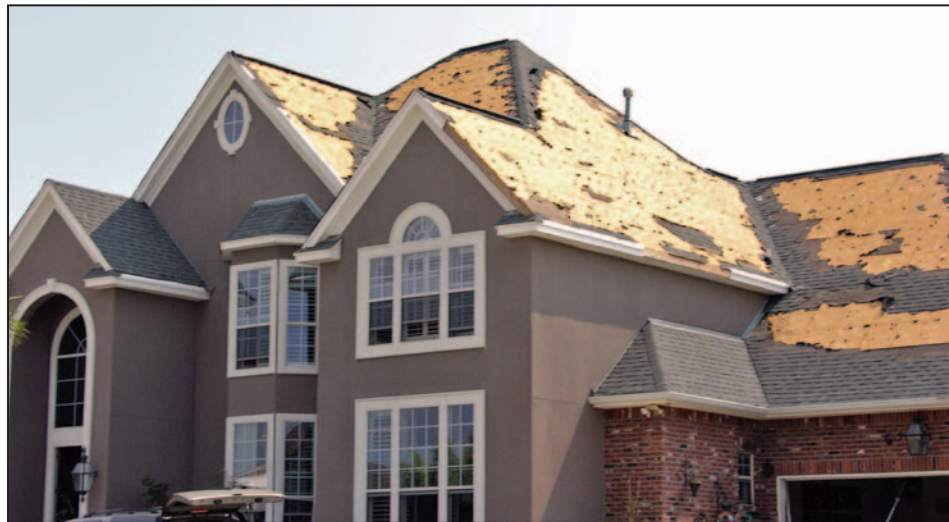
Figure 11-25.
Typical underlayment attachment; underlayment blow-off is common if the shingles are blown off, as shown. Estimated wind speed: 115 mph. Hurricane Katrina (Louisiana, 2005)

- **Enhanced Underlayment Option 3.** Option 3 is the typical underlayment scheme (i.e., a single layer of #15 felt tacked to the sheathing, as shown in Figure 11-25) with the added enhancement of self-adhering modified bitumen tape. This option provides limited protection against water infiltration if the shingles blow off. However, this option provides more protection than the typical underlayment scheme. Option 3 is illustrated in Fact Sheet 7.2 in FEMA P-499.

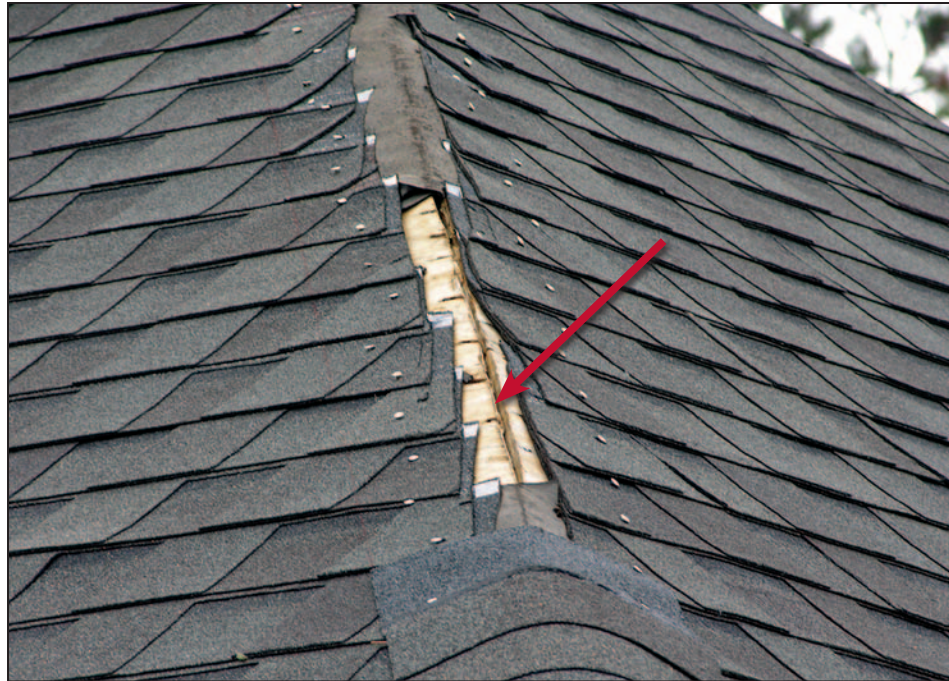
Figure 11-29. Underlayment that was not lapped over the hip; water entry possible at the sheathing joint (arrow). Estimated wind speed: 130 mph. Hurricane Katrina (Mississippi, 2005)

Shingle blow-off is commonly initiated at eaves (see Figure 11-30) and rakes (see Figure 11-31). Blow-off of ridge and hip shingles, as shown in Figure 11-29, is also common. For another example of blow-off of ridge

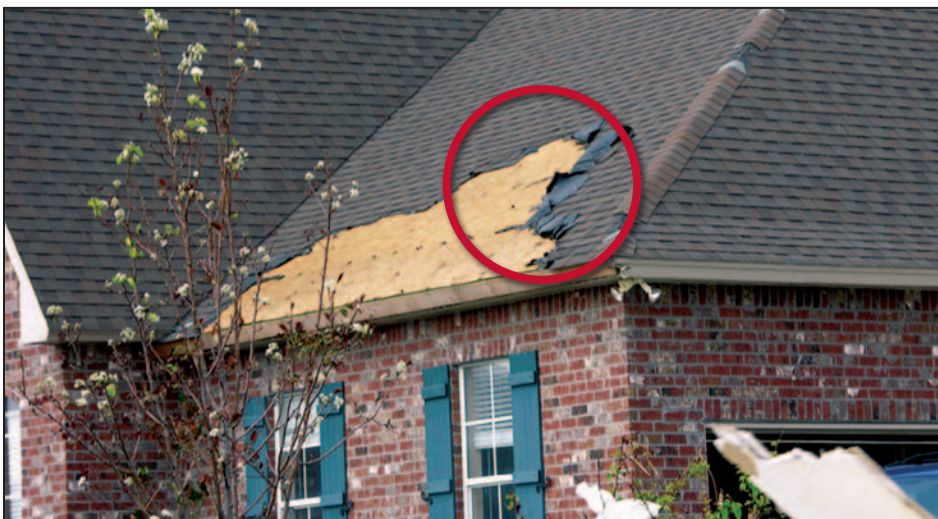
Figure 11-30. Loss of shingles and underlayment along the eave and loss of a few hip shingles. Estimated wind speed: 115 mph. Hurricane Katrina (Louisiana, 2005)

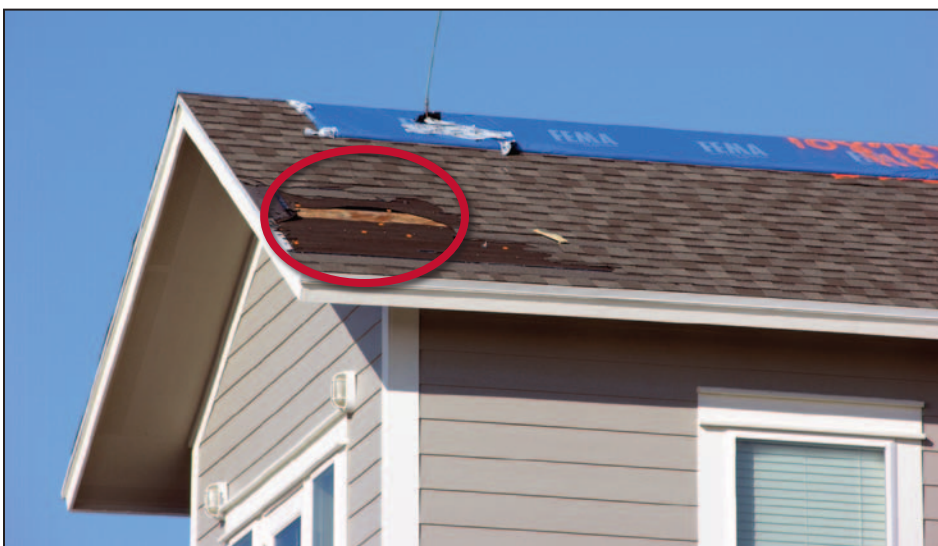
Figure 11-31. Loss of shingles and underlayment along the rake. Estimated wind speed: 110 mph. Hurricane Ike (Texas, 2008)

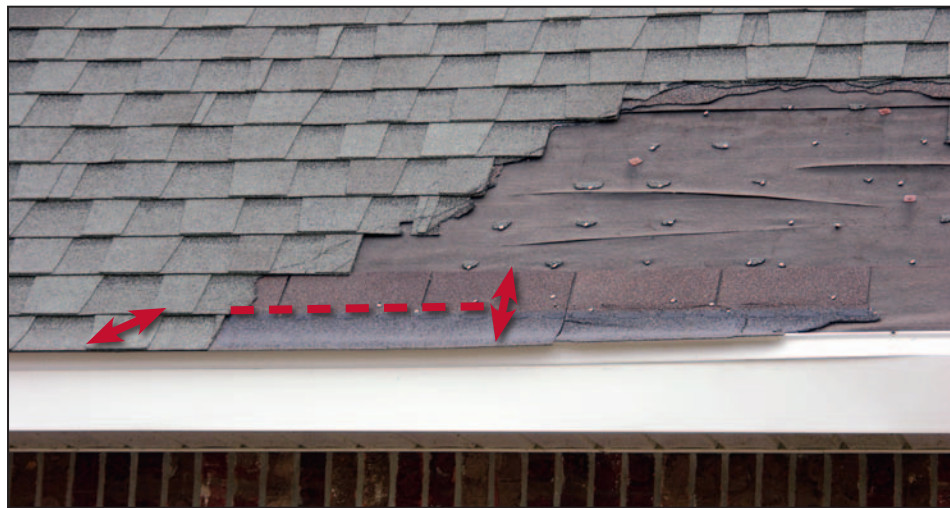
Figure 11-32.
Incorrect installation of the starter course (incorrectly rotated starter, right arrow, resulted in self-seal adhesive not near the eave, dashed line). Estimated wind speed: 130 mph. Hurricane Katrina (Mississippi, 2005)

Storm damage investigations have shown that when eave damage occurs, the starter strip was typically incorrectly installed, as shown in Figure 11-32. Rather than cutting off the tabs of the starter, the starter was rotated 180 degrees (right arrow). The exposed portion of the first course of shingles (left arrow) was unbounded because the self-seal adhesive (dashed line) on the starter was not near the eave. Even when the starter is correctly installed (as shown on shingle bundle wrappers), the first course may not bond to the starter because of substrate variation. Fact Sheet 7.3 in FEMA P-499 provides information about enhanced attachment along the eave, including special recommendations regarding nailing, use of asphalt roof cement, and overhang of the shingle at the eave.

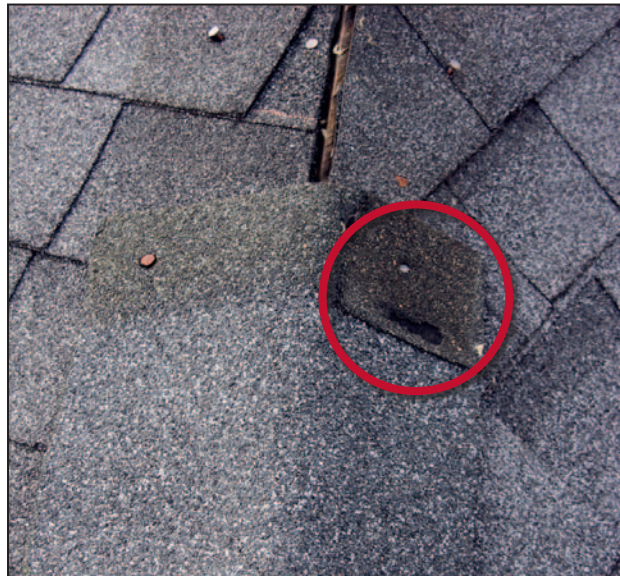
Figure 11-35.
Inadequate sealing of the self-sealing adhesive at a hip as a result of the typical hip installation procedure. Estimated wind speed: 105 mph. Hurricane Katrina (Mississippi, 2005)

Storm damage investigations have shown that when hip and ridge shingles are blown off, there was a lack of bonding of the self-seal adhesive. Sometimes some bonding occurred, but frequently none of the adhesive had bonded. At the hip shown in Figure 11-35, the self-seal adhesive made contact only at a small area on the right side of the hip (circle). Also, at this hip, the nails were above, rather than below, the adhesive line. Lack of bonding of the hip and ridge shingles is common and is caused by substrate irregularity along the hip/ridge line. Fact Sheet 7.3 in FEMA P-499 provides recommendations regarding the use of asphalt roof cement to ensure bonding in order to enhance the attachment of hip and ridge shingles.

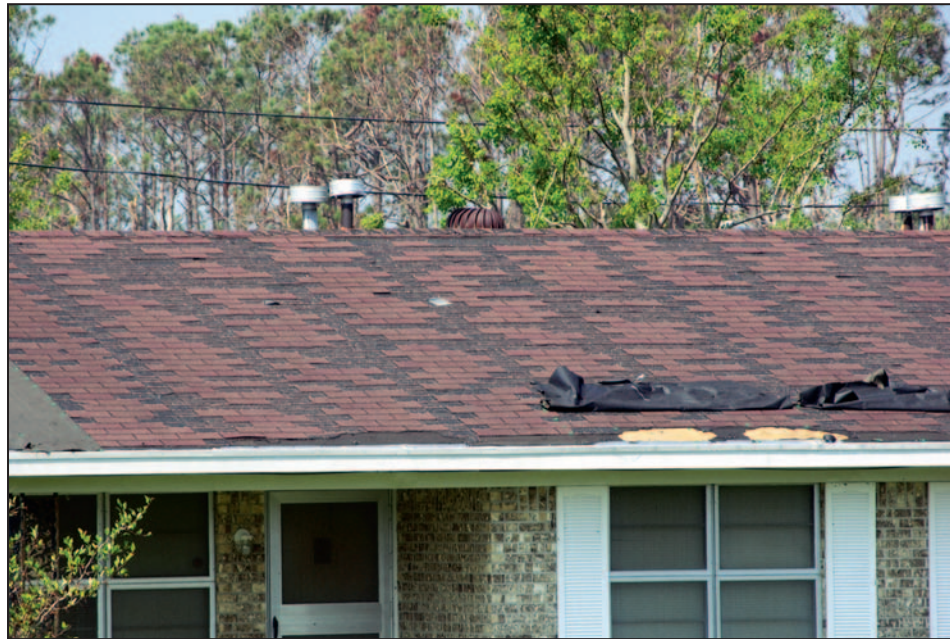
Figure 11-38.
Shingles that unzipped at the band lines because the raking method was used to install them. Estimated wind speed: 135 mph. Hurricane Katrina (Mississippi, 2005)

Shingle damage is also sometimes caused by installing shingles via the raking method. With this method, shingles are installed from eave to ridge in bands about 6 feet wide. Where the bands join one another, at every other course, a shingle from the previous row needs to be lifted up to install the end nail of the new band shingle. Sometimes installers do not install the end nail, and when that happens, the shingles are vulnerable to unzipping at the band lines, as shown in Figure 11-38. Raking is not recommended by the National Roofing Contractors Association or the Asphalt Roofing Manufacturers Association.

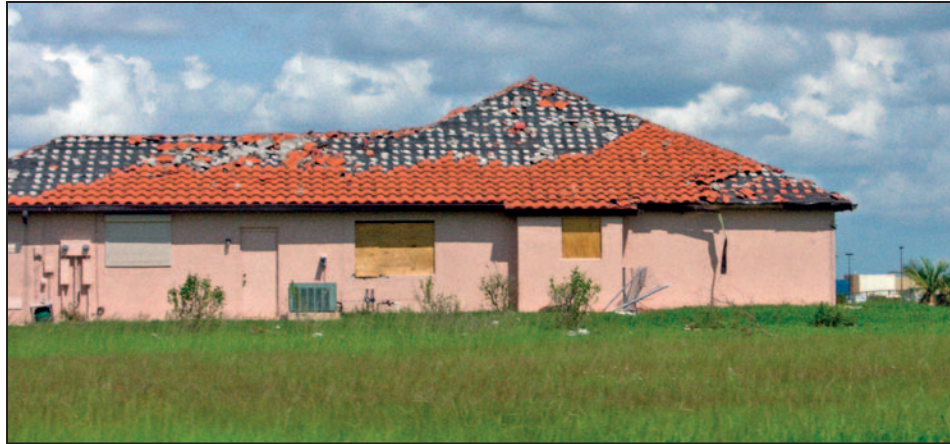
Figure 11-43.
Blown-off adhesive-set tile. Note the very small contact area of the foam at the tile heads (left side of the tiles) and very small contact at the nose (circles). Estimated wind speed: 140 to 160 mph. Hurricane Charley (Florida, 2004)

Figure 11-43 shows a house with adhesive-set tile. There were significant installation problems with the foam paddies, including insufficient contact area between the patty and the tile. As can be seen in Figure 11-43, most of the foam failed to make contact with the tile. Some of the foam also debonded from the mineral surface cap sheet underlayment (see Figure 11-44).

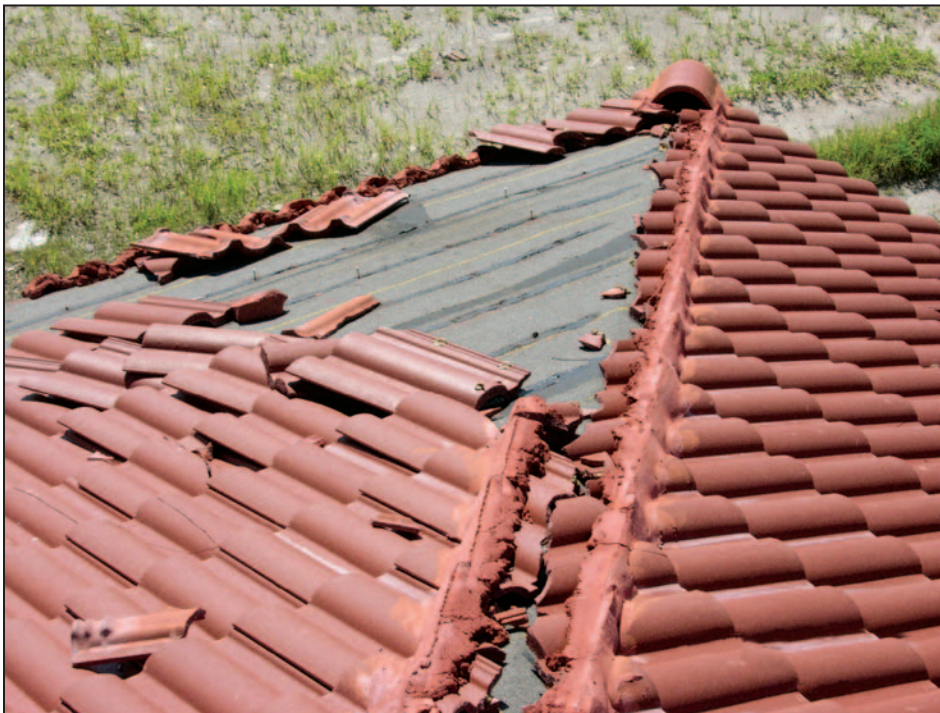
Figure 11-45.
Blow-off of mechanically
attached tiles. Estimated
wind speed: 140 to 160
mph. Hurricane Charley
(Florida, 2004)

Figure 11-45 shows tiles that were mechanically attached with screws. At the blow-off area, some of the screws remained in the deck, while others were pulled out. The ridge tiles were set in mortar.

Damage investigations have revealed that blow off of hip and ridge failures are common (see Figures 11-39, 11-45, and 11-46). Some of the failed hip/ridge tiles were attached with mortar (see Figure 11-45), while others were mortared and mechanically attached to a ridge board. At the roof shown in Figure 11-46, the hip tiles were set in mortar and attached to a ridge board with a single nail near the head of the hip tile.

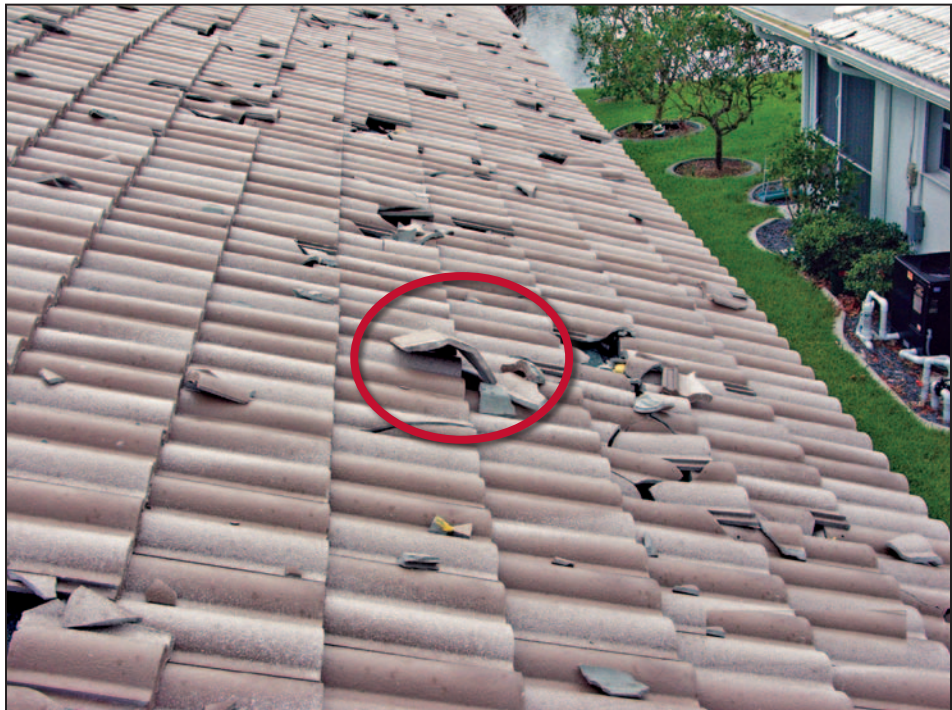
Figure 11-47.
Damage to field tiles
caused by tiles from
another area of the
roof, including a hip
tile (circle). Estimated
wind speed: 140 to 160
mph. Hurricane Charley
(Florida, 2004)

Because of the brittle nature of tile, tile is often damaged by wind-borne debris, including tile from nearby buildings or tile from the same building (see Figure 11-47).

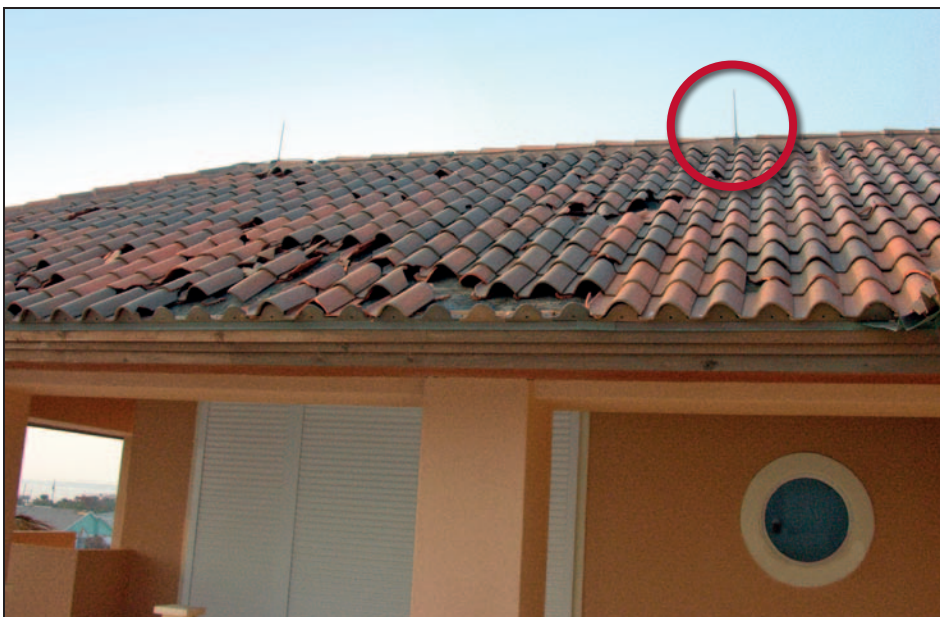
The house in Figure 11-48 had a lightning protection system (LPS), and the LPS conductors were placed under the ridge tile. Conductors are not susceptible to wind damage if they are placed under the tile and the air terminals (lightning rods) are extended through the ridge.

Figure 11-48.
The fastener heads on this mechanically attached tile roof had corroded; air terminals (lightning rods) in a lightning protection system (circle). Hurricane Ivan (Alabama, 2004)

At houses on the coast, fasteners and clips that are used to attach tiles are susceptible to corrosion unless they are stainless steel. Figure 11-48 shows a 6-year-old tile roof on a house very close to the ocean that failed because the heads of the screws attaching the tile had corroded off. Stainless steel straps, fasteners, and clips are recommended for roofs within 3,000 feet of an ocean shoreline (including sounds and back bays).

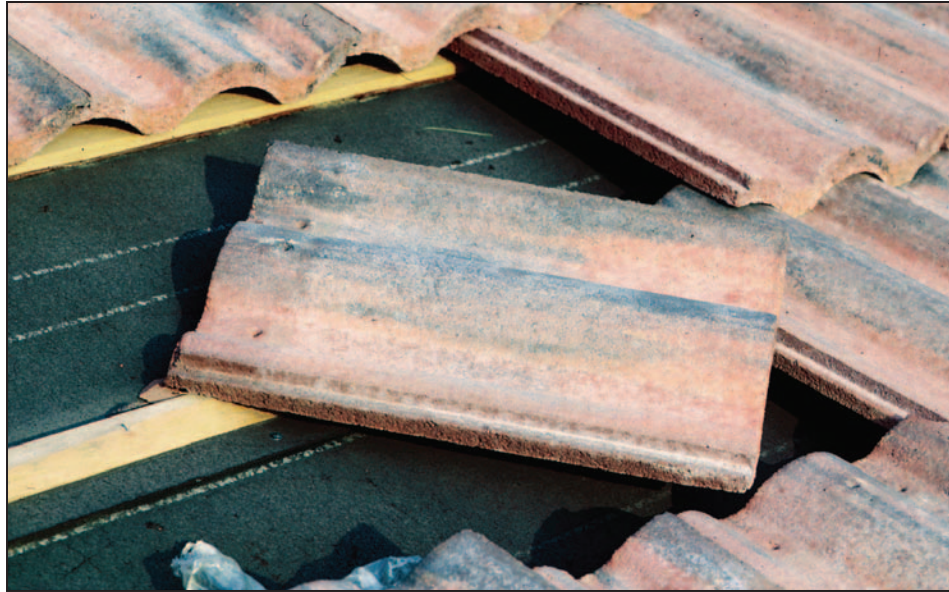
Figure 11-49.
Area of the roof where
tiles were not nailed to
batten strips. Northridge
Earthquake (California,
1994)

- If tiles are laid on battens, supplemental mechanical attachment is recommended. When tiles are only loose laid on battens, they can be shaken off, as shown in Figure 11-49 where most of the tiles on the roof were nailed to batten strips. However, in one area, several tiles were not nailed. Because of the lack of nails, the tiles were shaken off the battens.

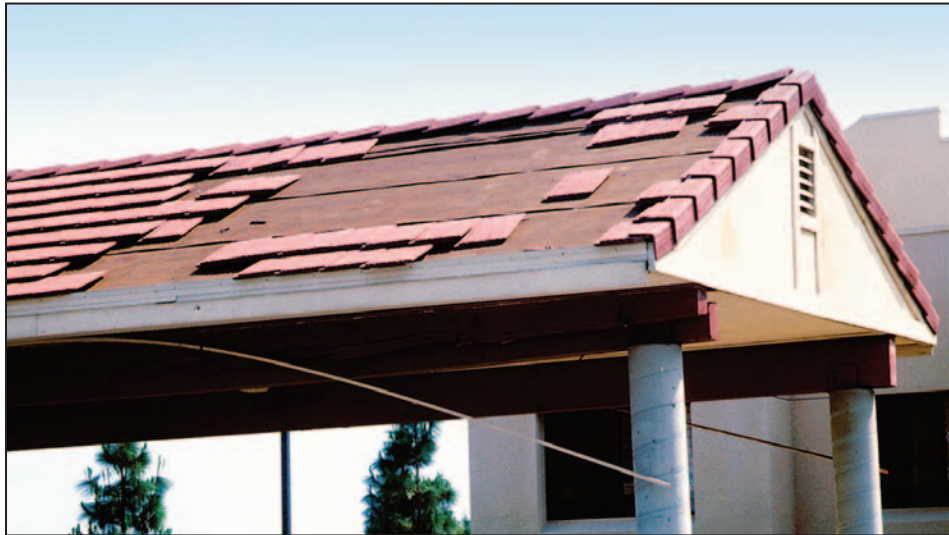
Figure 11-50.
Tiles that were nailed
to thin wood sheathing.
Northridge Earthquake
(California, 1994)

- Tiles nailed only at the head may or may not perform well. If they are attached with a smooth-shank nail into a thin plywood or OSB sheathing, pullout can occur. Figure 11-50 shows tiles that were nailed to thin wood sheathing. During the earthquake, the nose of the tiles bounced and pulled out the nails. Specifying ring-shank or screw-shank nails or screws is recommended, but even with these types of fasteners, the nose of the tile can bounce, causing enlargement of the nail hole by repeated pounding. To overcome this problem, wind clips near the nose of the tile or a bead of adhesive between the tiles at the headlap should be specified.

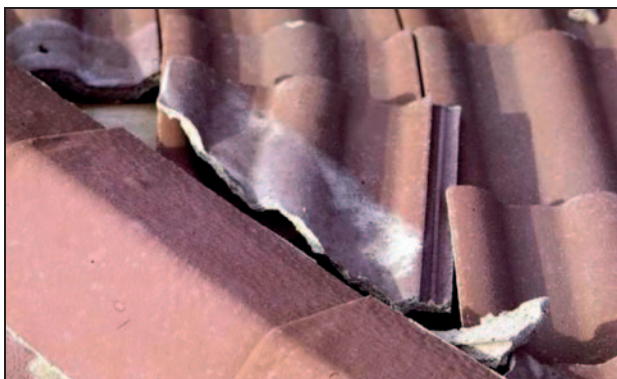
Figure 11-51.
Tile that slipped out from under the hip tiles.
Northridge Earthquake (California, 1994)

- When tiles are cut to fit near hips and valleys, the portion of the tile with the nail hole(s) is often cut away. Figure 11-51 shows a tile that slipped out from under the hip tiles. The tile that slipped was trimmed to fit at the hip. The trimming eliminated the nail holes, and no other attachment was provided. The friction fit was inadequate to resist the seismic forces. Tiles must have supplemental securing to avoid displacement of these loose tiles.

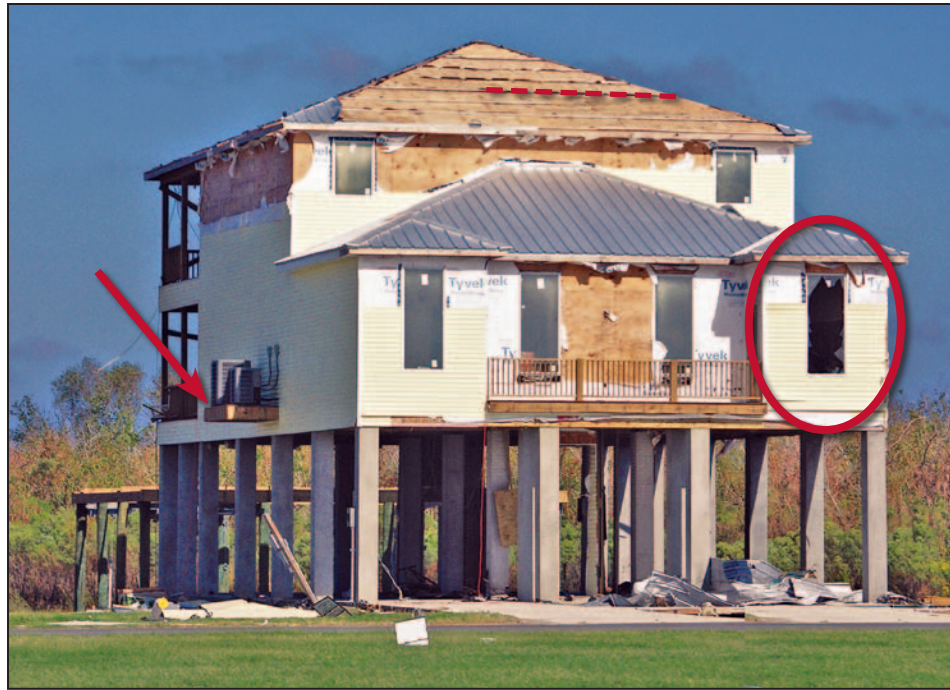
Figure 11-52.
Blow-off of one of the nailers (dashed line on roof) caused panels to progressively fail; cantilevered condenser platform (arrow); broken window (circle). Estimated wind speed: 130 mph. Hurricane Katrina (Louisiana, 2005)

Figure 11-52 illustrates the importance of load path. The metal roof panels were screwed to wood nailers that were attached to the roof deck. The panels were well attached to the nailers. However, one of the nailers was inadequately attached. This nailer lifted and caused a progressive lifting and peeling of the metal panels. Note the cantilevered condenser platform (arrow), a good practice, and the broken window (circle).

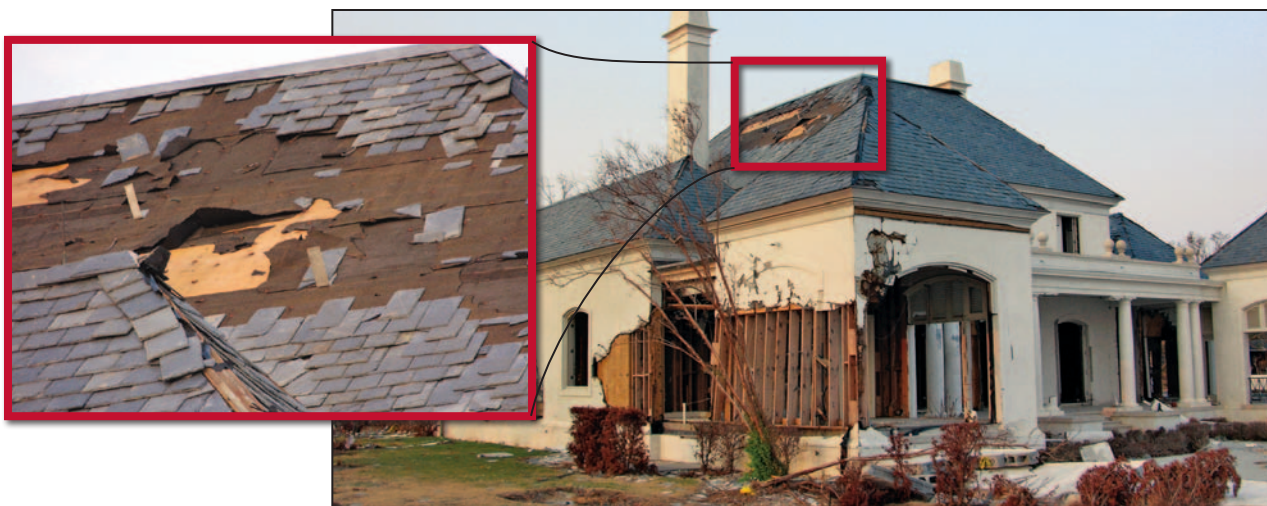
Figure 11-53.
Damaged slate roof with nails that typically pulled out of the deck. Some of the slate broke and small portions remained nailed to the deck. Estimated wind speed: 130 mph. Hurricane Katrina (Mississippi, 2005)

Because of limited market share of slate in areas where research has been conducted after high-wind events, few data are available on its wind performance. However, as shown in Figure 11-53, wind damage can occur.

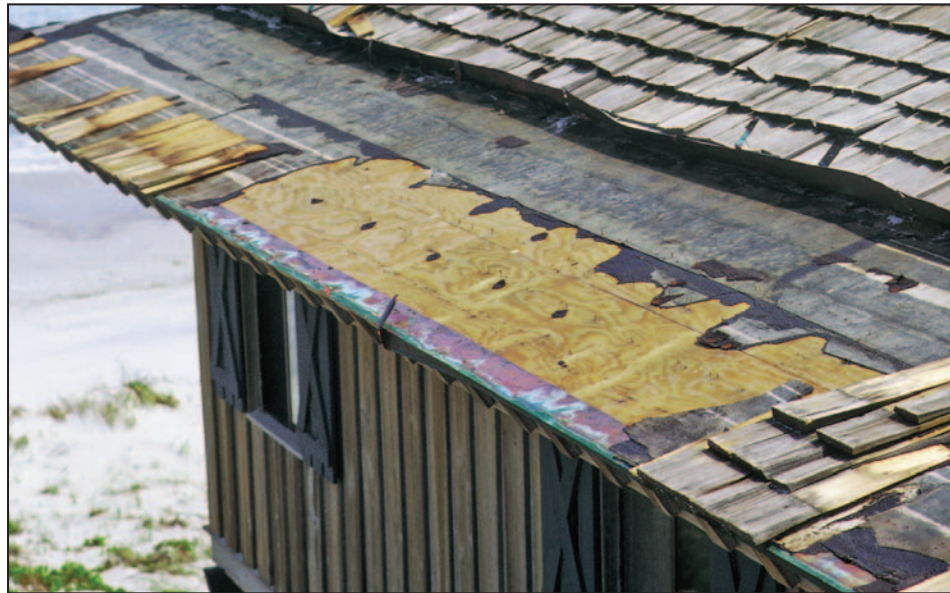
Figure 11-54.
Loss of wood shingles
due to fastener corrosion.
Hurricane Bertha (North
Carolina, 1996)

For enhanced durability, preservative-treated wood is recommended for shingle or shake roofs on coastal buildings. Stainless steel fasteners are recommended for roofs within 3,000 feet of an ocean shoreline (including sounds and back bays). See Figure 11-54 for an example of shingle loss due to corrosion of the nails.
