Coastal Construction: Historical Perspective on Storm Damage

Coastal Construction Manual Chapter 2, Volume I 4th Edition

Historical Perspective

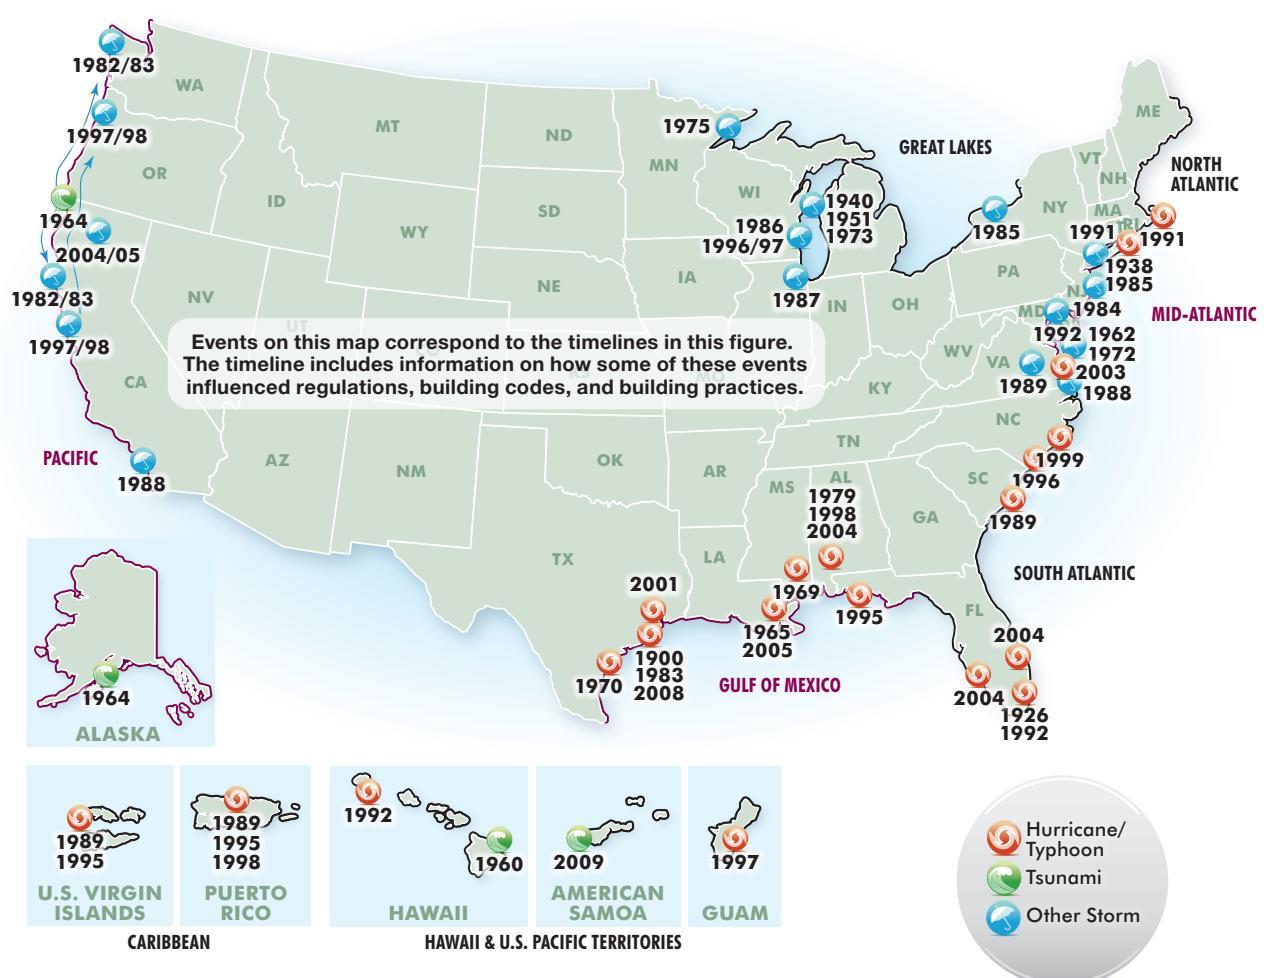
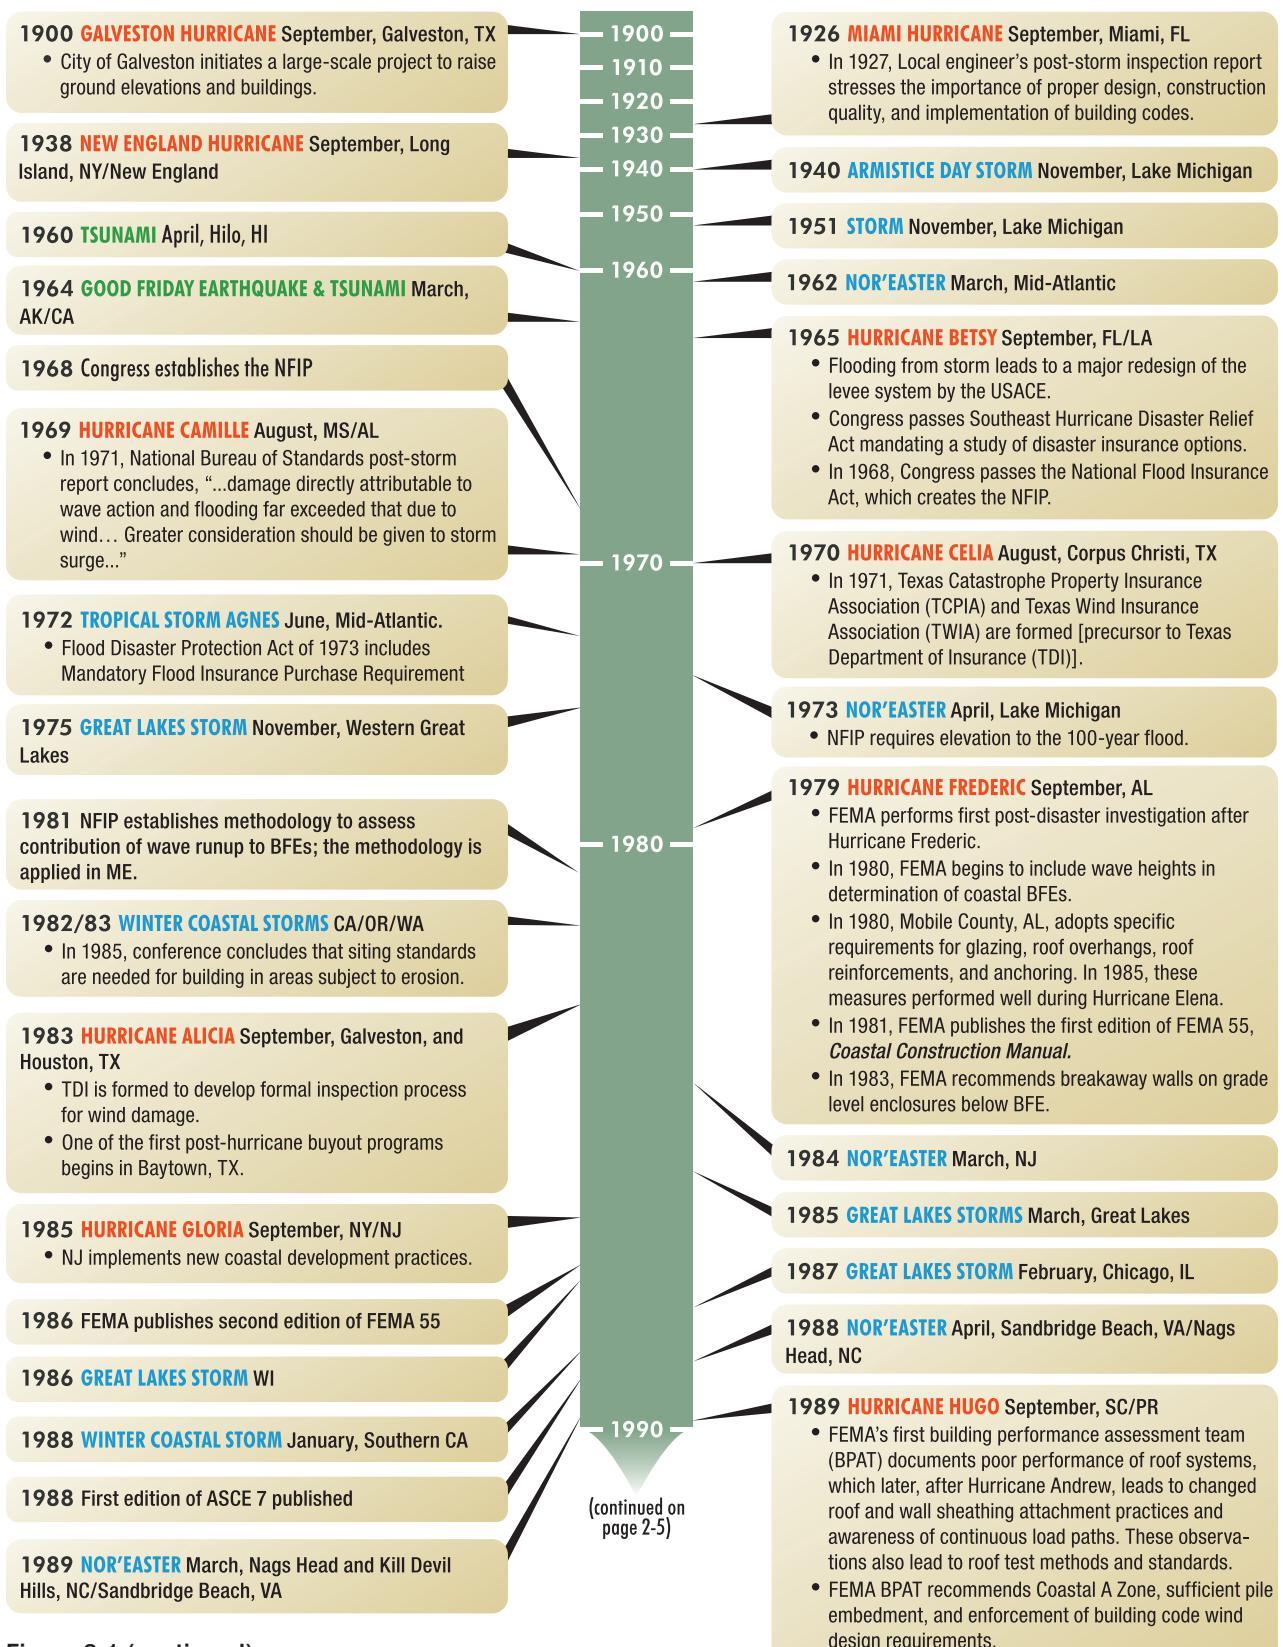
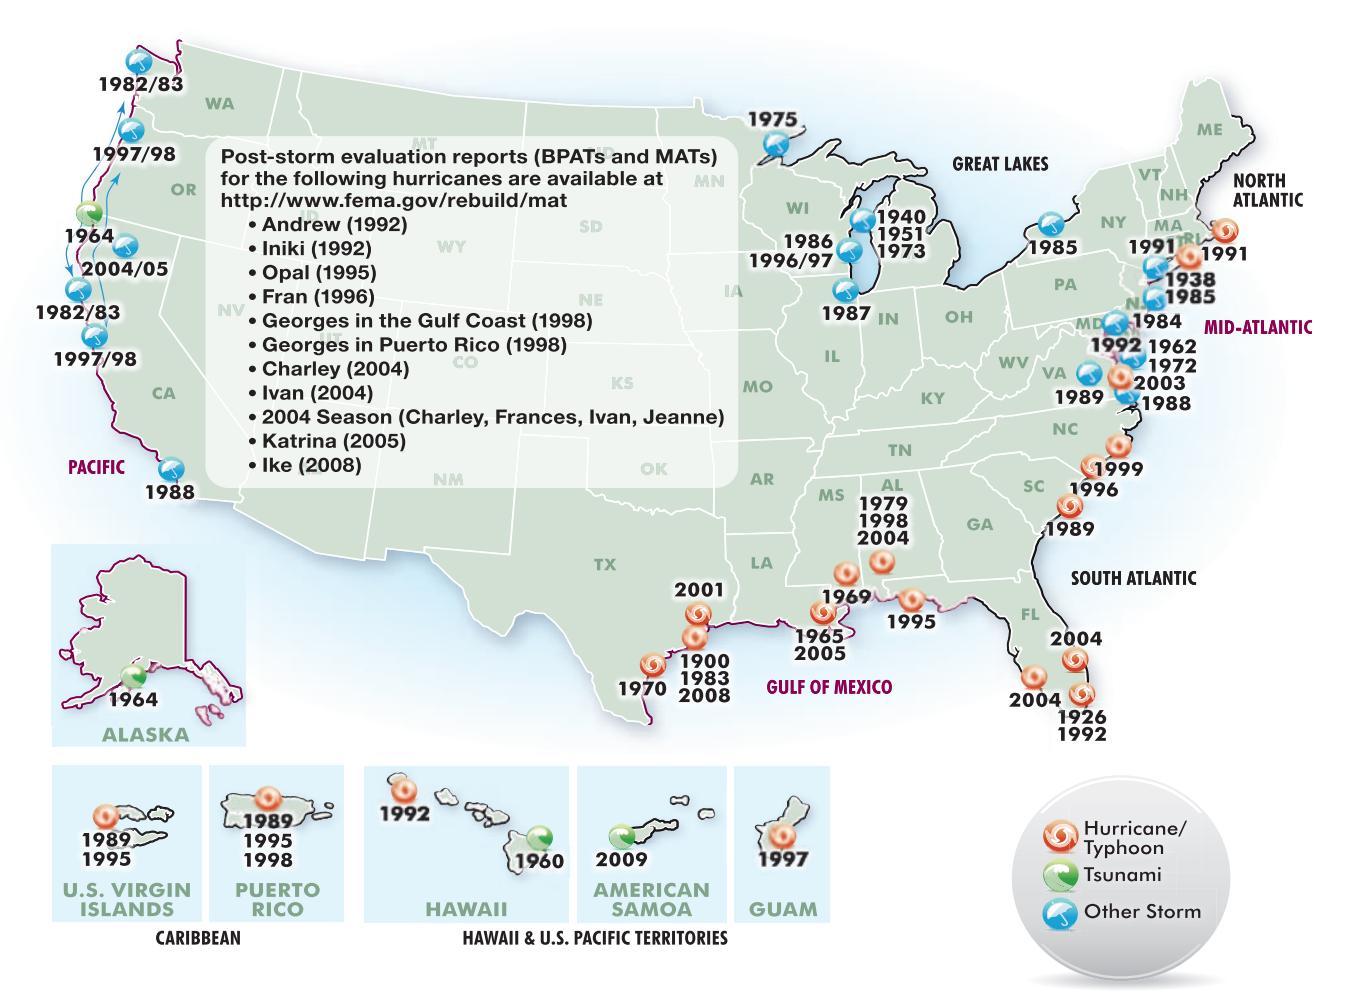
Figure 2-1.

Map and timeline of significant coastal flood and wind events, and milestones for regulations, building codes, and building practices

mitigation practices in the United States since the year 1900. Each event is color-coded by hazard type and corresponds to a symbol on the map where the storm occurred. The map shows the eight coastal regions defined in this chapter.

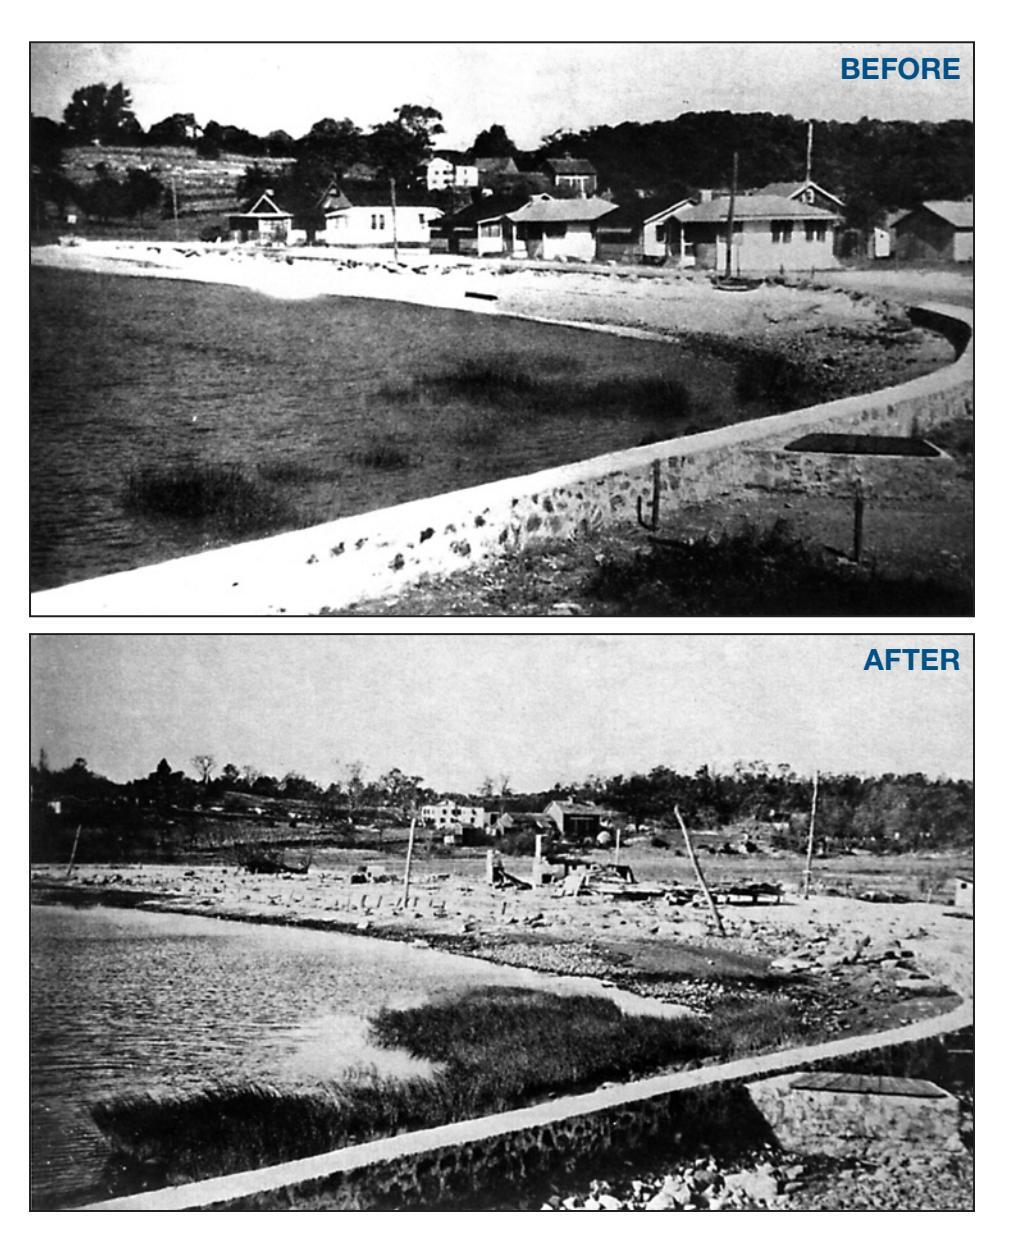
Figure 2-2. Schell Beach before and after the Long Island Express Hurricane in 1938; houses near the shoreline were destroyed and more distant houses were damaged (Guilford, CT)

In 1938, the *"Long Island Express" hurricane* moved rapidly up the east coast from New York through New England. The storm caused widespread surge and wind damage to buildings, and is still used as a benchmark for predicting worst-case scenario damage in the region (Figure 2-2). Although not shown in the photograph, this hurricane also destroyed many elevated homes along this stretch of coastline.

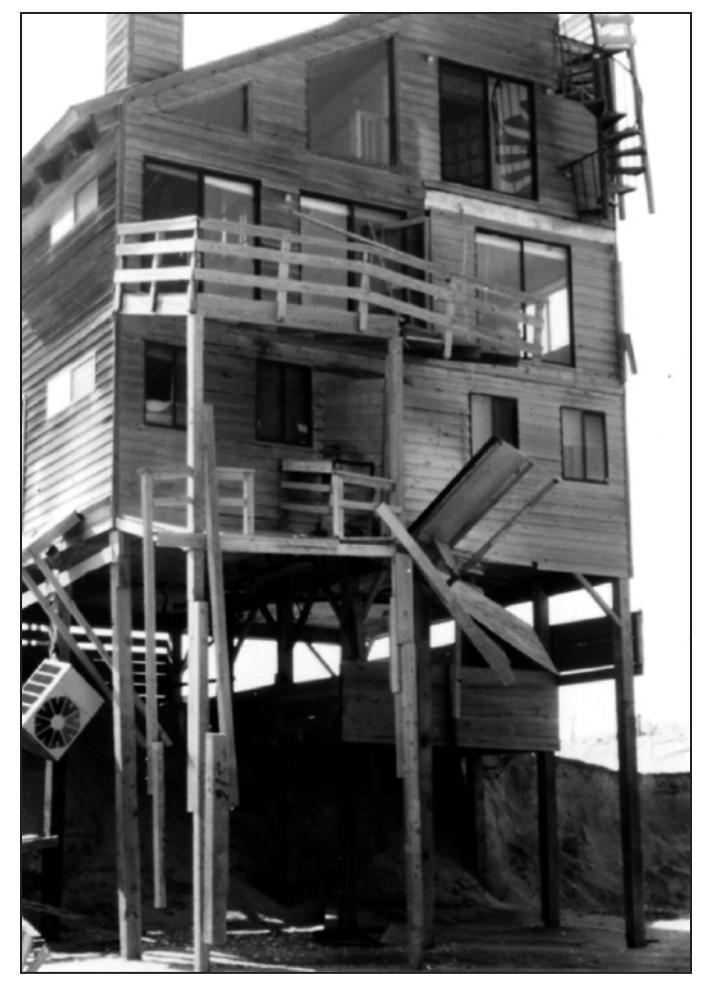
Although this house seems to have lost only several decks and a porch during the March 1989 nor'easter, the loss of supporting soil due to long-term erosion left its structural integrity in question following successive storms In September 2003, *Hurricane Isabel* made landfall near Cape Lookout, NC, as a Category 2 hurricane, breaching the barrier island. Storm surge and heavy rainfall caused extensive flooding across the Mid-Atlantic region, especially in areas adjacent to the Chesapeake Bay. Maximum observed water levels at stations along the Chesapeake Bay exceeded historical observations (NOAA 2004).

An April 1988 nor'easter caused foundation damage to elevated homes in Virginia and North Carolina. Long-term shoreline erosion, coupled with the effects of three previous coastal storms, had left the area vulnerable. Inspections following the 1988 nor'easter revealed that repairs to previous foundation damage were only partially effective. In some cases, ineffective repairs implemented after storms resulted in subsequent storm damage that may not have occurred if the original repair had been properly made (URS 1989). A March 1989 nor'easter in the same area caused even further foundation damage. The damage from the 1988 and 1989 storms showed that longterm erosion makes buildings increasingly vulnerable (Figure 2-3) to the effects of even minor storms (URS 1990).

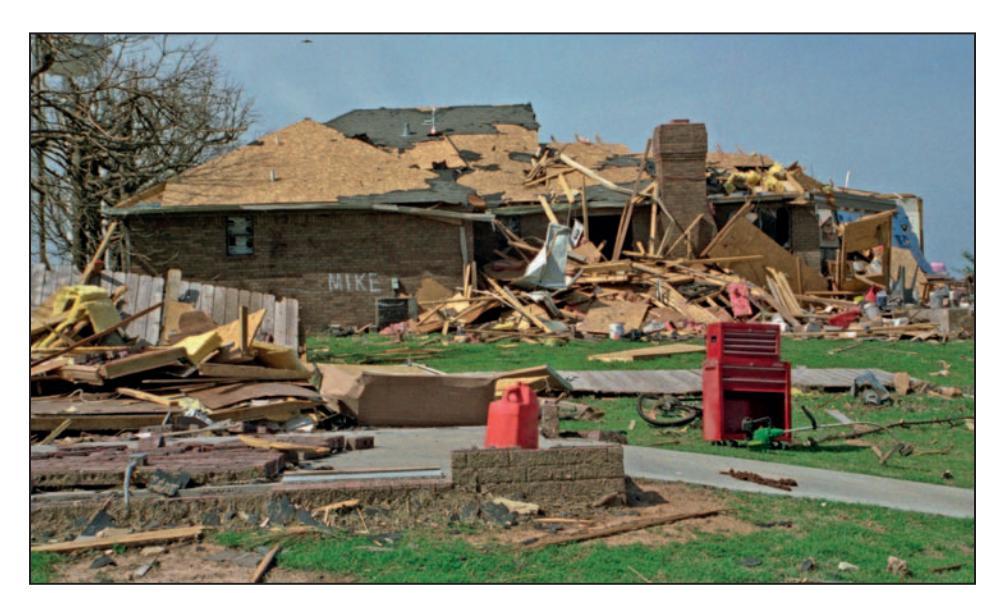
Figure 2-4.

Roof structure failure due to inadequate bracing and inadequate fastening of the roof deck, Hurricane Andrew (Dade County, FL, 1992)

In August 1992, *Hurricane Andrew* struck the southeast Atlantic coast. This hurricane remains one of the most memorable hurricanes to hit this region and one of the costliest to date. The majority of the damage from this hurricane was due to wind; many of the failures were traced to inadequate connections between building elements (Figure 2-4). As such, buildings could not resist wind forces because of the lack

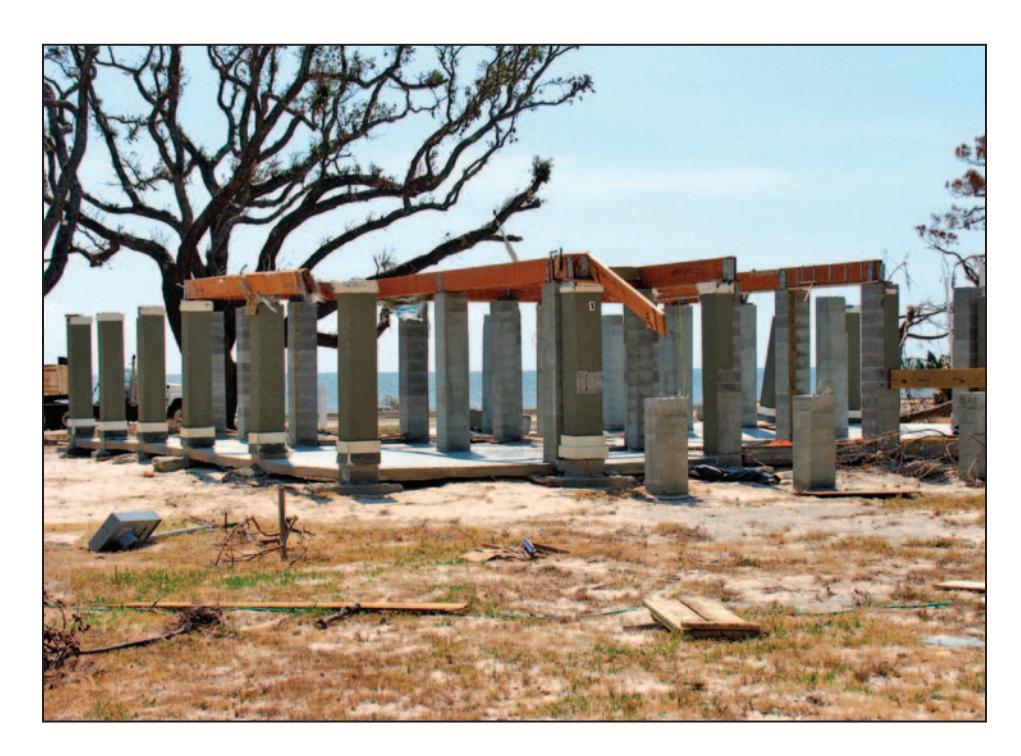
Figure 2-5. This elevated house atop a masonry pier foundation was lost, probably due to waves and storm surge reaching above the top of the foundation, Hurricane Katrina (Long Beach, MS, 2005)

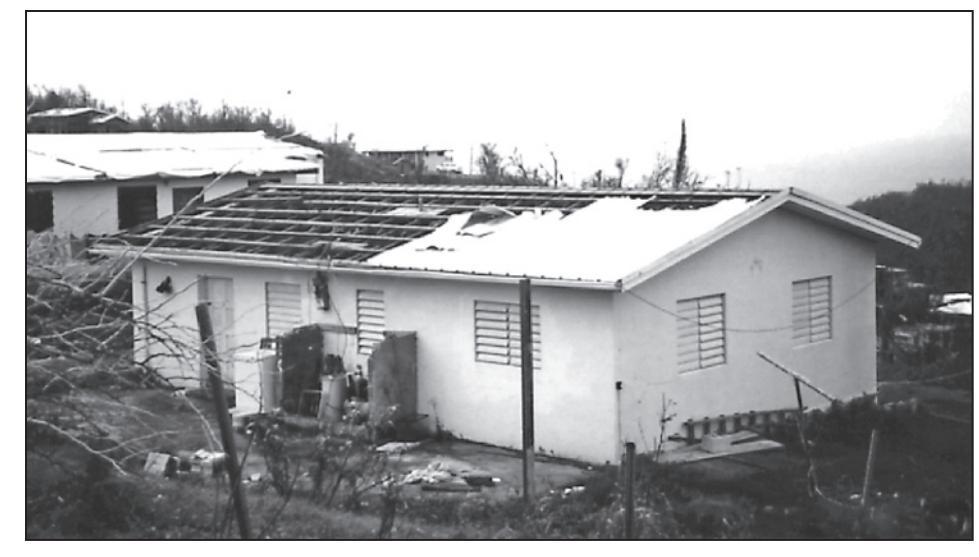
Figure 2-6. This house lost most of its metal roof covering due to high winds during Hurricane Marilyn in 1995 (location unknown) SOURCE: NRCA 1996

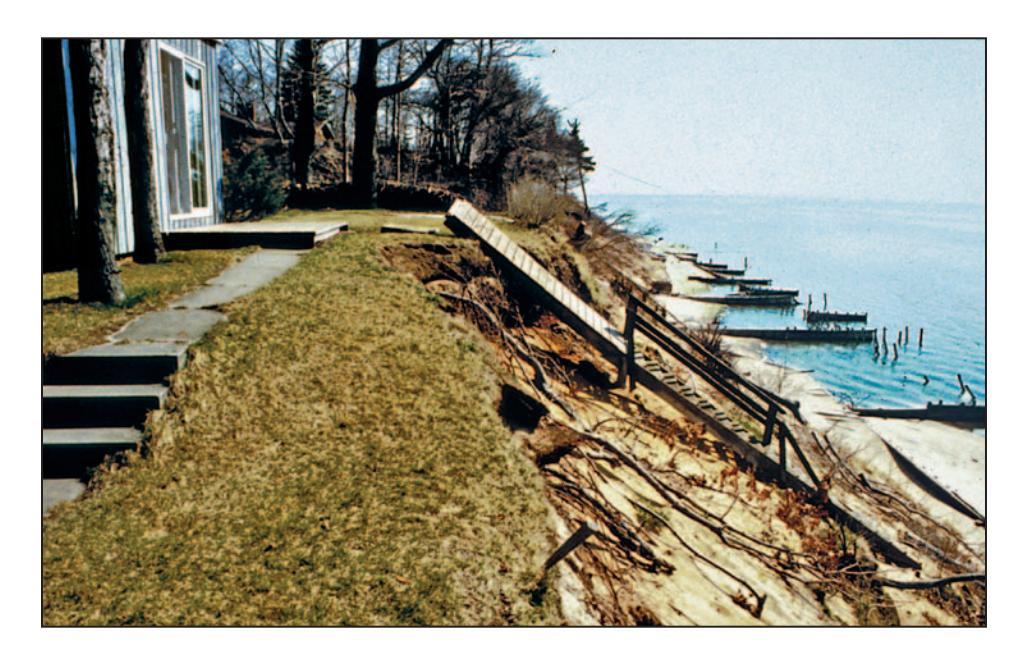
Figure 2-7. Erosion along the Lake Michigan shoreline at Holland, MI, resulting from high lake levels and storm activity (August 1988) SOURCE: MARK CROWELL, FEMA

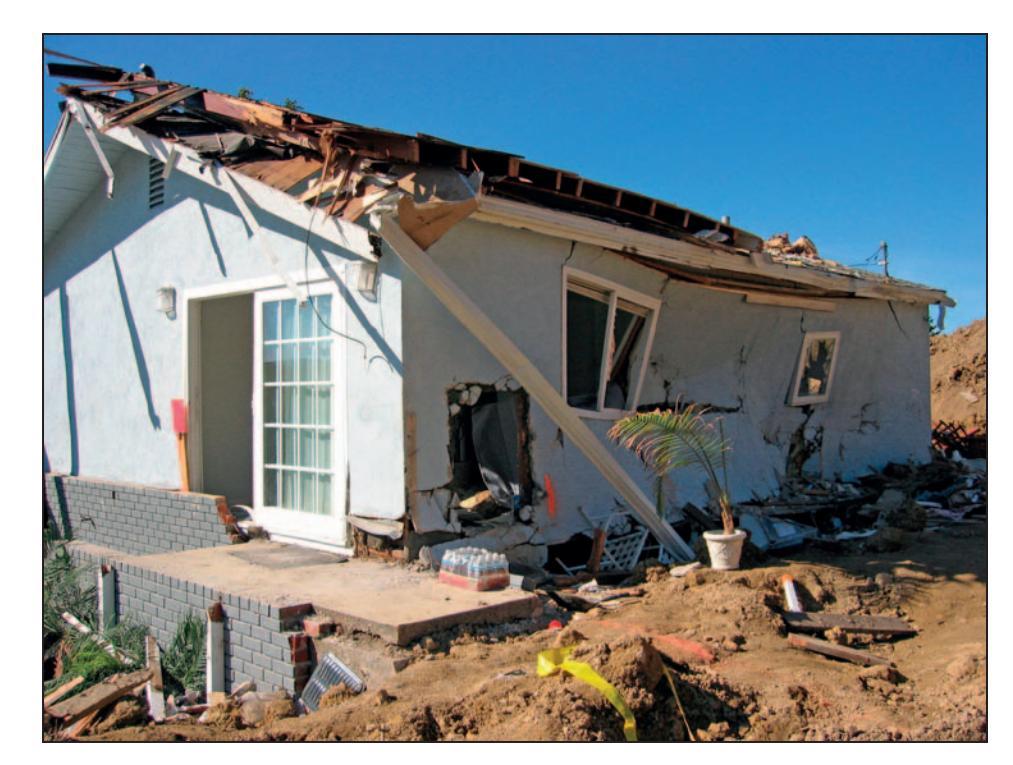
Figure 2-8.

This building experienced structural damage due to a landslide in La Conchita, CA, after a January 2005 storm event SOURCE: JOHN SHEA, FEMA

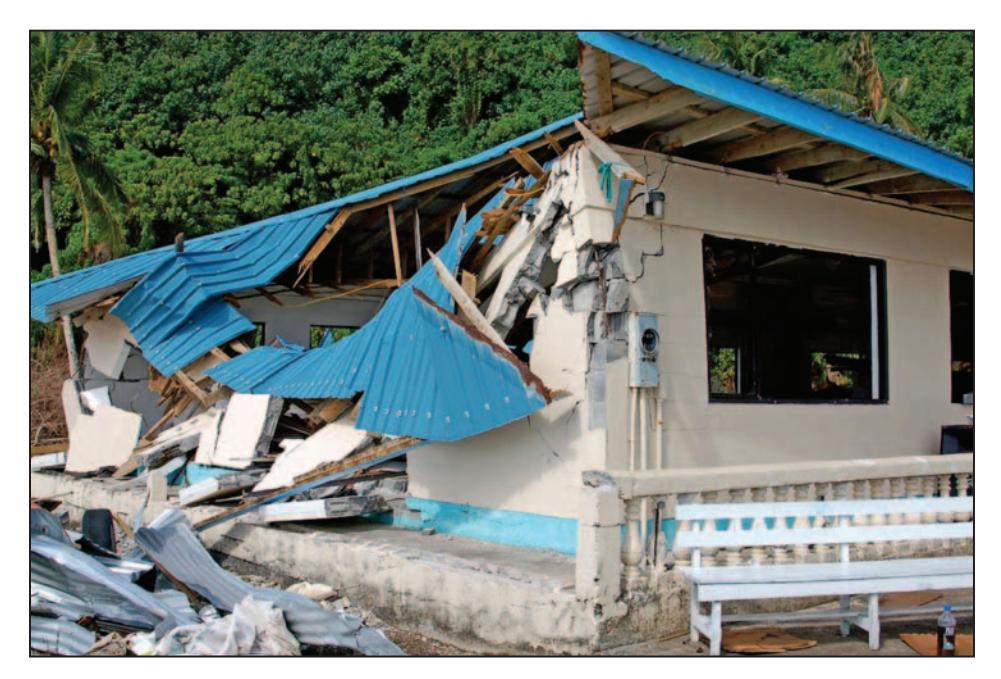
Figure 2-9. Tsunami damage at Poloa, American Samoa SOURCE: ASCE, USED WITH PERMISSION

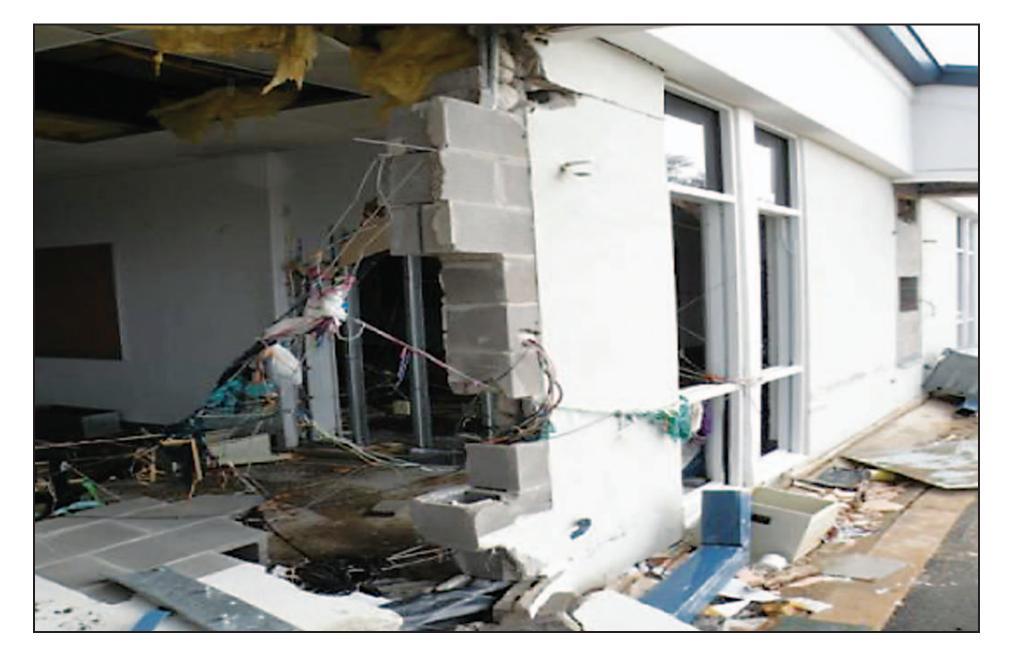
Figure 2-10. School located approximately 1.3 miles from the Gulf shoreline damaged by storm surge and small waves, Hurricane Ike (Cameron Parish, LA, 2008) may be exposed to wind pressures higher than in areas of flat terrain, especially at high pressure zones of the roof. The house in Figure 2-11 sustained damage at the roof edge and roof corners, even though the hurricane was below the design event and wind damage should not have occurred. Recent studies have influenced wind design standards to increase design wind pressures on these exposed structures. Failure to consider the *effects of topography* (and changes in topography such as bluff erosion) on wind speeds can lead to an underestimation of design wind speeds. *Siting buildings on bluffs* or near high-relief topography requires special attention by the designer.

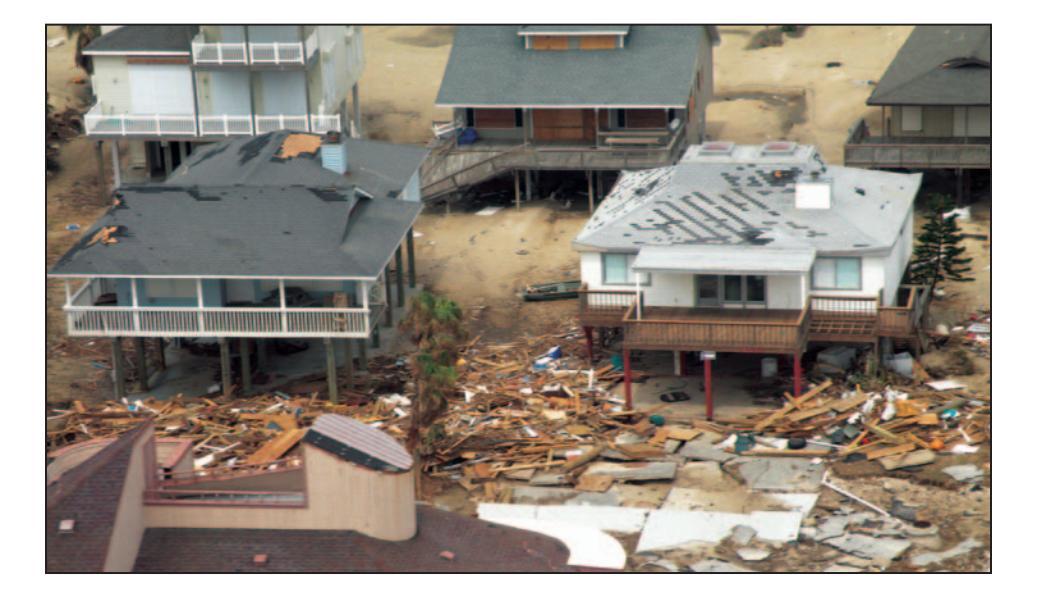
Figure 2-11.

Galveston Island beach house with wind damage to roof in high pressure zones at roof edge and roof corners, Hurricane Ike, 2008

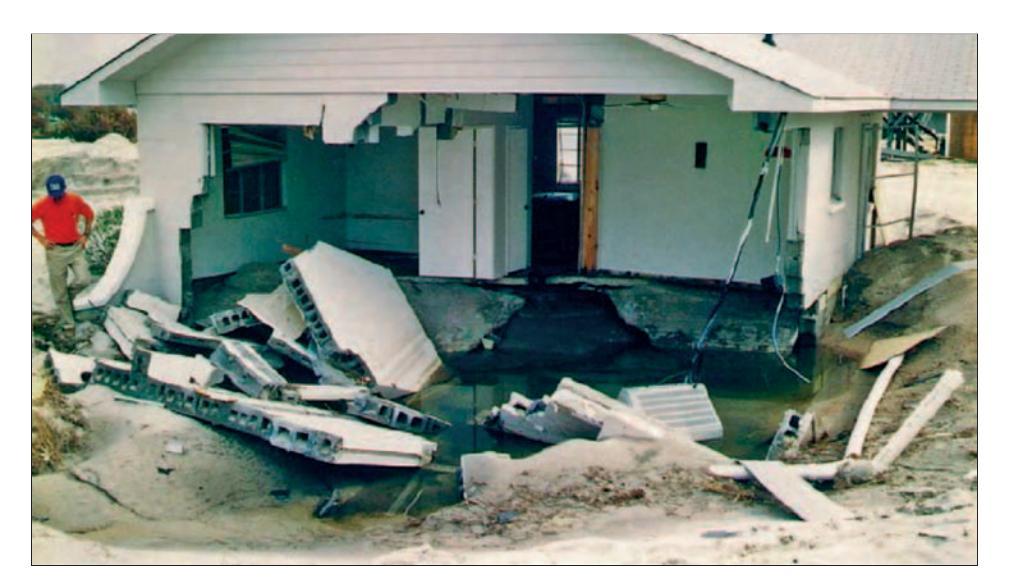
Figure 2-13. Extreme case of localized scour undermining a Zone A continuous perimeter wall foundation located several hundred feet from the shoreline, Hurricane Fran (Topsail Island, NC, 1996) Figure 2-14. Successful example of well-elevated and embedded pile foundation tested by Hurricane Katrina. Note adjacent building failures (Dauphin Island, AL, 2005)

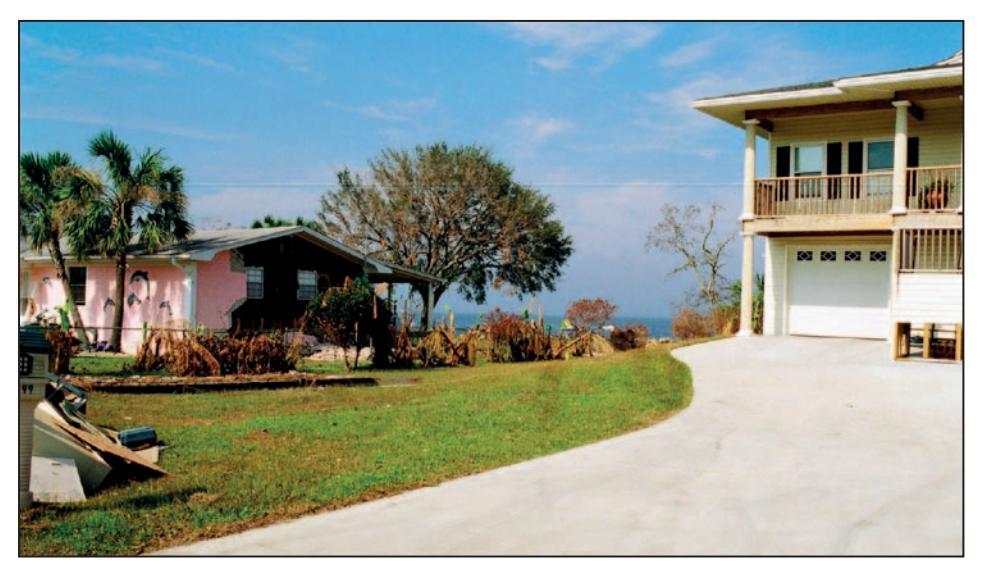
Figure 2-15.

The pre-FIRM house (left) experienced damage due to surge and waves while the newer, elevated, post-FIRM house (right) experienced minimal damage, Hurricane Ivan (Santa Marina, Pensacola, FL, 2005)

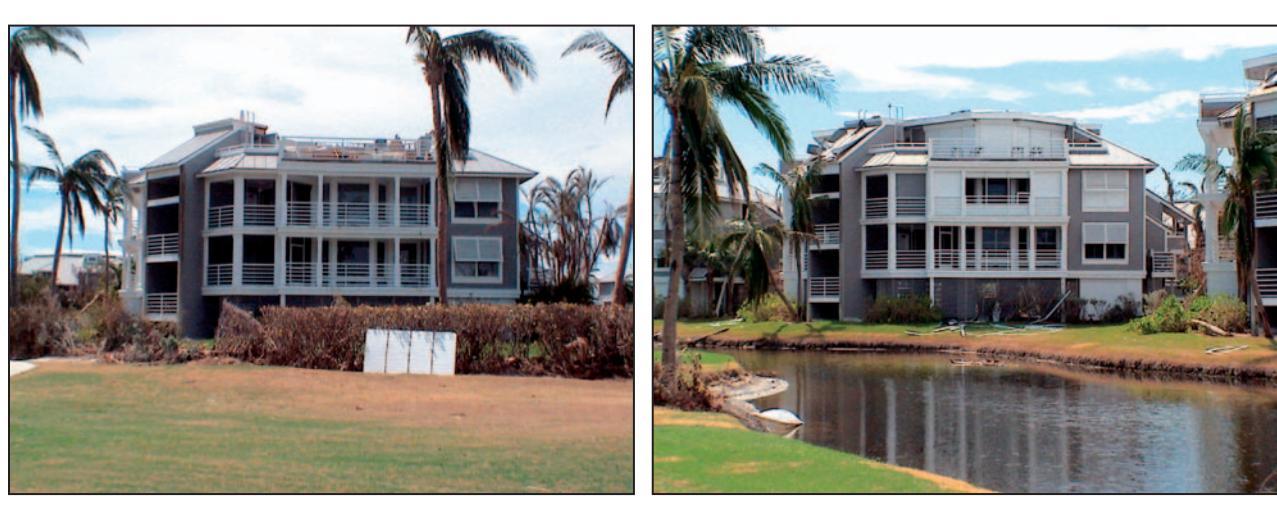
Figure 2-16.

The unprotected building sustained roof damage due to pressurization (left) while the other sustained only minor damage because it was protected by shutters (right), Hurricane Charley (Captiva Island, FL, 2004)

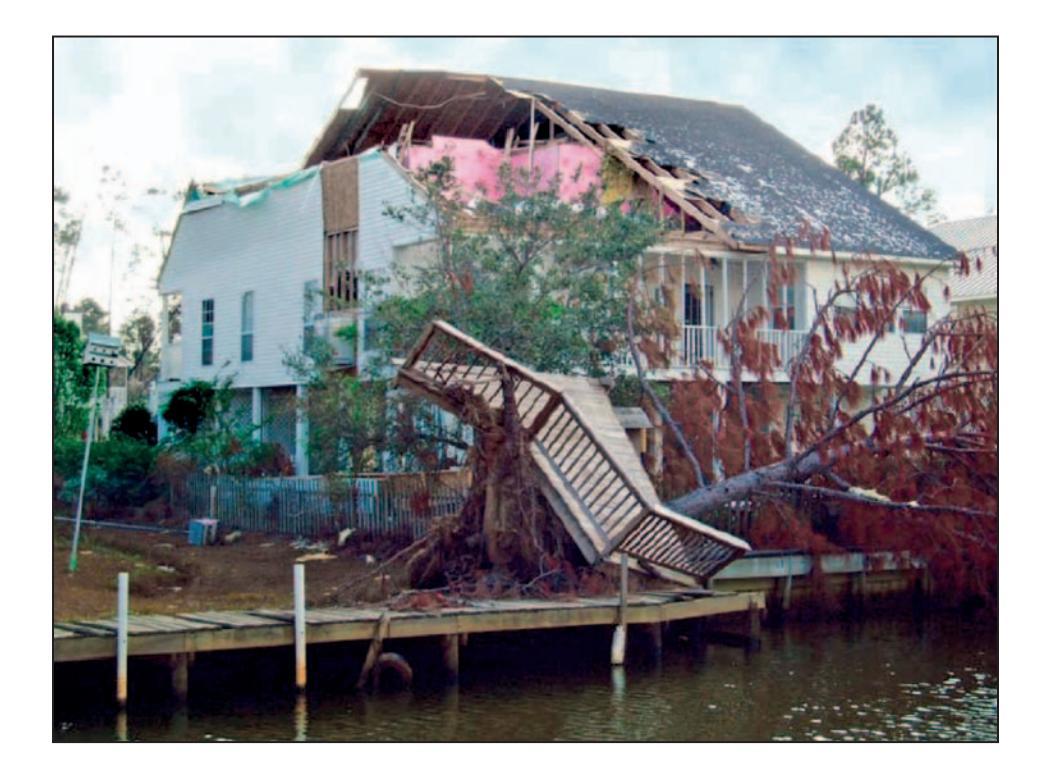
Figure 2-17. Wind damage to roof structure and gable end wall, Hurricane Katrina (Pass Christian, MS, 2005)

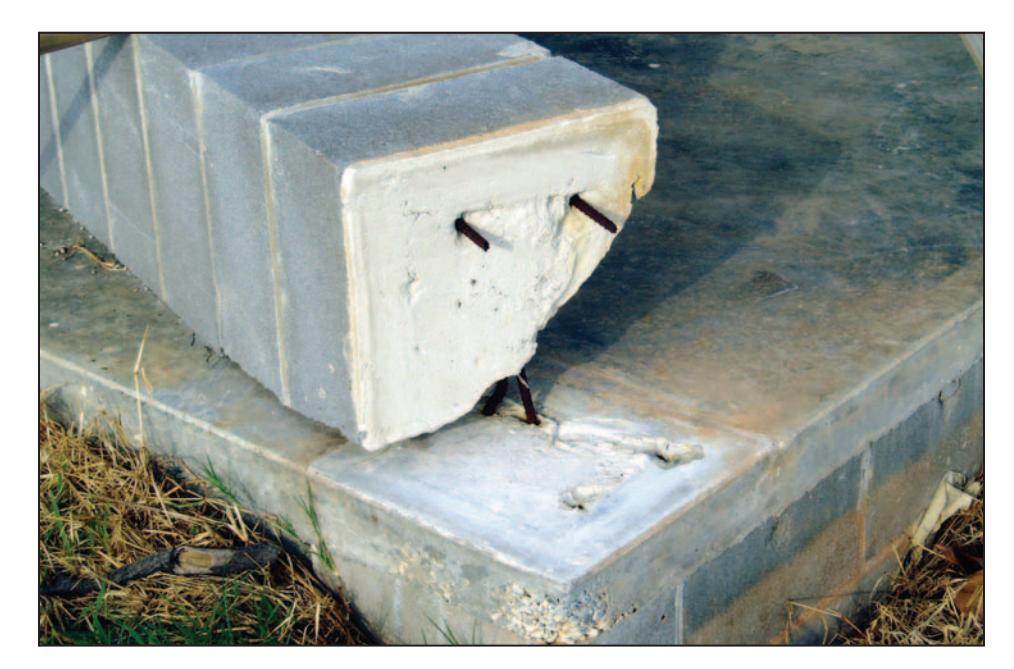
Figure 2-18. Failed masonry column connection, Hurricane Katrina (Jackson County, MS, 2005)

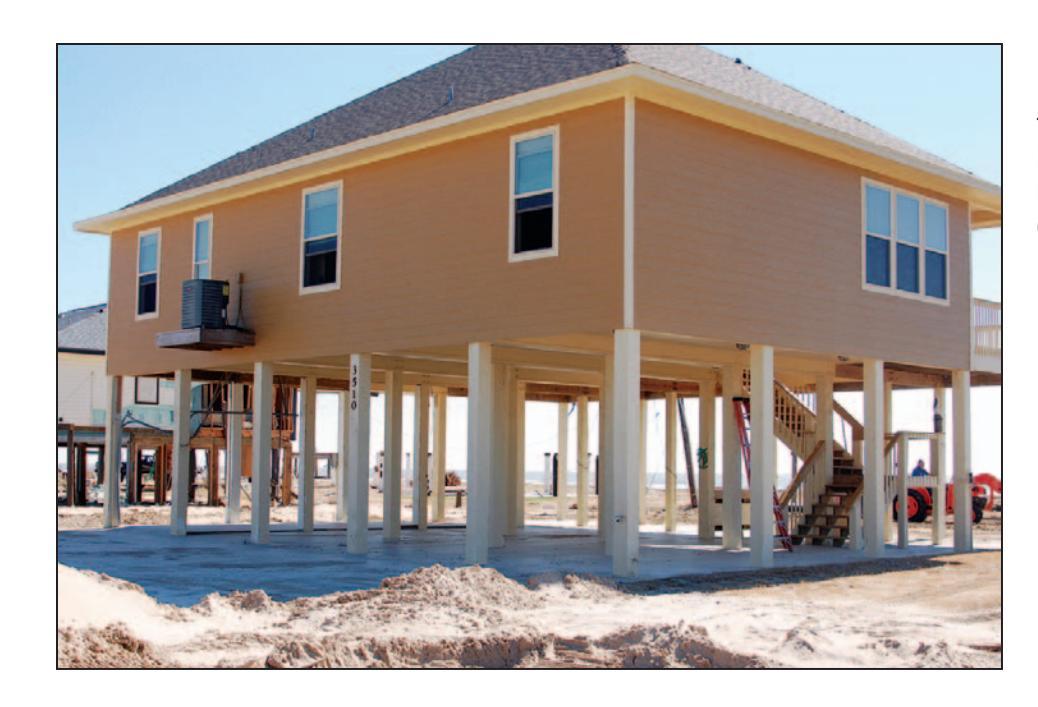
Figure 2-19. Breakaway walls below the first floor of this house broke as intended under the flood forces of Hurricane Ike (Bolivar Peninsula, TX, 2008)

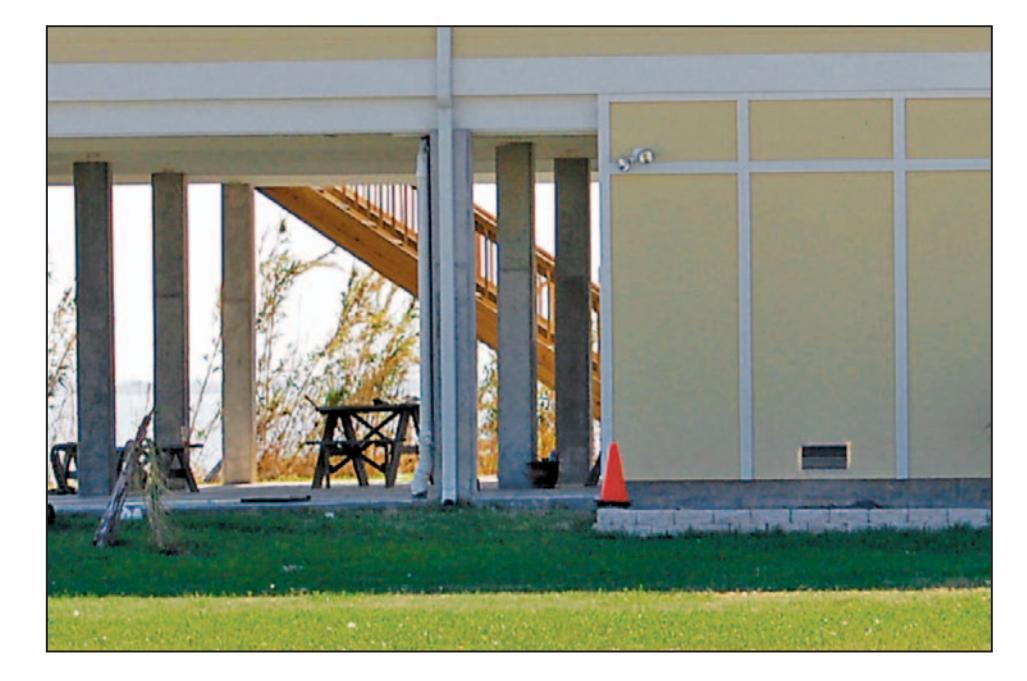
Figure 2-20. Flood opening in an enclosure with breakaway walls, Hurricane Ike (Galveston Bay shoreline, San Leon, TX)

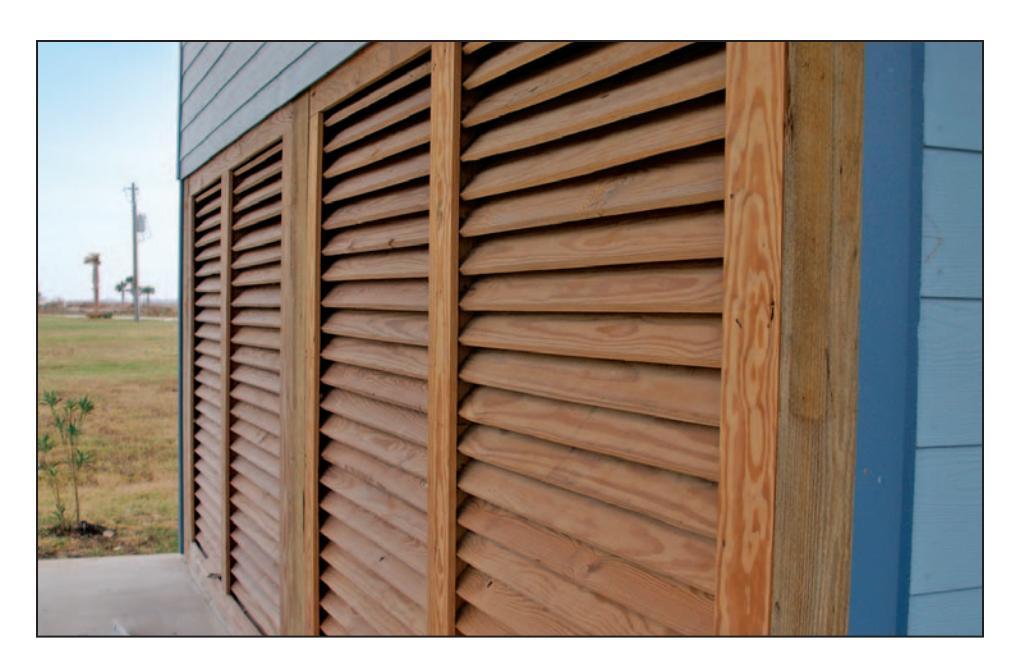
Figure 2-21. Louvers installed beneath an elevated house are a good alternative to breakaway walls SOURCE: FEMA P-499 2010

premiums. Flood insurance premiums for a building located in Zone V are much less when a below-BFE enclosure is formed by louvers than by breakaway walls. A building with an enclosure formed by louvers is classified the same as if it had insect screening or open lattice (Figure 2-22), i.e., as "free of obstructions," while a solid breakaway wall enclosure results in a "with obstruction" rating for the building.

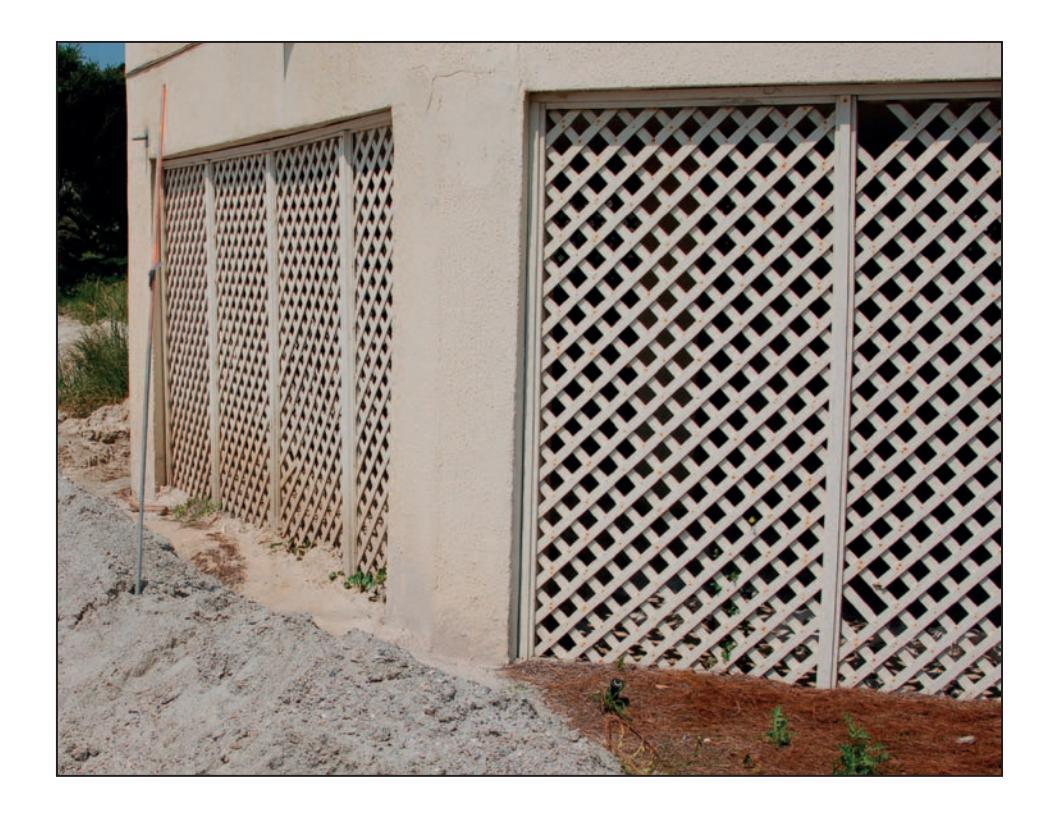
Figure 2-22. An enclosure formed by open lattice (Isle of Palms, SC)

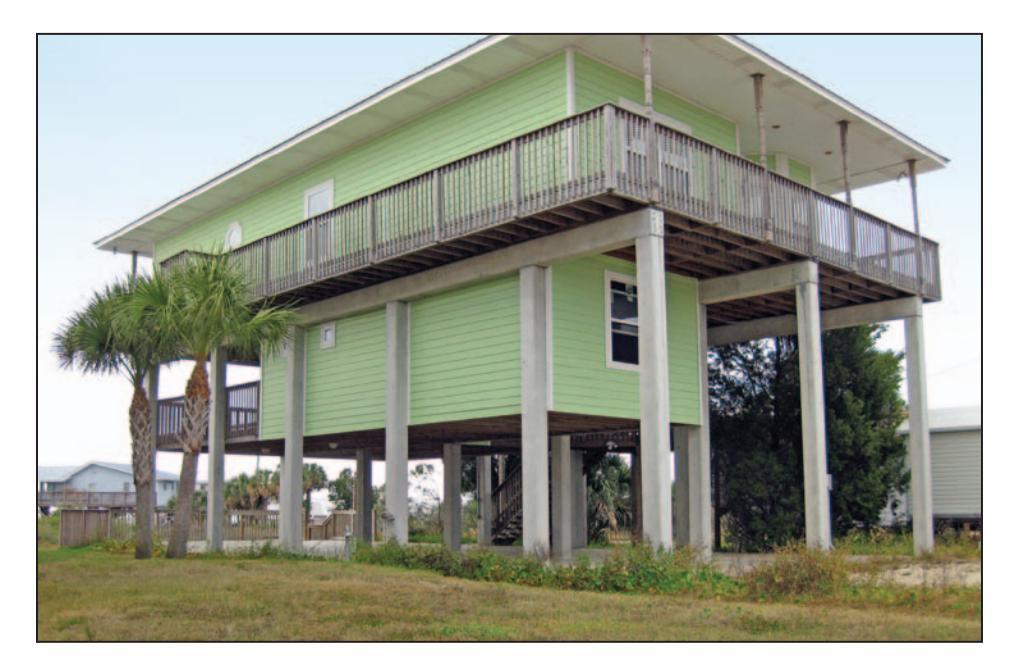
Figure 2-23. Above-grade enclosure (Perry, FL) Figure 2-24. Two-story enclosure SOURCE: FEMA P-499 2010

Enclosures that do not extend all the way to the ground (sometimes called "above-grade," "hanging," or "elevated" enclosures). These enclosures have a floor system that is not in contact with the ground, but that may be connected to the building foundation or supported on the primary pile system or short posts (Figure 2-23). Having the floor of the enclosure above grade means frequent flooding passes underneath, which may reduce the frequency and severity of damage. These enclosures were not contemplated when flood insurance premium rate tables were prepared, and thus can result in significantly higher flood insurance premiums. As of early 2011, the NFIP was working to address this type of construction, but until such time as it is resolved, owners will pay a substantial premium penalty for this type of enclosure.
