# Design of Trombe Walls

# **Trombe Walls in Low-Energy Buildings: Practical Experiences**

**Preprint**

P. Torcellini and S. Pless

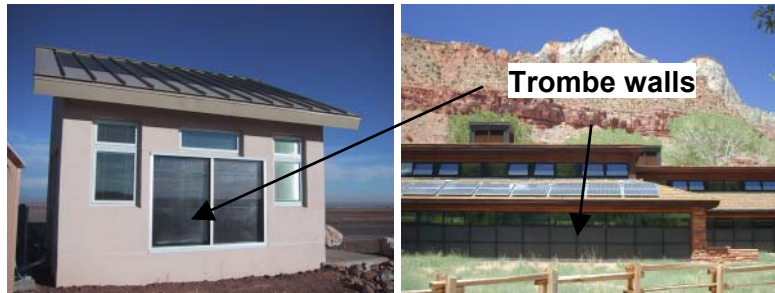
Figure 1 shows the Trombe wall locations in the NREL SEB (a), and the Zion Visitor Center (b).

**Figure 1. a) NREL SEB, b) Zion Visitor Center**

These Trombe wall design concepts were applied to the low-energy design of the Visitor Center at Zion National Park in Utah and to NREL's Wind Site SEB in Colorado.

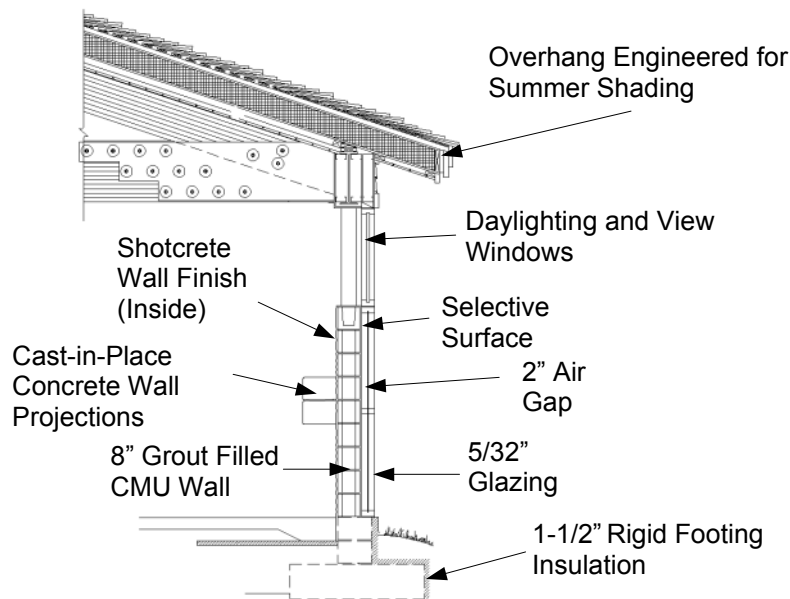
The Visitor Center Trombe wall design details are shown in the cross section in Figure 2. The 6-ft-high (1.8-m) Trombe wall (740-ft<sup>2</sup> total area (68.7-m<sup>2</sup>) is located on the entire length of south-facing walls of the Visitor Center. The wall is 44% of the total south facing wall area. The Trombe wall is 8-in (20-cm) grout-filled concrete masonry units (CMU) with an R-value of 2.5 hr·ft<sup>2</sup>·°F/Btu (0.4 K·m<sup>2</sup>/W). The other walls are 6-in (15-cm) framed walls with an R-value of R-16 hr·ft<sup>2</sup>·°F/Btu (2.8 K·m<sup>2</sup>/W). The Trombe wall has a single piece of high transmittance patterned glass installed on a thermally broken storefront system.

**Figure 2. Cross-section details of Zion Trombe wall**

The performance of Trombe walls is diminished if the wall interior is not open to the interior zones. Based on previous experiences with Trombe walls (Balcomb 1998), the heat delivered by a Trombe wall in a residence was reduced by over 40% because kitchen cabinets were placed on the interior of the wall. The wall design at Zion includes cast-in-place concrete projections attached to the interior of the wall. These projections were included to ensure bookshelves were not placed against the Trombe wall.

The interior surface of the Zion Trombe wall was selected to maximize the heat transfer to the space. Some interior surfacing materials, such as drywall, can reduce the heat delivered by Trombe walls due to nonconductive air gaps in between the concrete wall and the interior surface (Balcomb 1998). A shotcrete wall finish was specified to provide a more continuous conductivity throughout the wall.

During the construction process, the filling of the CMU wall was monitored to ensure the concrete block cores were completely filled, which provides a consistent conductivity through the wall. The placement of the footing insulation was also verified during the construction process to ensure proper installation. The location of this insulation is critical, as Trombe wall performance can be diminished due to three-dimensional heat

transfer to the ground. By thermally decoupling the footings from the ground with insulation, unnecessary heat loss is avoided and more heat from the Trombe wall is supplied to the building.

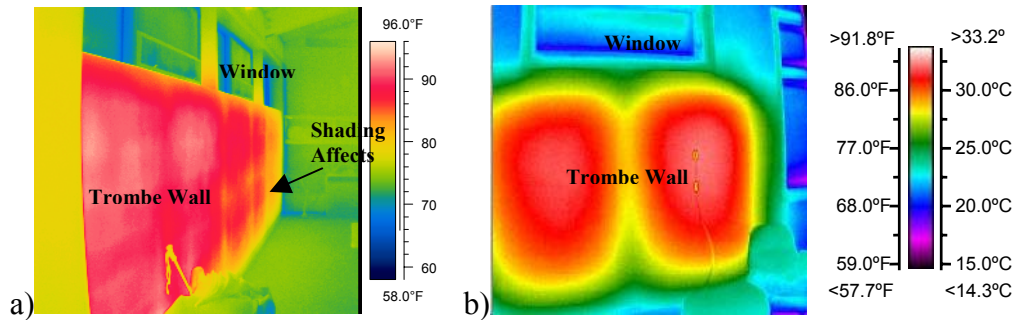
Figure 3 shows the thermal distribution of the Zion Trombe wall at 8:30 p.m. on December 16, 2000. The interior surface temperature is generally homogeneous, ranging from 90-96°F (32-36°C). The wall temperature typically peaks between 8-9 p.m. The reduced wall temperature at the far right section of Trombe wall is due to shading. The

building shades a portion of the Trombe wall in the afternoon, resulting in reduced interior temperatures.

**Figure 3. Infrared pictures of a) Zion Trombe wall December 16, 8:30 p.m. and b) NREL SEB Trombe Wall January 21, 8:00 p.m.**

The interior surface temperature of the SEB Trombe wall typically peaks at 120-130°F (49-54°C) at 3:30-4:00 p.m. during the heating season. The interior temperatures of the SEB wall are generally higher, but earlier in the day than the Zion wall. This difference is due to the 4-in (10-cm) SEB wall that releases the heat quicker than the 8-in (20-cm) Zion wall. During good solar days in the heating season, the Trombe wall typically provides all of the necessary heating throughout the afternoon and evening.

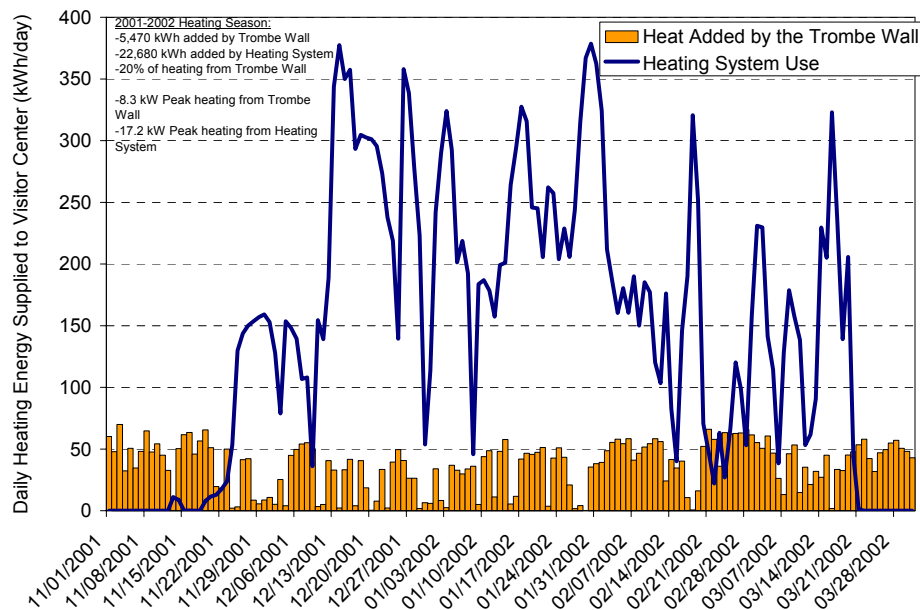
The temperature gradient in the wall was measured during the 2001-2002 heating season. With internal temperature measurements, the Trombe wall energy supplied to the building was calculated based on published heat flux calculation methods (Balcomb 1980). The Visitor Center Trombe wall daily performance during the 2001-2002 heating season is shown in Figure 4. The electric radiant heating system used 22,680 kWh (81.6 GJ) over the year, with the Trombe wall contributing 20% of the total heating to the building. The Trombe wall imposed a heating load on the building for only two of the 151 days of the 2001-2002 heating season. For the other 149 heating days, the wall was a net positive. The peak heat flux through the wall was 11.2 W/ft<sup>2</sup> (89 W/m<sup>2</sup>), or 8.3 kW over the entire Trombe wall area. The average efficiency of the wall (defined as the heat delivered to the building divided by the total solar radiation incident on the exterior of the wall) was 13%.

**Figure 4. Zion Visitor Center Trombe wall and heating system performance, 2001-2002 heating season**
