Mine Subsidence and Damage to Residential Structures

MSD101

Mine Subsidence in Illinois: Facts for Homeowners

Circular 569 2006

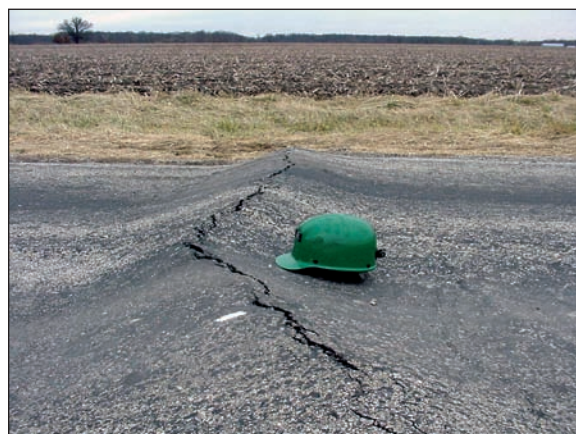
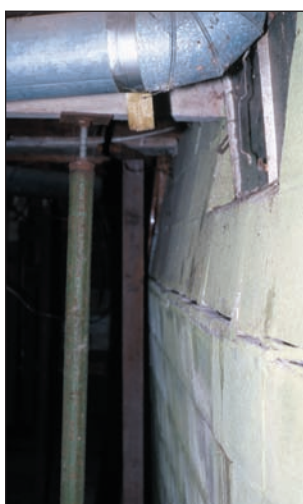
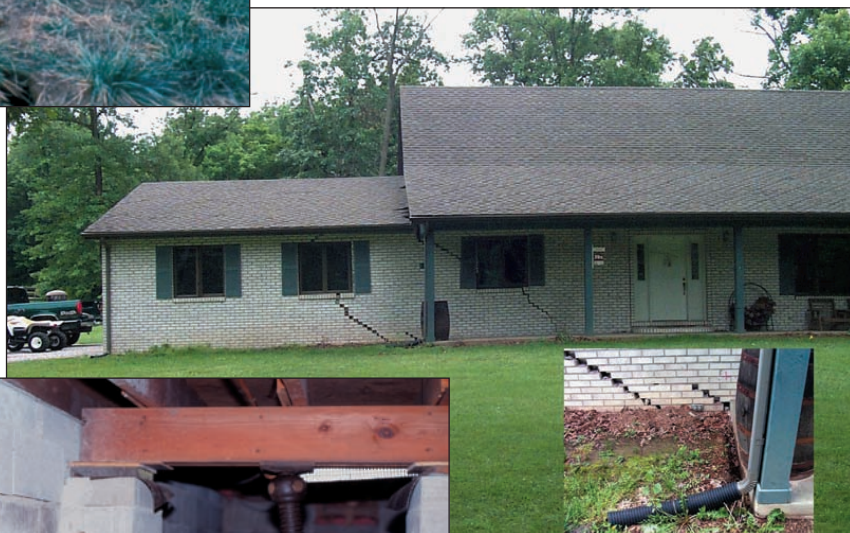
Front Cover: (a) Tension cracks formed in the ground surface extending through a home; the foundation has settled at the house corner closer to center of sag. (b) Compression ridges formed in a road as the result of ground movement (compression) associated with coal mine subsidence. (c) The brick-sided house in the tension zone shows downward bending (compare roof lines). The left side of the home is closest to the sag center and has dropped down. Insert: ground has pulled away from the porch toward the sag center (left). (d) Settlement of main beam caused by construction problems. (e) This basement damage was unrelated to mine subsidence. It was caused from decades of seasonal wetting and drying of soils, which built up pressure against the basement foundation walls. With each cycle, dryness allows fine grains of soil to fall into the gap between the soil and the foundation wall. When moisture returns, the soil expands, increasing pressure until the wall fails and is pushed inward.

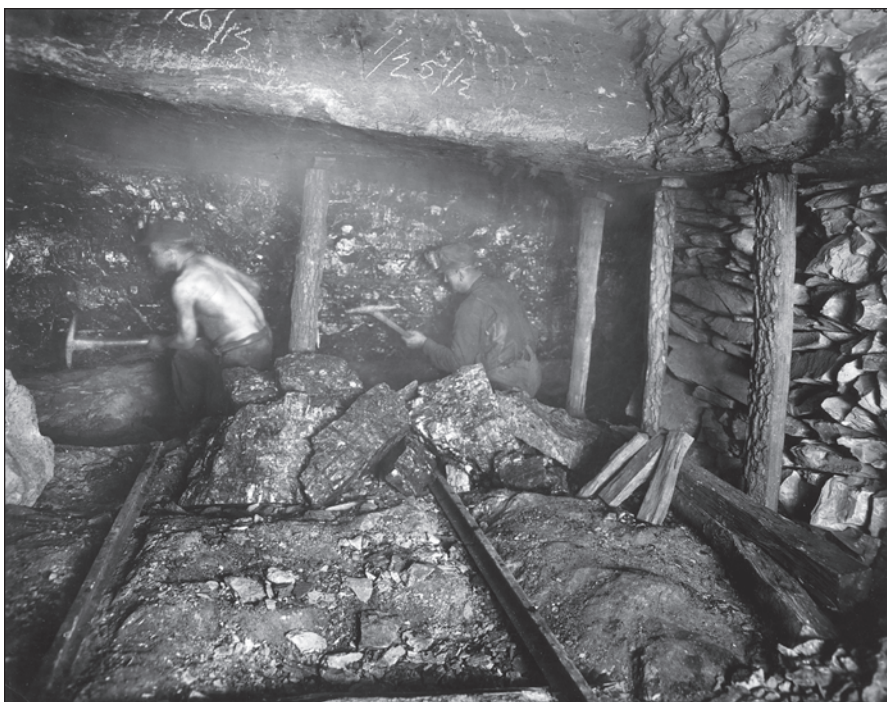
Figure 5 Photograph of mining at the face in an early longwall mine. Note the rock support on the right side of photograph. These mines operated from the 1870s to 1951 in fifteen counties. Most were located in the northern counties from Bureau through Will (fig. 2).

In the late 1800s and early 1900s, longwall mines (figs. 5 and 6a) were excavated by hand, and workers maintained the haulageways (entryways) by placing stacked rock, wooden props, and rock-filled wooden structures to replace the support lost by the removal of coal. The mine roof and the rest of the overburden’s weight settled onto the stacks of rock and compressed them. When this occurred, a few feet of subsidence resulted at the ground surface over the entire mined area.

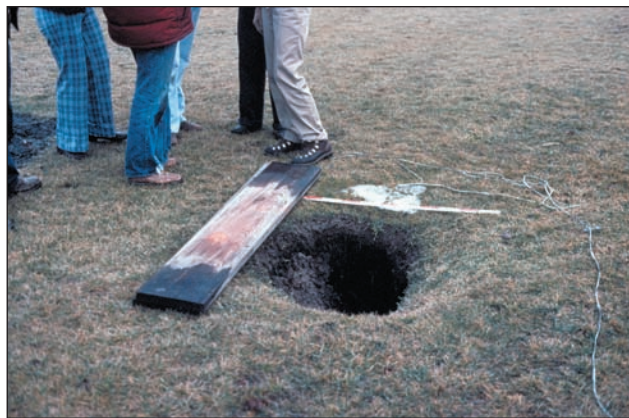
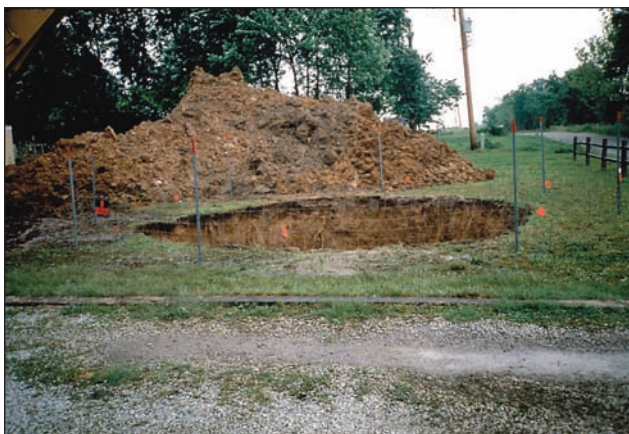
Figure 8 Diagram (Wildanger et al. 1980) and photographs of typical pit subsidence events.

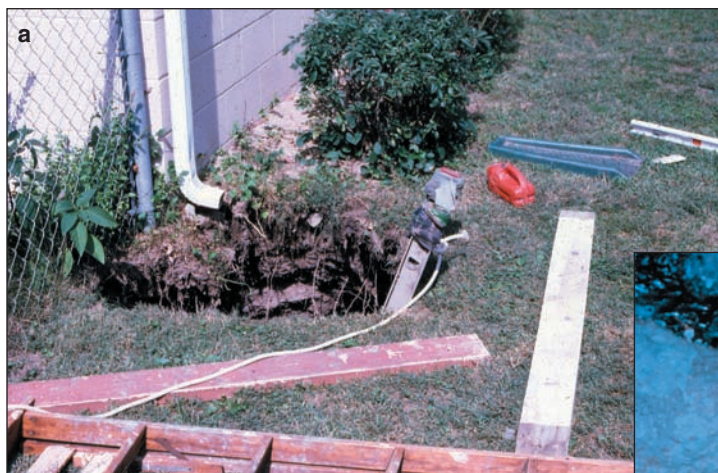
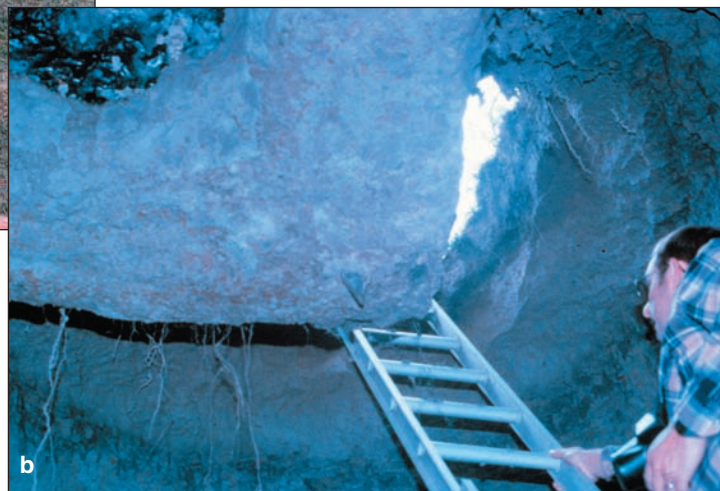
Figure 9 Pit subsidence under the corner of a house from (a) above and (b) below ground.

Structures can be damaged if pit subsidence develops under the corner of a building, the support posts of a foundation, or another critical spot. Otherwise, the probability of a structure being damaged by pit subsidence is low because most pits are relatively small—only a few feet across. If pit subsidence develops under foundation walls, the house may not be affected immediately because the foundation may temporarily bridge the pit (figs. 8 and 9). Left unfilled, the structure (bridge) may become damaged from lack of support.

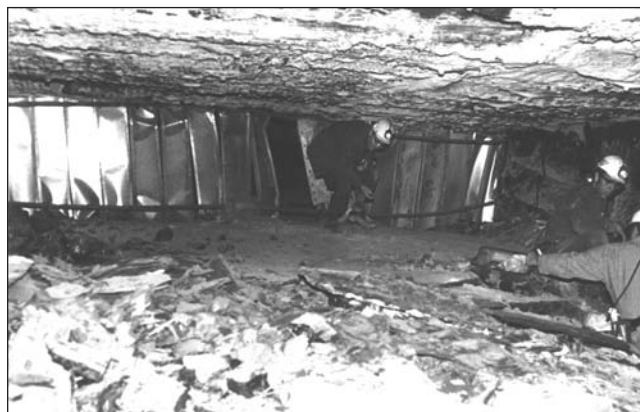
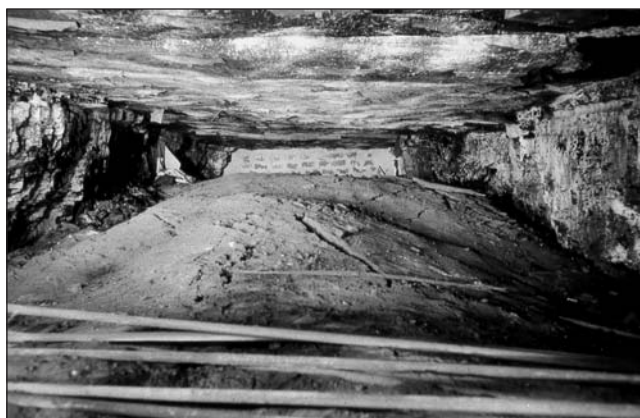
Figure 12 Diagram and photographs of coal pillars being pushed into a soft floor. The claystone material is being squeezed out from under the pillar up into the entryway.

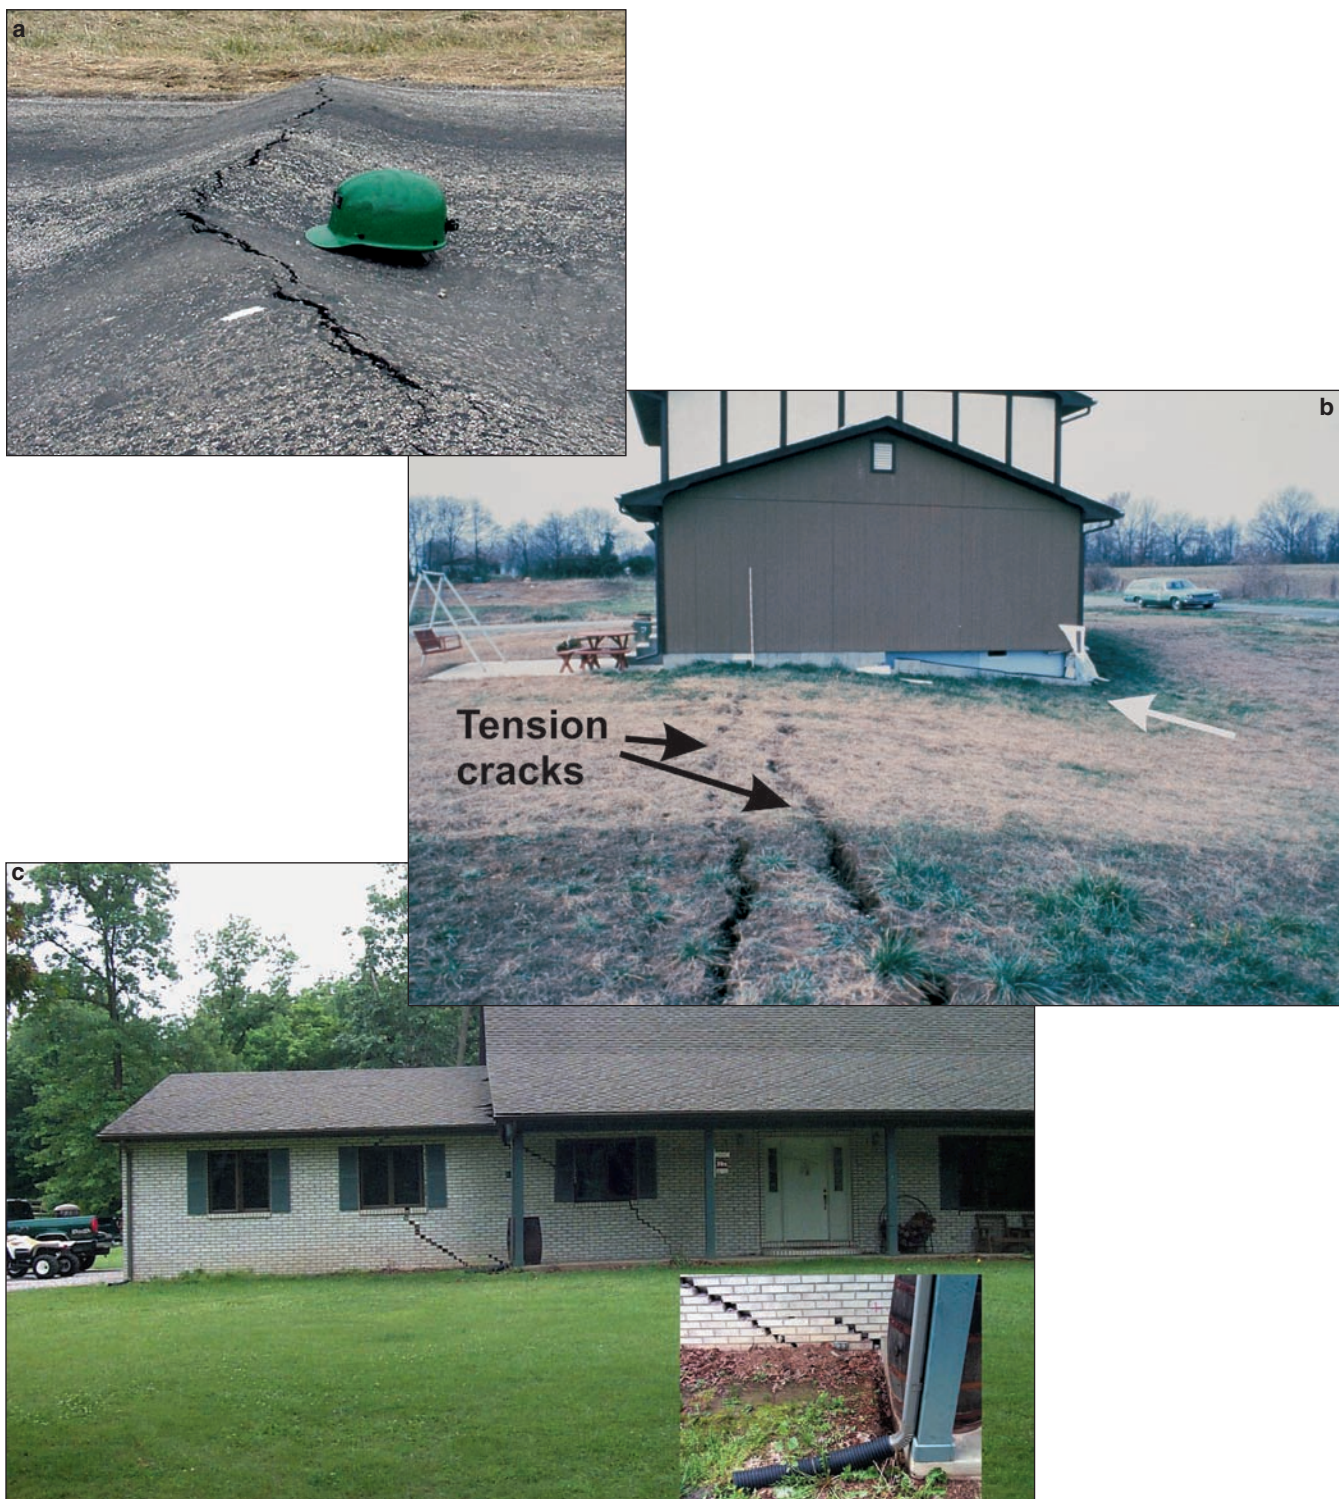
Figure 14 Photographs illustrating the sag subsidence event and features shown in figure 13. (a) Compression ridges formed in the road (feature R) as the result of ground movement (compression) associated with coal mine subsidence. (b) Tension cracks form in the ground surface extending through a home (feature H1); the foundation has settled at the house corner close to the center of the sag. (c) The brick-sided house (feature H2) in the tension zone shows downward bending (compare roof lines). The left side of the home is closest to the sag center and has dropped down. Insert: Ground has pulled away from the porch toward the sag center (left).

The ground moves in two directions during sag subsidence (figs. 13 and 14). The ground drops vertically and moves horizontally toward the center of the sag. At the surface, the sag may be much broader than the collapsed part of the mine. For example, a failure in a mine 160 feet deep could cause minor surface subsidence more than 70 feet beyond the edge of the collapsed area underground (edge of panel). The deeper the mine, the larger the area affected out over the unmined area. Collapsed areas in abandoned underground mines may occur in only part of a panel or mined-out area (fig. 15).

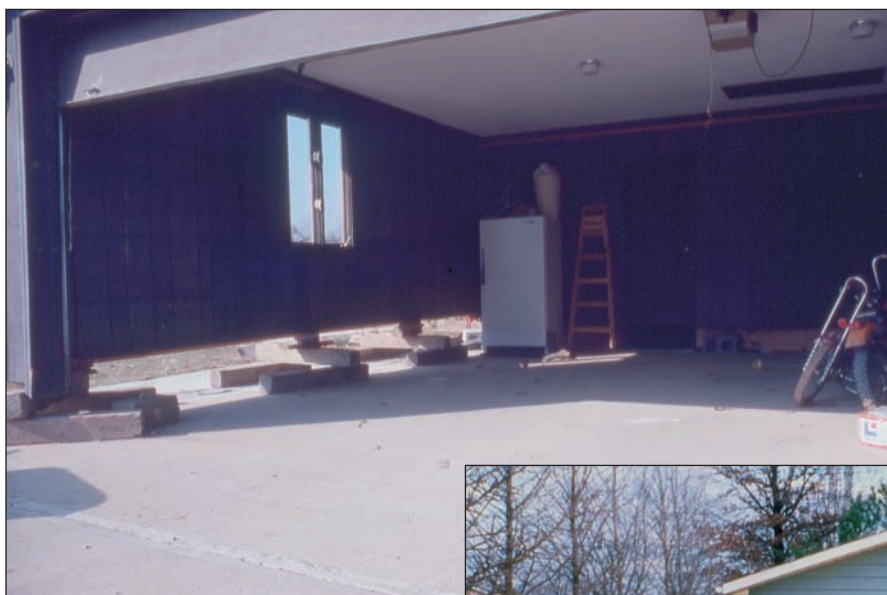
Figure 16 Load-bearing walls of a garage on a slab. The entire superstructure (frame) has been raised to a level position, exposing the interior of the garage. This re-leveling eliminates damaging stresses from differential movements of the foundation and maintains the superstructure level throughout the life of the event.

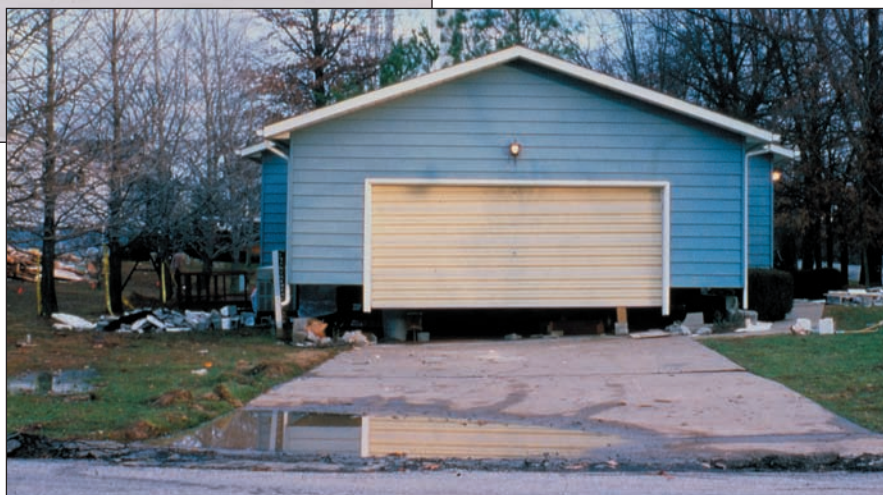
Figure 17 Concrete blocks of a crawl space have been removed to make room to jack the house to a level position. I-beams support the re-leveled house.

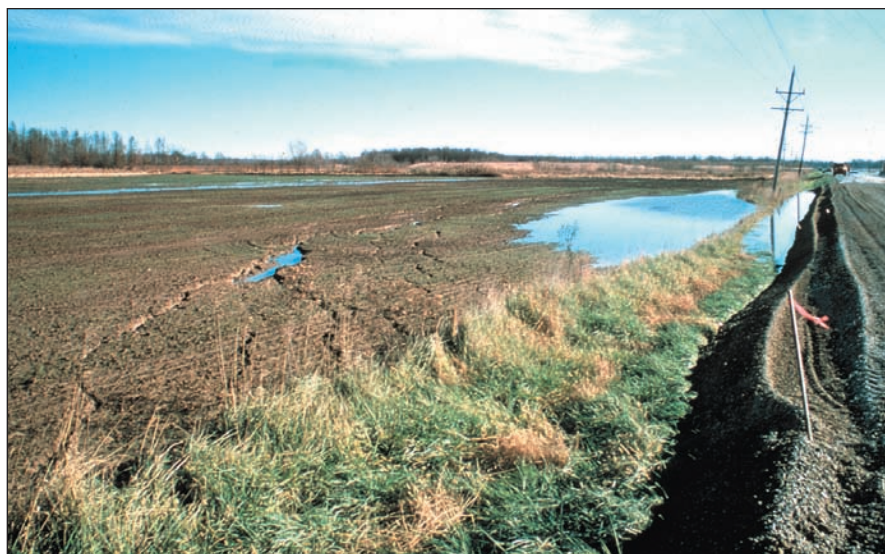
Figure 18 Ponding created by sag subsidence. Note the tension cracks around the edge of the depression.

Water can also pond in a sag subsidence event (fig. 18). If any part of a house is in a sag, an attempt should be made to keep water from accumulating around and under it. The ground surrounding the foundation must be kept

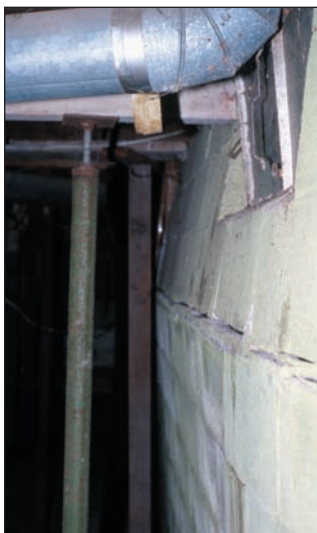
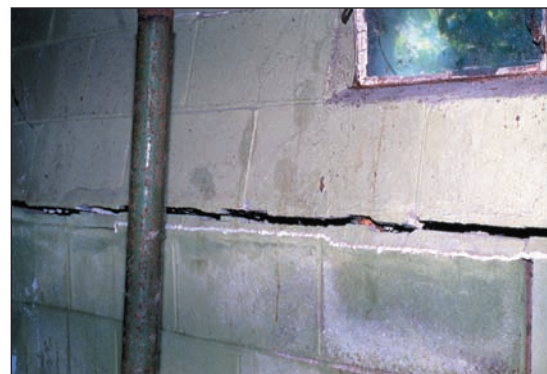
Figure 19 Basement damage unrelated to mine subsidence. Damage was caused from decades of seasonal wetting and drying of soils, which built up pressure against the basement foundation walls. With each cycle, dryness allows fine grains of soil to fall into the gap between the soil and the foundation wall. When moisture returns, the soil expands, increasing pressure until the wall fails and is pushed inward.

Shrinking and swelling Moisture-sensitive soils expand when wet and shrink when dry. Many decades of cyclic wetting and drying build up pressure against basement foundation walls as soil and other debris fall into the space between the foundation wall and the dry, shrunken soil. Pressures build until basement walls are pushed inward, forming horizontal cracks that continue across the length of the wall until they propagate downward in a stair-step pattern near the corners. Often these cracks form on all walls but tend to be more severe along the longer, load-bearing walls of rectangular-shaped homes. Typically, these horizontal cracks form a foot or more below the ground surface. If the walls move inward an excessive amount, the floor of the house may drop and tilt (fig. 19).

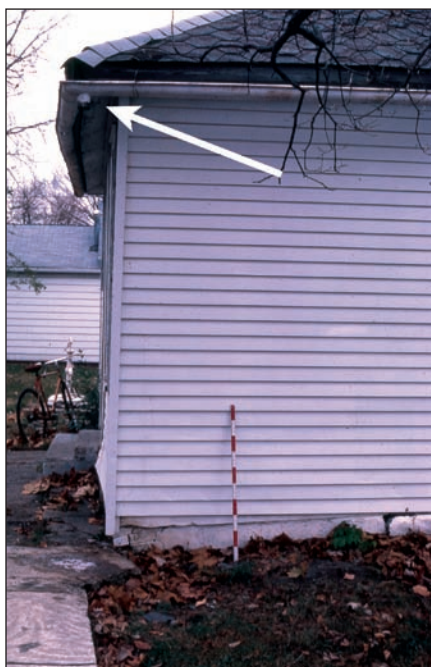
Figure 20 Foundation sinking at the corner of building due to reduced support caused by excessive, repeated moisture changes. Note gutter drainage (arrow) and lack of downspout to channel drainage away from foundation.

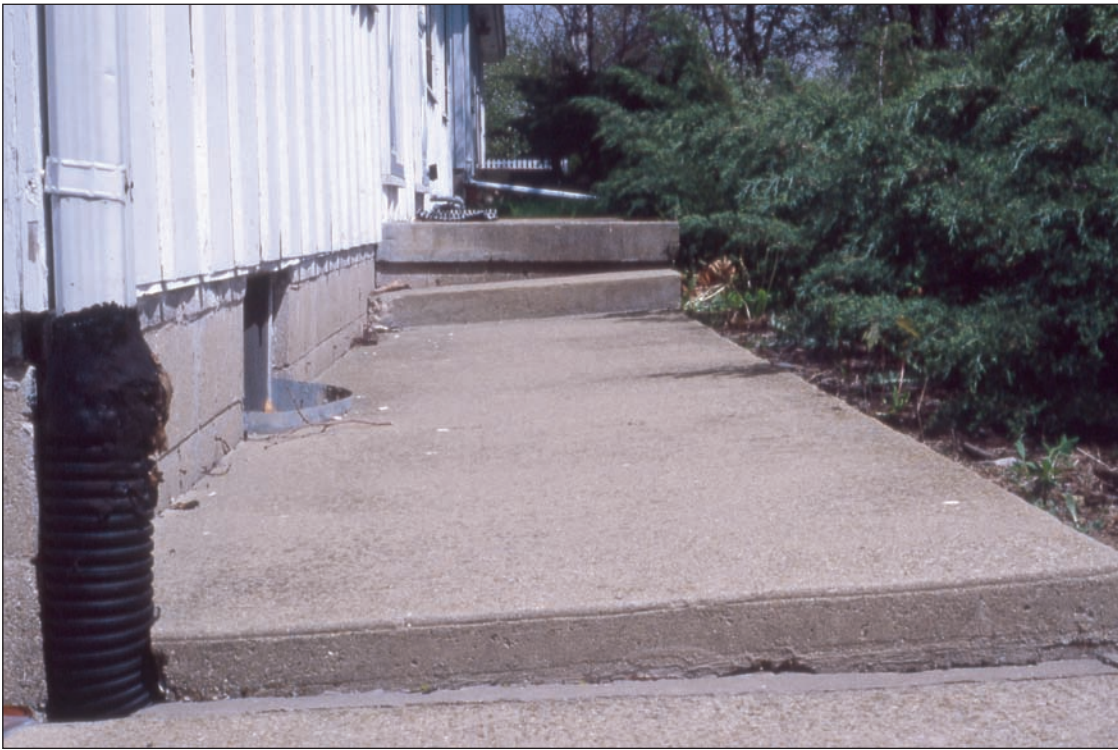
Figure 24 A moat-type depression along the foundation wall and lowered sidewalk and patio slabs caused by the kind of peripheral drainage system shown in figure 23.

Piping Piping, or subsurface erosion from water washing away fine-grained soil, can occur along broken or separated sewer lines, water lines, old farm tile, and buried downspout extensions (fig. 22). Older drainage systems around the outside base of the foundation—the peripheral drainage system—slowly remove soil particles and lower the ground surface around the house (fig. 23). This removal causes sidewalks, stairs, and patio slabs located along the foundation to drop and tilt toward the house (fig. 24).

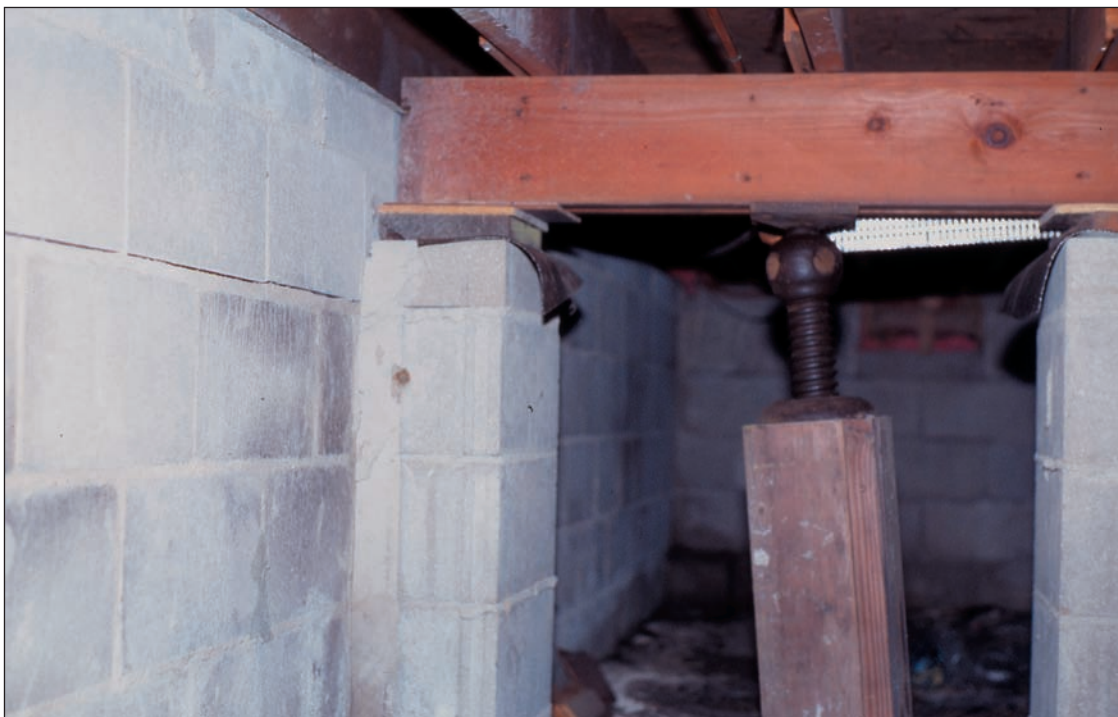
Figure 25 This main beam is not attached directly to the foundation wall. Because the beam is settling a different amount than the foundation and because some of the thick layers of shims are compressing, cracks have developed in the house above the beam.

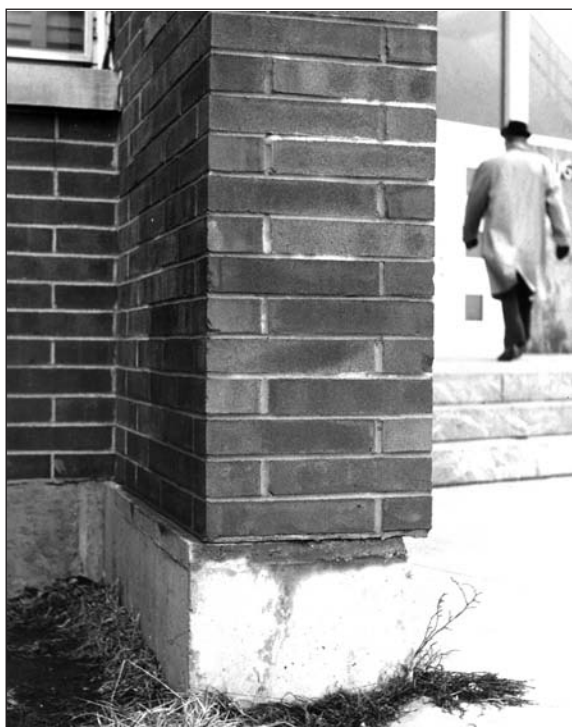
Figure 28 The largest movements are at the edges of the long continuous wall. At this point, the brick wall is being pushed off the foundation.

(fig. 28); weaker materials in the wall, such as glass blocks, may be crushed (fig. 29), and the sliding wall may become separated from the interior floor slab. To minimize this type of problem, functioning expansion joints should be incorporated into the construction. Expansion joints should be clear of any hard materials that may have fallen in during construction, and pliable caulk should be used to seal the gap.

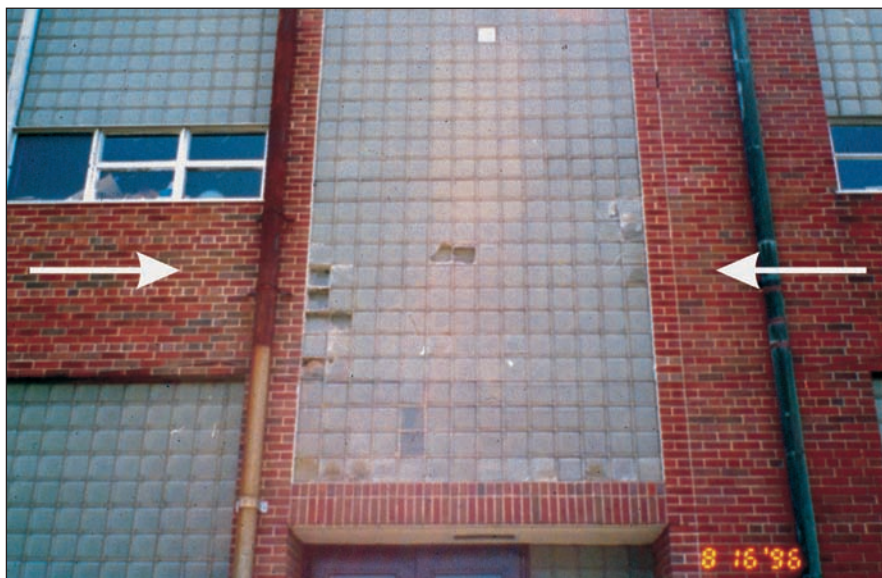
Figure 29 The long, continuous brickwork intersects the vertical glass block wall. Pressures have broken the glass blocks in line with the long continuous expanse of brick work.
